Refurbishing for Thermal Comfort: The rehabilitation of an abandoned village school building

MARYAM FARZIN MOGHADDAM¹, MEYSAM FARHOUDI¹, SOOFIA TAHIRA ELIAS
OZKAN¹, FRANCOISE SUMMERS²

¹Faculty of Architecture, Middle East Technical University, Ankara, Turkey

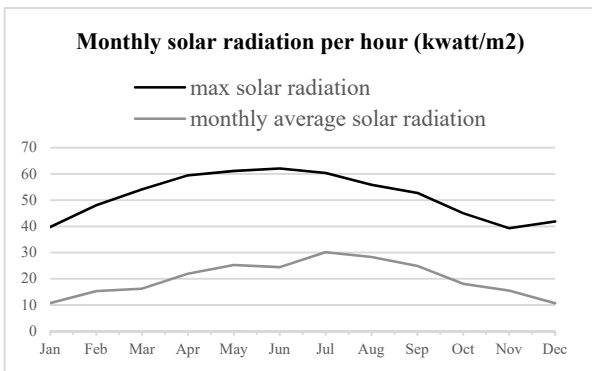
According to the hourly solar radiation data obtained from meteorology for the year 2015, the highest monthly average solar radiation amount is 62.1kwatt/m²

gained in June while in December and January the least amount of solar radiation gain is 10.7kwatt/m². Maximum amount of solar radiation for each month together with average values for each month are given in Figure 2.

Figure 2: Monthly maximum and average values of solar radiation. (Data source: TSMS)

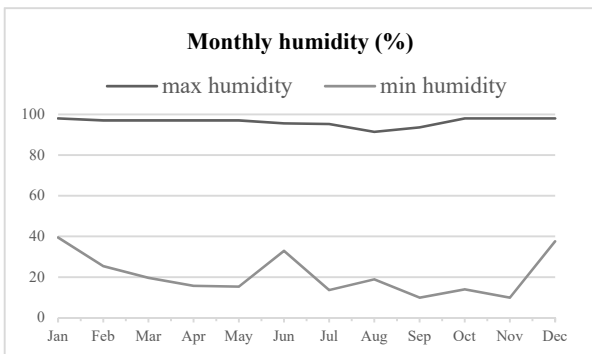
Figure 3: Monthly maximum and minimum values of humidity. (Data source: TSMS)

Analysing hourly humidity data shows that the annual average humidity is 66.8%. The highest humidity value

is recorded in October, November, December and January rising to 98% while the lowest humidity value is recorded in September and November falling to 9.9% (Fig. 3).

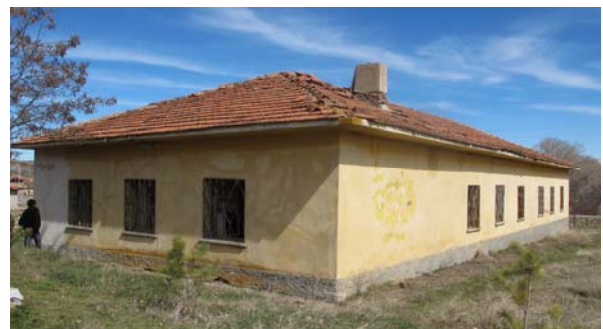
The refurbishment project was carried out on an abandoned school building (Fig. 5). The building has an east-west orientation such that its longest façades are facing north and south directions.

Figure 5: The abandoned village school before being taken over by the Kerkenes Eco-Center.

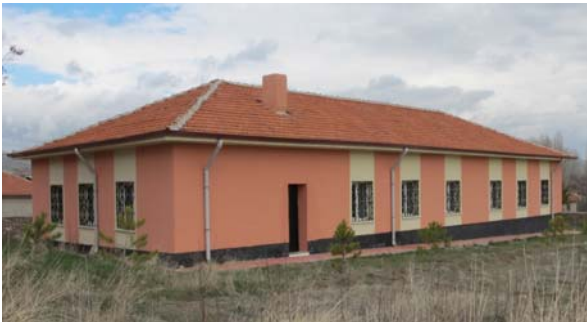
The school was converted into a multipurpose building to hold workshops and university courses, and to house the participants (Fig. 6). These courses are run by the faculty members of the Architecture department of a leading Turkish university, who are also running the Kerkenes Eco-Center in the same village. The village

school refurbishment project was aimed at maximizing thermal comfort and using solar energy for water and space heating. To this end thermal insulation was added to the part of the wall facing north and under the ceiling, a solar water heater was installed on the roof; the floor was covered with laminated wood flooring; the single glazed wooden windows were replaced with air-tight double glazed PVC windows; and a sunspace was designed to be constructed along the southern façade of the building (Fig. 7). The sunspace was divided into three areas: solar drying of fruits and vegetables on one end; a greenhouse for growing vegetables on the other end; and a dining area in the middle for use by the course students. The building was painted inside and outside according to the villagers' tastes. The funding for the refurbishment project was provided by the local government and the university students were involved in its construction.

Figure 6: The village school building after renovations.

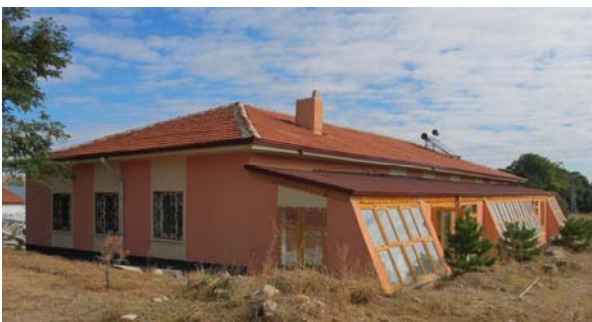
Figure 7: A solar space was added to the south façade of the school and a solar water heater was installed on the roof.

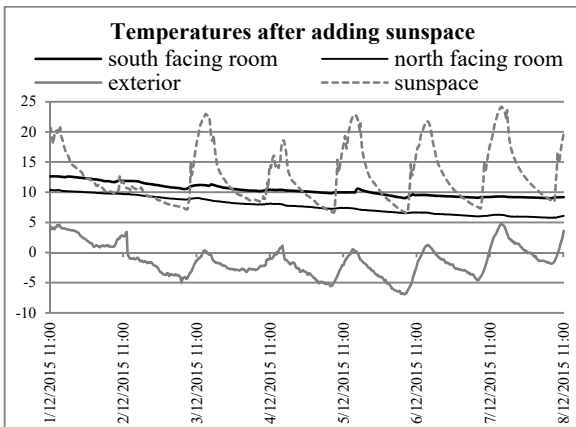
Data collected a year later for these rooms as well as the sunspace has been presented in another graph (Fig. 11) for the first week in December 2015.

Figure 11: Exterior and ambient interior temperatures after refurbishment as well as addition of sunspace.

An inspection of the graphical information given in Figures 10 and 11, it is understood that in the absence of the sunspace, the interior temperature of the room facing

south has a fluctuation relatively similar to that of exterior temperature. The maximum difference between interior and exterior temperatures in this case was about 5°C for the coldest day in December 2014. On the other hand, after adding the sunspace when the exterior temperature dropped to -6°C on December 6, 2015, the temperature in the south facing room was almost 10°C; thus giving a considerable difference of 16°C between the internal and external thermal conditions. This is because the south facing room is adjacent to the sunspace and therefore absorbs heat from it during the day while the thick stone wall in between stores heat thus leading to relatively consistent temperatures during the night.

In the case of the north facing room, it has a lower temperature compared to the south facing room; yet, it is always warmer than the exterior. The temperature in the sunspace follows the same trends as the outside temperature; however, the diurnal fluctuations in the sunspace are greater than that of the exterior.

The data presented in Figures 10 and 11 were collected when the windows between the rooms and the sunspace were closed; i.e. in absence of ventilation. In order to observe the effect of ventilation on interior temperatures for a limited period, from November 20th to 26th, the windows of the room adjacent to sunspace were opened during the day to allow harvested solar heat from the sunspace to enter the room interiors; but were kept closed during the night to retain the warmth inside the room.
