# THE KERKENES PROJECT

## A PRELIMINARY REPORT ON THE 2003 SEASON

Geoffrey and Françoise Summers

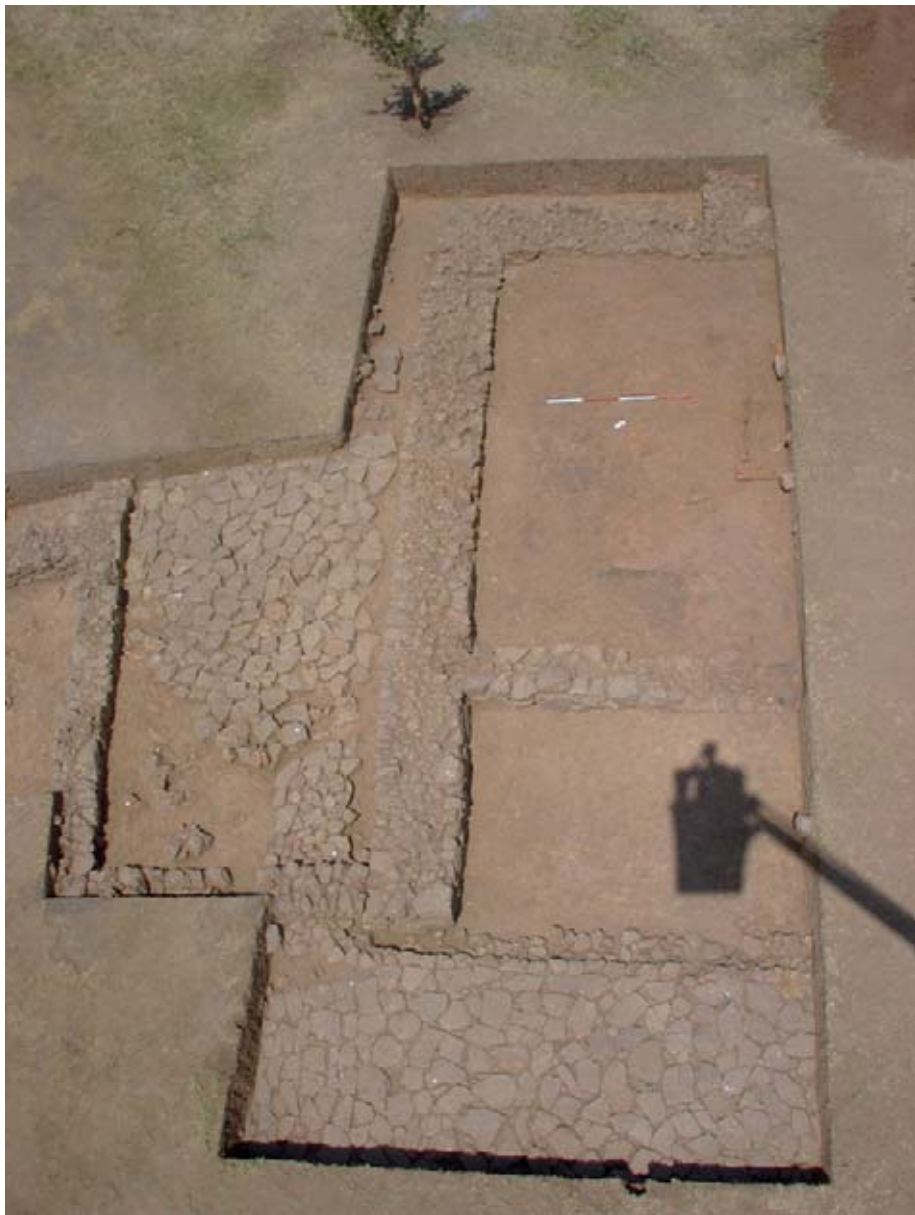
*Figure 1. Half of a megaron, identified through geophysical survey, was excavated in 2003. (03dpjv4223)*

No decorative revetment or roof tiles have been discovered at Kerkenes. The decision to excavate half of the megaron, in trench TR07, at the start of the 2003 season was partially influenced by the idea that if tiles of the types well known from Gordion, Pazarlı and elsewhere had been used at Kerkenes there seemed to be a high probability that they would be found in association with this megaron. It can now be asserted, with not inconsiderable confidence, that decorative tiles were not used at Kerkenes. The precise chronological implications of this observation are a matter for further discussion since the date of the earliest such tiles at both Sardis and Gordion, together with the date of those rock-cut façades in the Highlands of Phrygia that appear to depict both tiled roofs and tiled façades, is far from settled. In this context it should not however be forgotten that the site of Pazarlı lies only some 70km from Kerkenes as the crow flies.

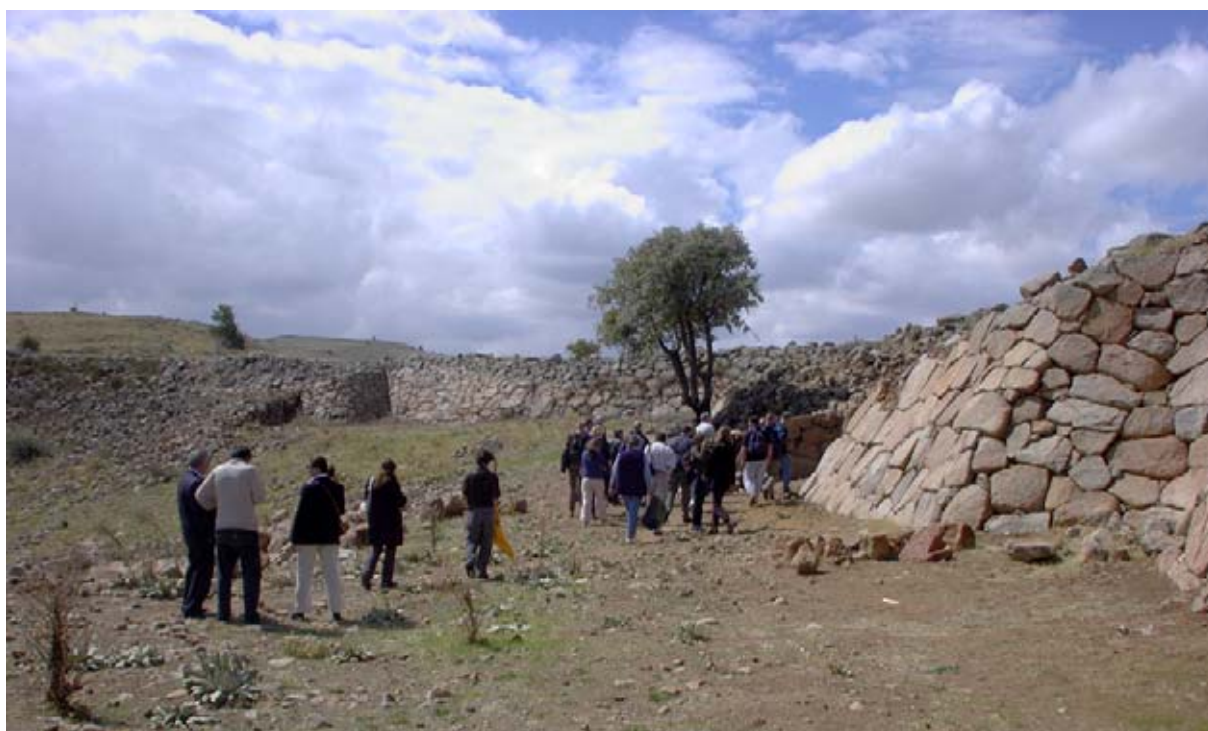
*Figure 5. The Cappadocia Gate at the end of the 2003 season. (03dpjv7409)*

In 2000 incontrovertible evidence was found that the entire 7km circuit of defences, together with the seven city gates were built entirely of stone (Figs 3 and 4). Not only were the defences found to have been completed, but additionally the fronts of the outer towers at the Cappadocia Gate were shown to have been crowned by a single course of cut sandstone (Fig. 5 at centre right) which was brought to the site from a considerable distance.

In 2003 partial clearance of the inner chamber at this same gate has provided evidence for some internal structure that included raised wooden flooring. Further, it was found that the surface of the Cappadocia Gate passageway had undergone significant erosion, forming a gully which had threatened to undermine a stretch of the passage walling on the north-western side that had been bolstered by the addition of stones along part of the gully edge (Fig. 6). Careful observations at other points around the defences suggest that the entire circuit would, if probed by excavation, provide similar evidence for embellishment together with a significant period of use.

It can now be concluded, therefore, that the built defences were not only fully completed but that the gate towers were embellished with a topmost course of sandstone and had also undergone some minor repairs before their destruction. On the other hand, there is no sign that the original scheme of seven city gates was altered by the addition of further entrances in spite of the fact there is only one gateway in the entire length of the long western side of the circuit.

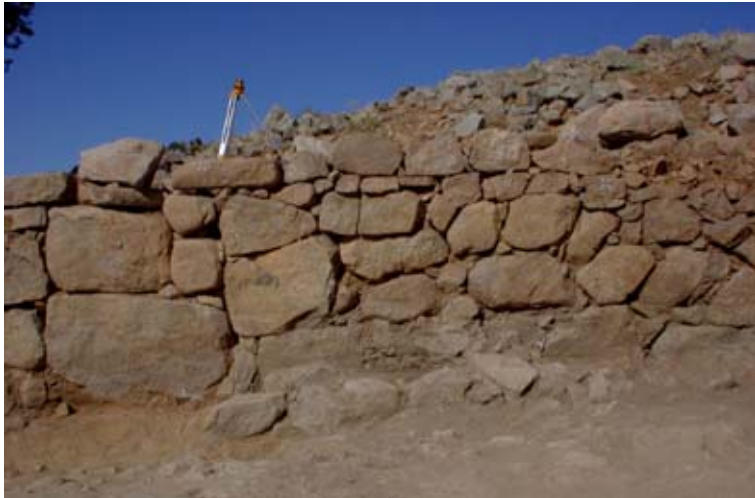
*Figure 6. The north-west wall of the gate passage where, at left, the gully has eroded down below the base of the wall which, at centre, has been protected by the addition of a row of stones. The vertical junction in the wall face at the extreme left is where the glacis butts against the front of the tower wall. (03dpjv6303)*

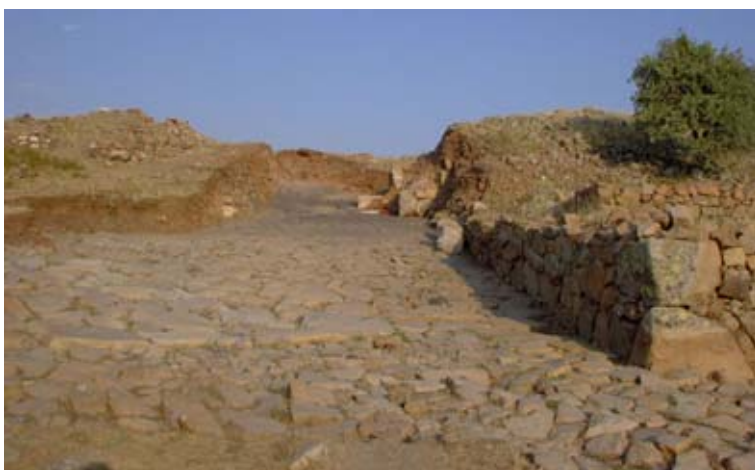
*Figure 7. The monumental entrance, trenches TR01 and TR11, at the end of the 2003 season. The scale is in front of the column base with the tower wall to the right. Structure B is in the foreground at right. (03dpjv6101)*

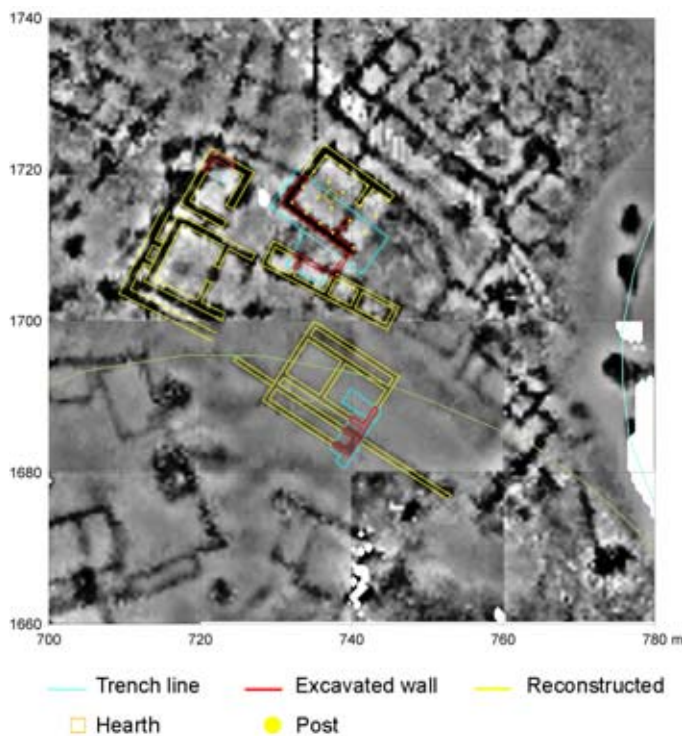
Figure 8. Resistivity survey map of part of the central area of the city with trenches TR06 to TR10 and a block plan of Structures A to E overlaid. See also Figure 28.

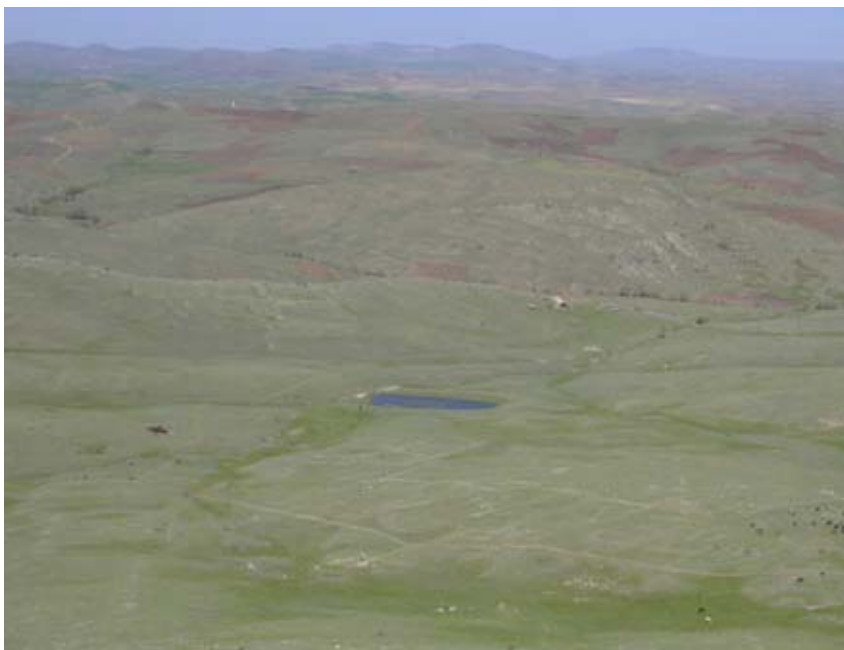
*Figure 11. The central part of the city in spring with the artificial Büyük Göl full of water. Stone foundations of urban blocks and structures can be seen as can part of the western defences. Grazing cattle at right provide an idea of scale. The animal pound at centre left lies partially over the megaron that was excavated in the summer season. (03dpjv1411)*

At Kerkenes water resources were carefully managed (Fig. 11). As well as the stone-lined Sülük Göl on the high southern ridge and the very large Büyük Göl in the centre of the city, tiers of reservoirs are found both inside and outside the city, often constructed according to a sophisticated system of bank-side storage,. Most or all of these reservoirs were primarily designed to be filled by underground seepage rather than rain-fed runoff. Similar systems can be observed in the Hittite management of water resources at Bronze Age Hattuša where artificial pools also appear to have been fed by underground seepage.

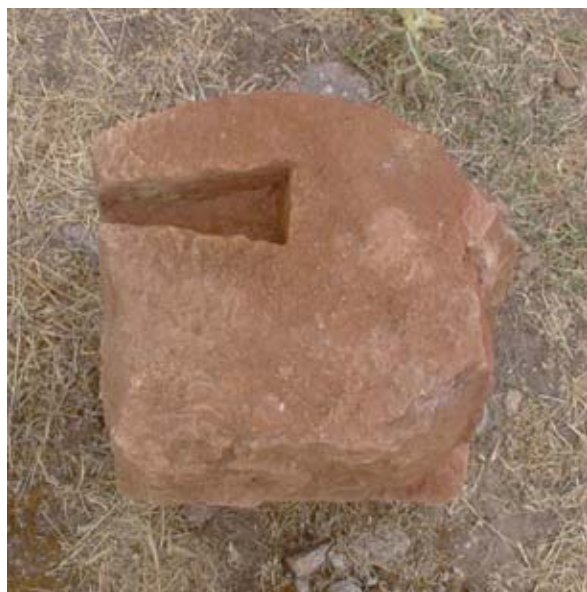
*Figure 12. Part of a sandstone block, with a swallowtail cutting for a wooden clamp, from the Monumental Entrance to the Palace Complex. (03dpjv5444)*

With regard to details of construction techniques, at the Monumental Entrance to the Palace Complex it has been found that some, and perhaps most, of the large sandstone blocks were secured together with the aid of wooden clamps (Fig. 12). The date of the first use of such clamps in Central Anatolia is not clear, but I do not know of any examples from Gordion or Boğazköy. Nor are there any such clamps in Urartu. At Sardis the earliest clamps are found in a few of the blocks in the Tomb of Alyattes, but these appear to have been entirely lead filled (Crawford Greenewalt pers. comm.).

The Kerkenes clamps vary in size, but not in depth, even where two occur on the same face of the same stone. The form resembles the swallow-tailed rather than the dovetailed variety, although the sides are sometimes slightly curved. It is generally assumed that iron bars were fixed into these wooden clamps, as they were later fixed into lead, but no such iron clamps have been recovered from amongst the large number of very well preserved iron building elements which were found in the burnt debris. Yet other cuttings in the sandstone blocks appear to represent additional forms of fixing that employed squared wooden elements, but the sandstone blocks were smashed and usually shattered, with the result that it has been difficult to reconstruct the precise form of these cuttings.

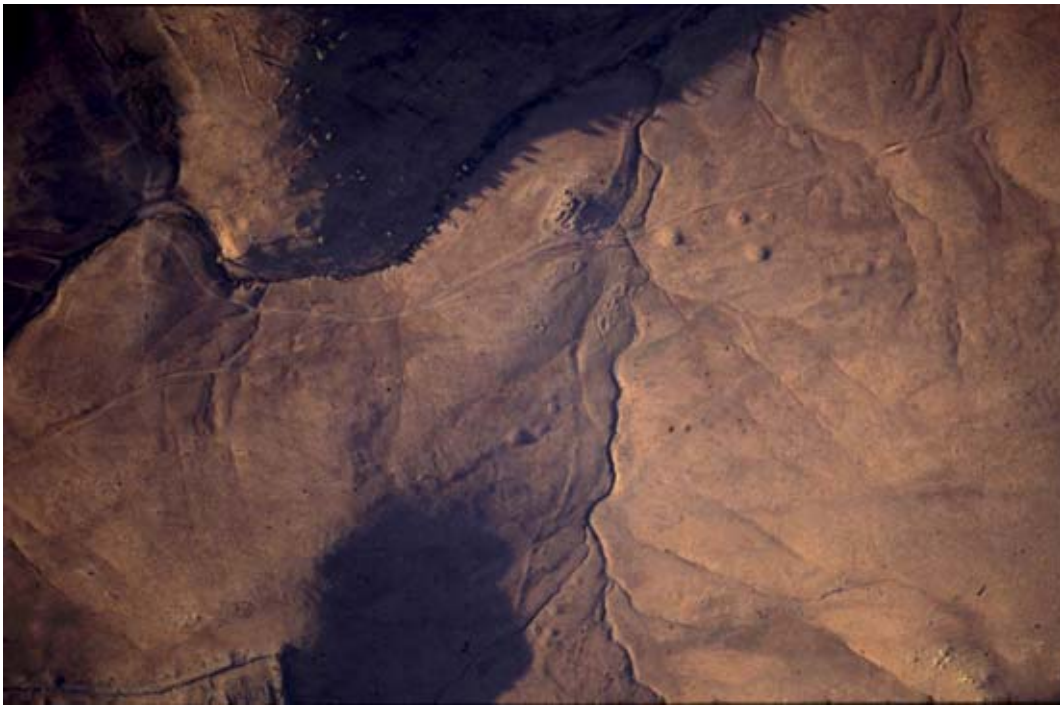
*Figure 13. Karabaş at centre top and some of the many tumuli outside the city seen from the hot air balloon in 1993. The north tip of the defences can be seen at the left bottom corner of the photo. (93slhb0232)*

Tumulus burials of various type, dating from the Iron Age to the Hellenistic or Roman period, abound in Central Anatolia. There is, however, a particularly heavy concentration of tumuli, some of which were certainly for cremation, on the ridges to the west of Kerkenes (Fig. 13). It may be safely presumed that most if not all of these tumuli are associated with the city, although that does not mean that all of the inhabitants were buried in the same way. Tumuli are, of course, characteristic of the Gordion Ankara region of Phrygia in the Iron Age.

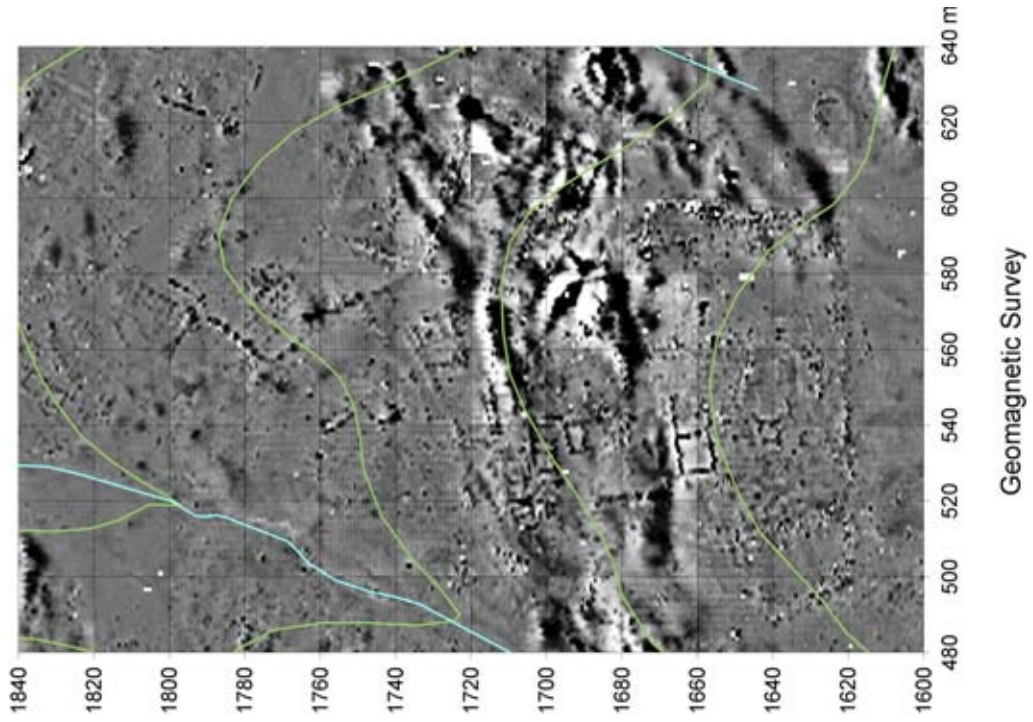
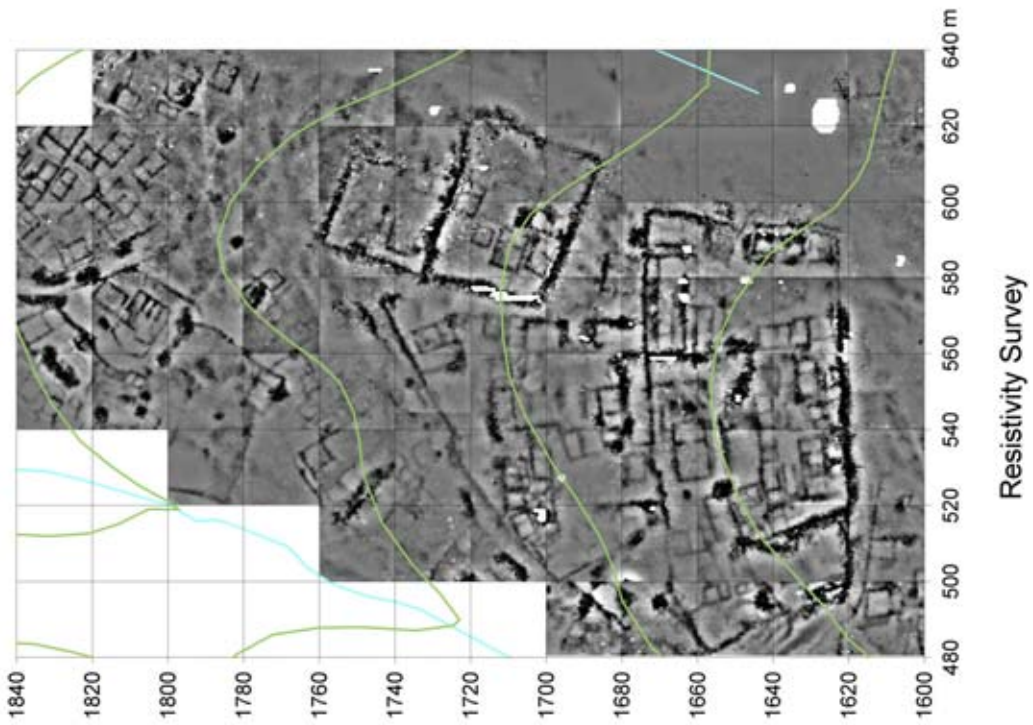
*Figure 15. In the lower area of the city resistivity provides much clearer imagery than geomagnetic survey.*

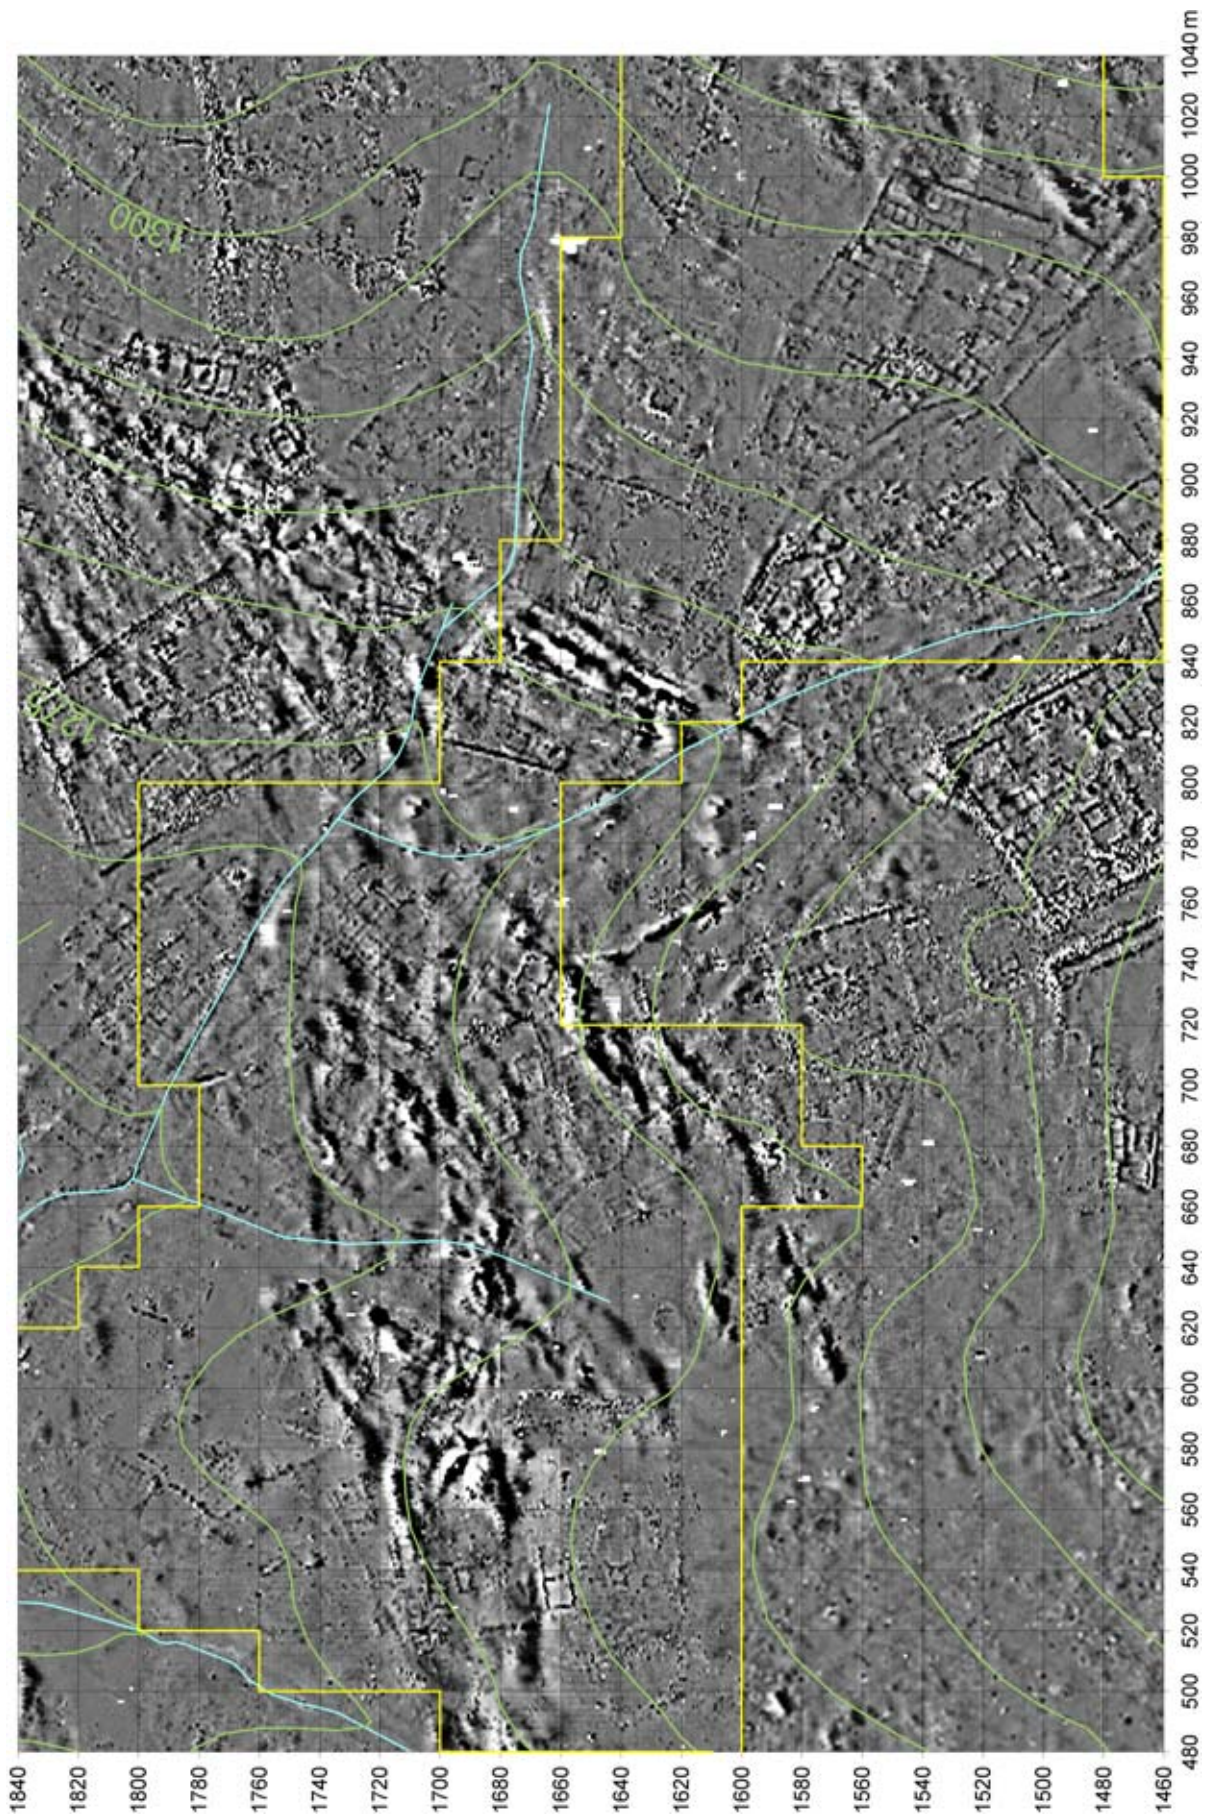
Figure 16. The area of Resistivity Survey, in yellow, over the gradiometer map.

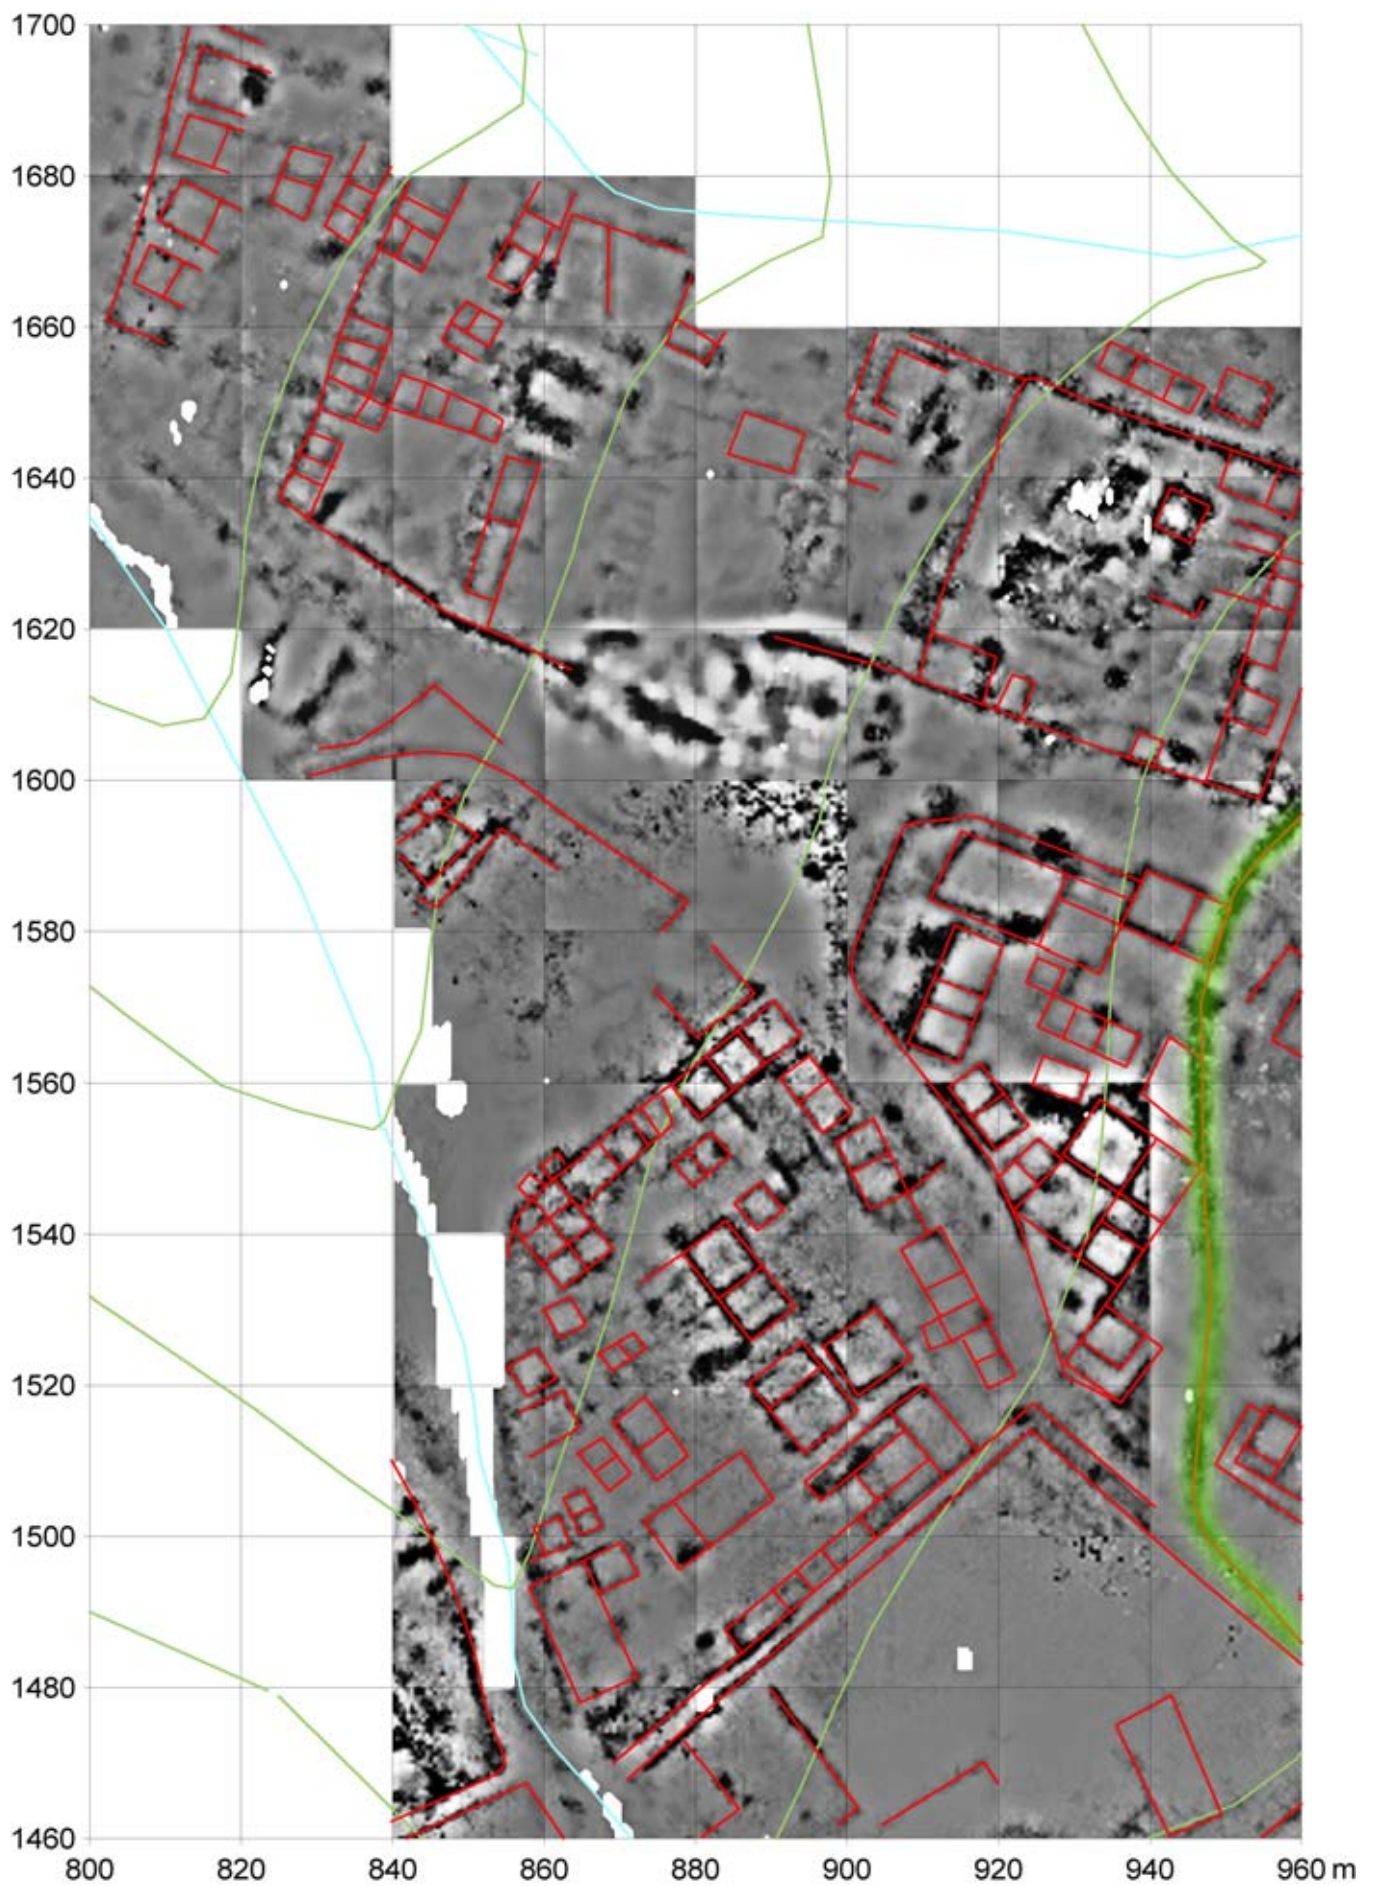
*Figure 23. The east-central portion of the resistivity survey with buried walls shown in red and a later enclosure wall in green.*

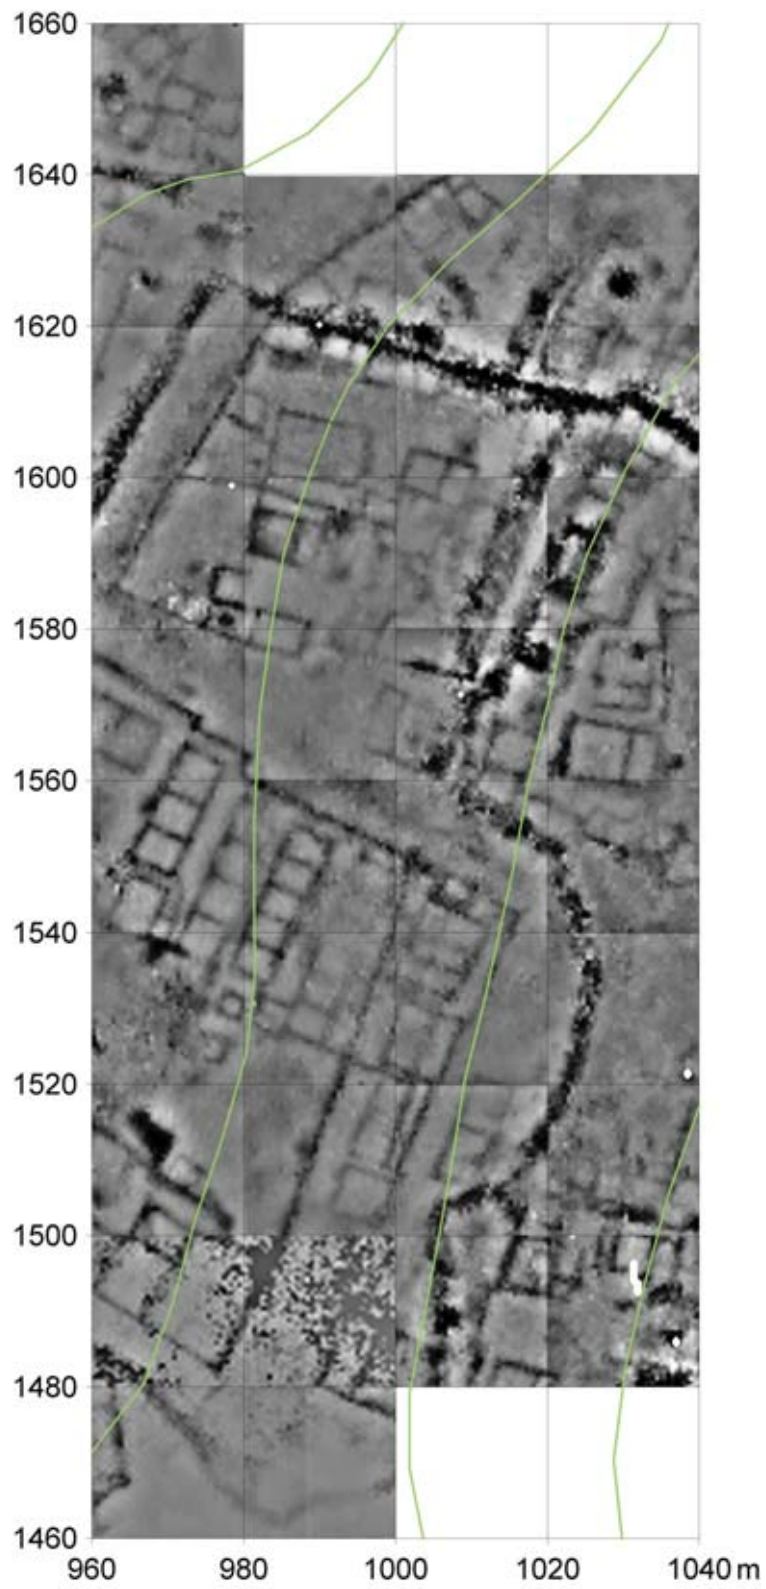
Figure 24. The eastern end of the resistivity survey.

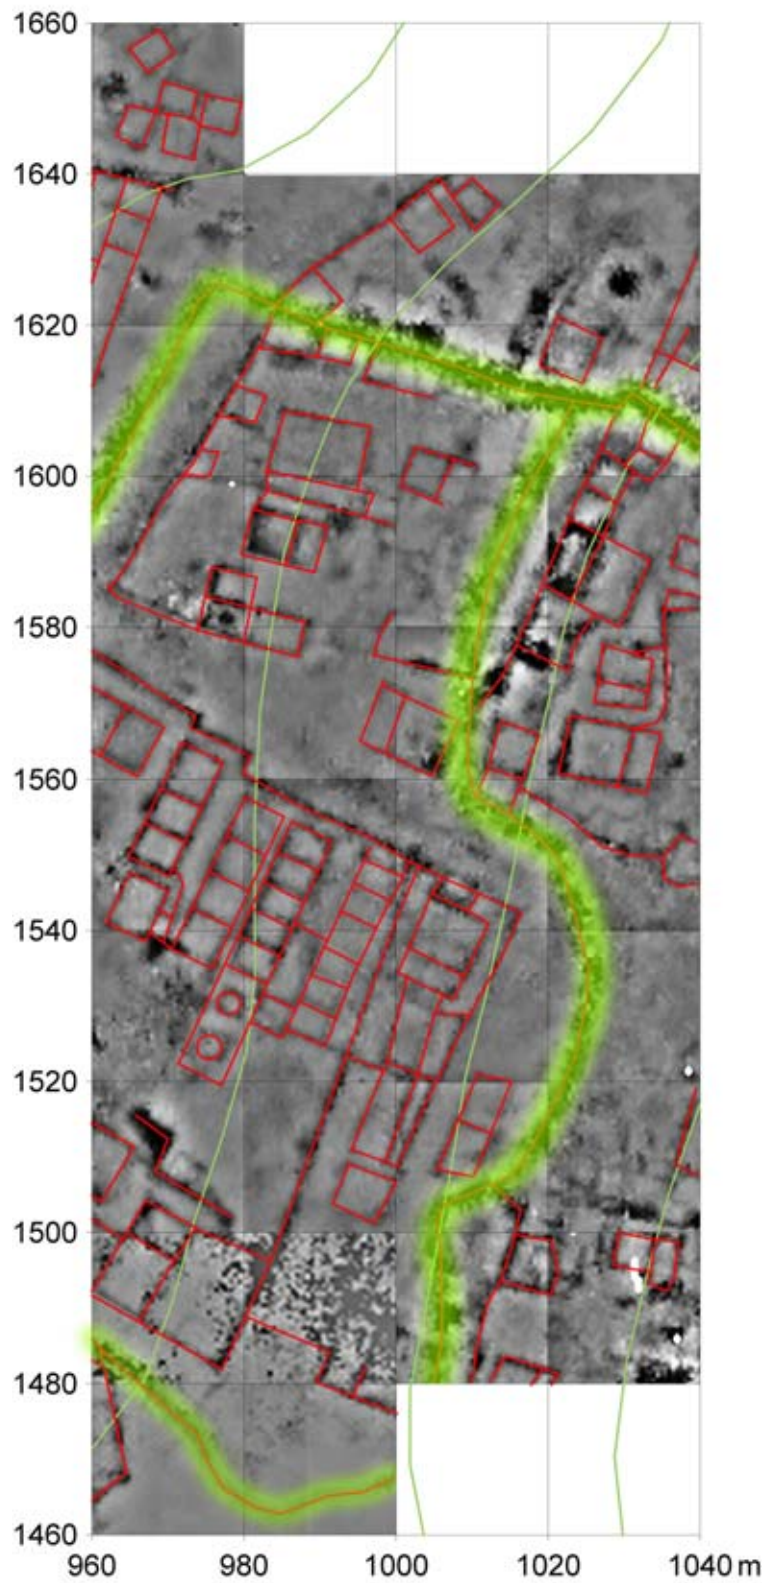
*Figure 25. The eastern end of the resistivity survey with buried walls shown in red and later enclosure walls in green.*

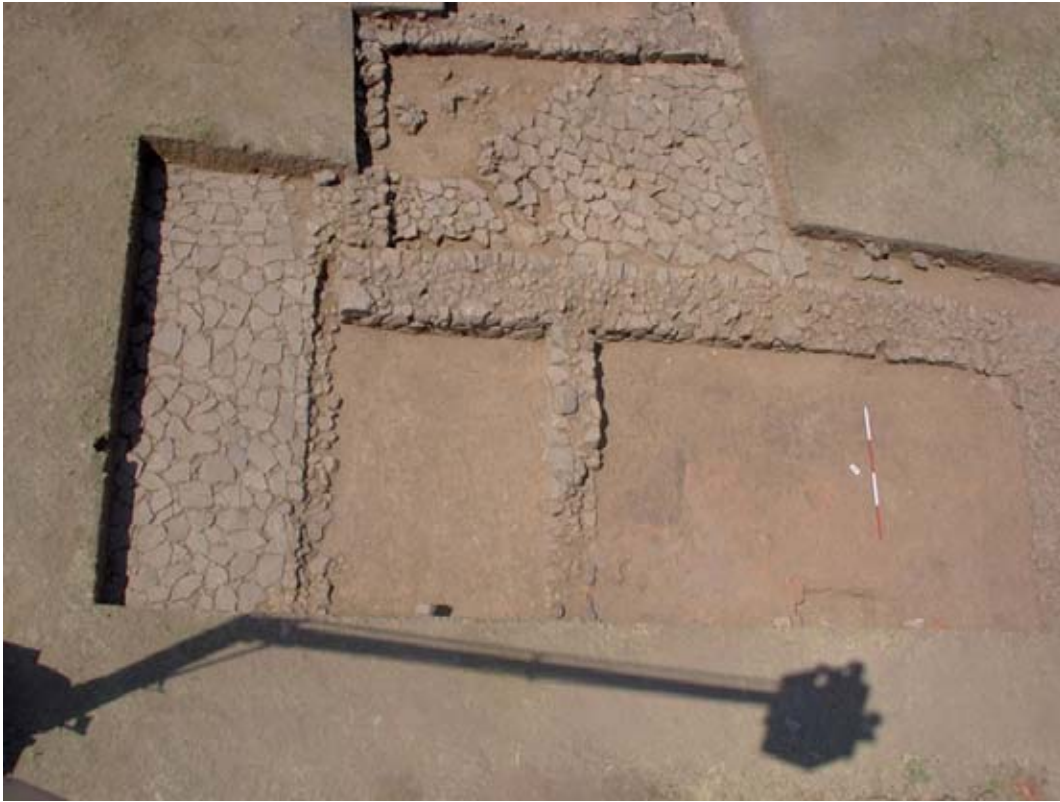
*Figure 32. TR06 and TR07 photographed from the TEDAŞ lorry. The scale is in the main room of the megaron. (03dpjv4112)*

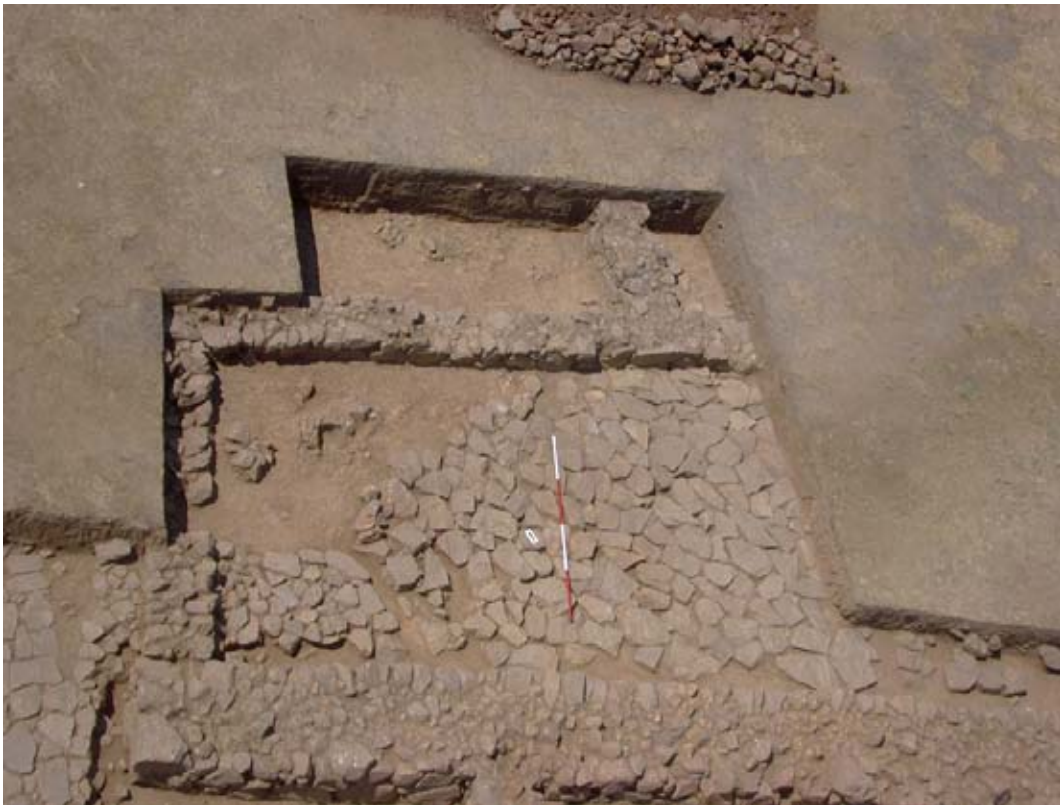
*Figure 33. TR06 and TR07 with Structure C at top, the scale rests on external paving between the row of cells and the megaron at bottom. (03dpjv4204)*

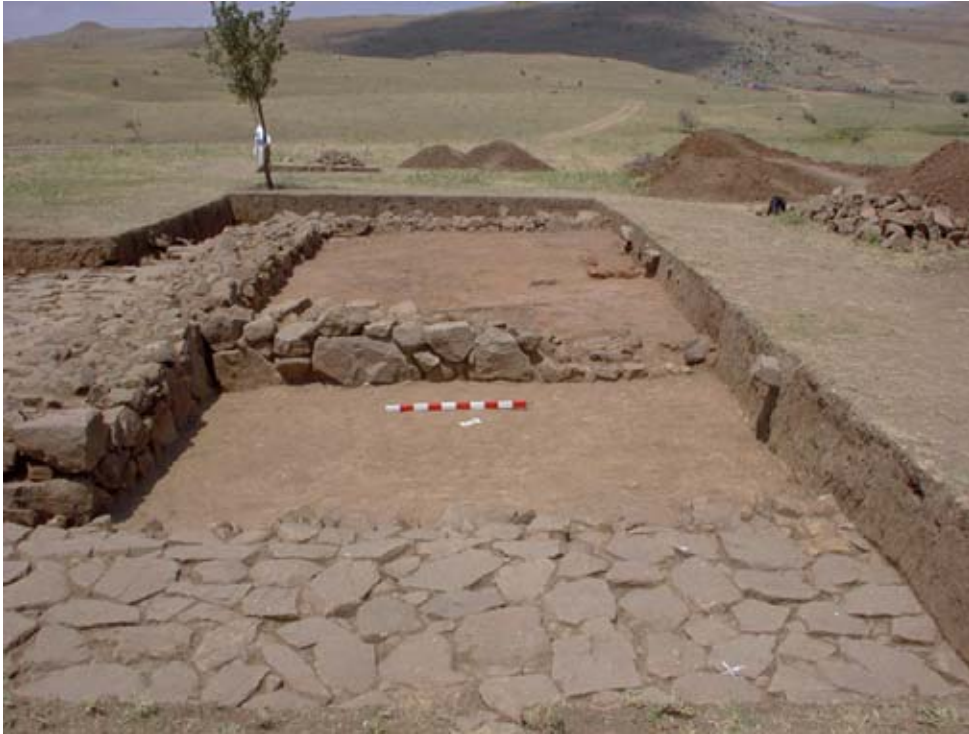
*Figure 34. The megaron, Structure A, looking west with the scale in the open porch, external stone paving in front and the scant remains of a central hearth in the main room. (03dpjv4311)*

The identification of two megarons, i.e. buildings with double pitched roofs comprising a single large room with a central hearth and an open porch, was indisputably confirmed by excavation. On the other hand, the function of the megarons and the associated structures within this special compound or urban block has not been resolved with complete satisfaction. None of the excavated buildings were found to contain domestic installations, nor was any evidence for everyday domestic activity discovered. The recovery of three tripod footed stone bowls (Figs 43 and 44 plus one not illustrated), a number of pottery lids (two shown on Fig. 45) and a few other poorly preserved pottery vessels (Figs 46 and 47) might point towards some special public function for these distinctive buildings, although further support for such a function is best found in the negative evidence for recognisable activity. The recovery of an ornate rosette headed tack (Fig. 48) and a small stone inlay of a feather, as well as fragments of one or more stone trinket moulds, while of intrinsic interest in their own right, are of little help in determining the function of this area and its special buildings since none were recovered from primary contexts. The absence of charred floral and faunal remains was not unexpected because similar results had been obtained in test trenches dug in 1996, although it had been hoped that there would have been a greater depth of deposit in this low central area of the city. The complete absence of architectural decorative tiles is a negative result of wider significance (as discussed earlier in this report).

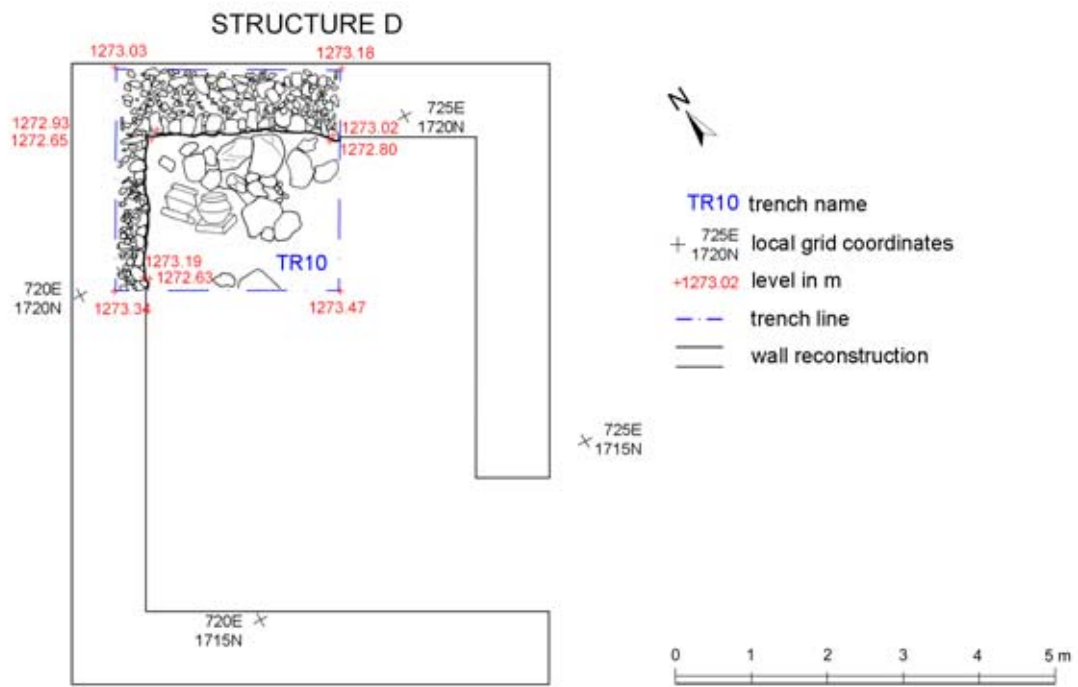
Figure 36. Plan of TR10 with Structure D.

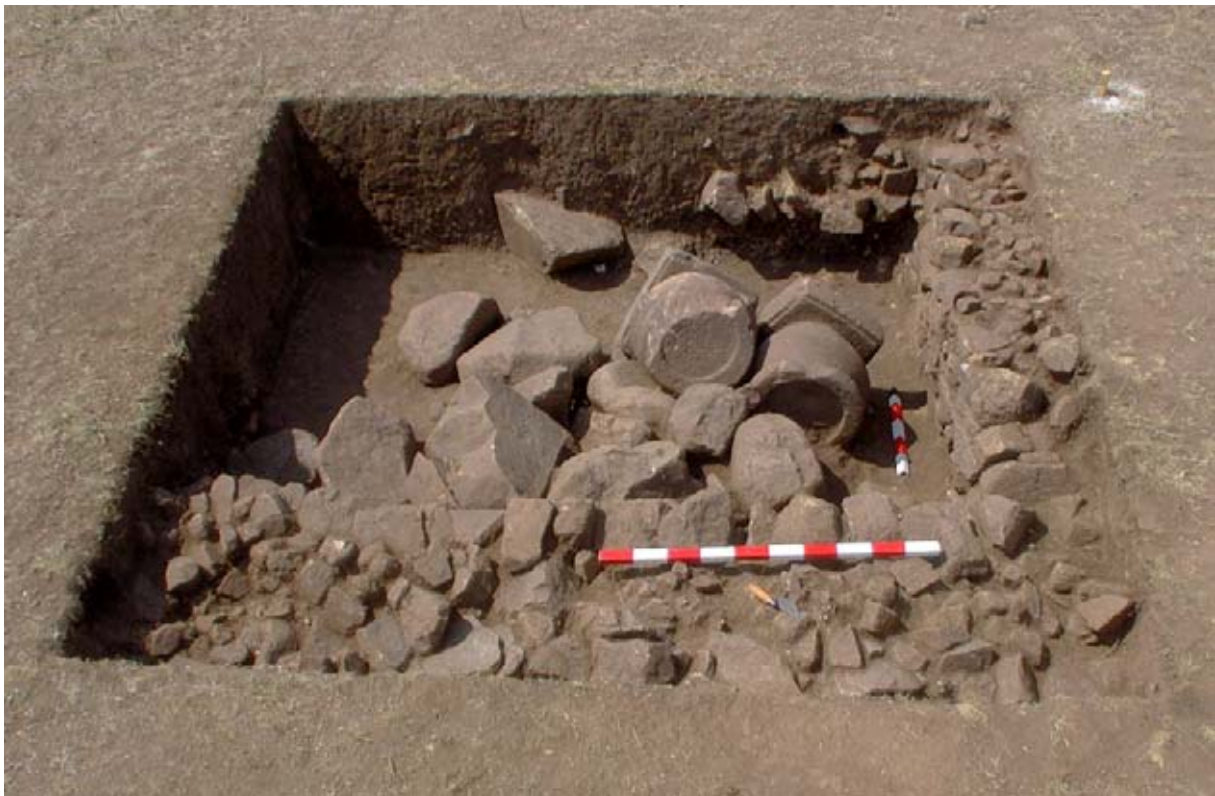
Figure 37. TR10 with the pair of column bases as they were found in Structure D. (03dpjv3903)

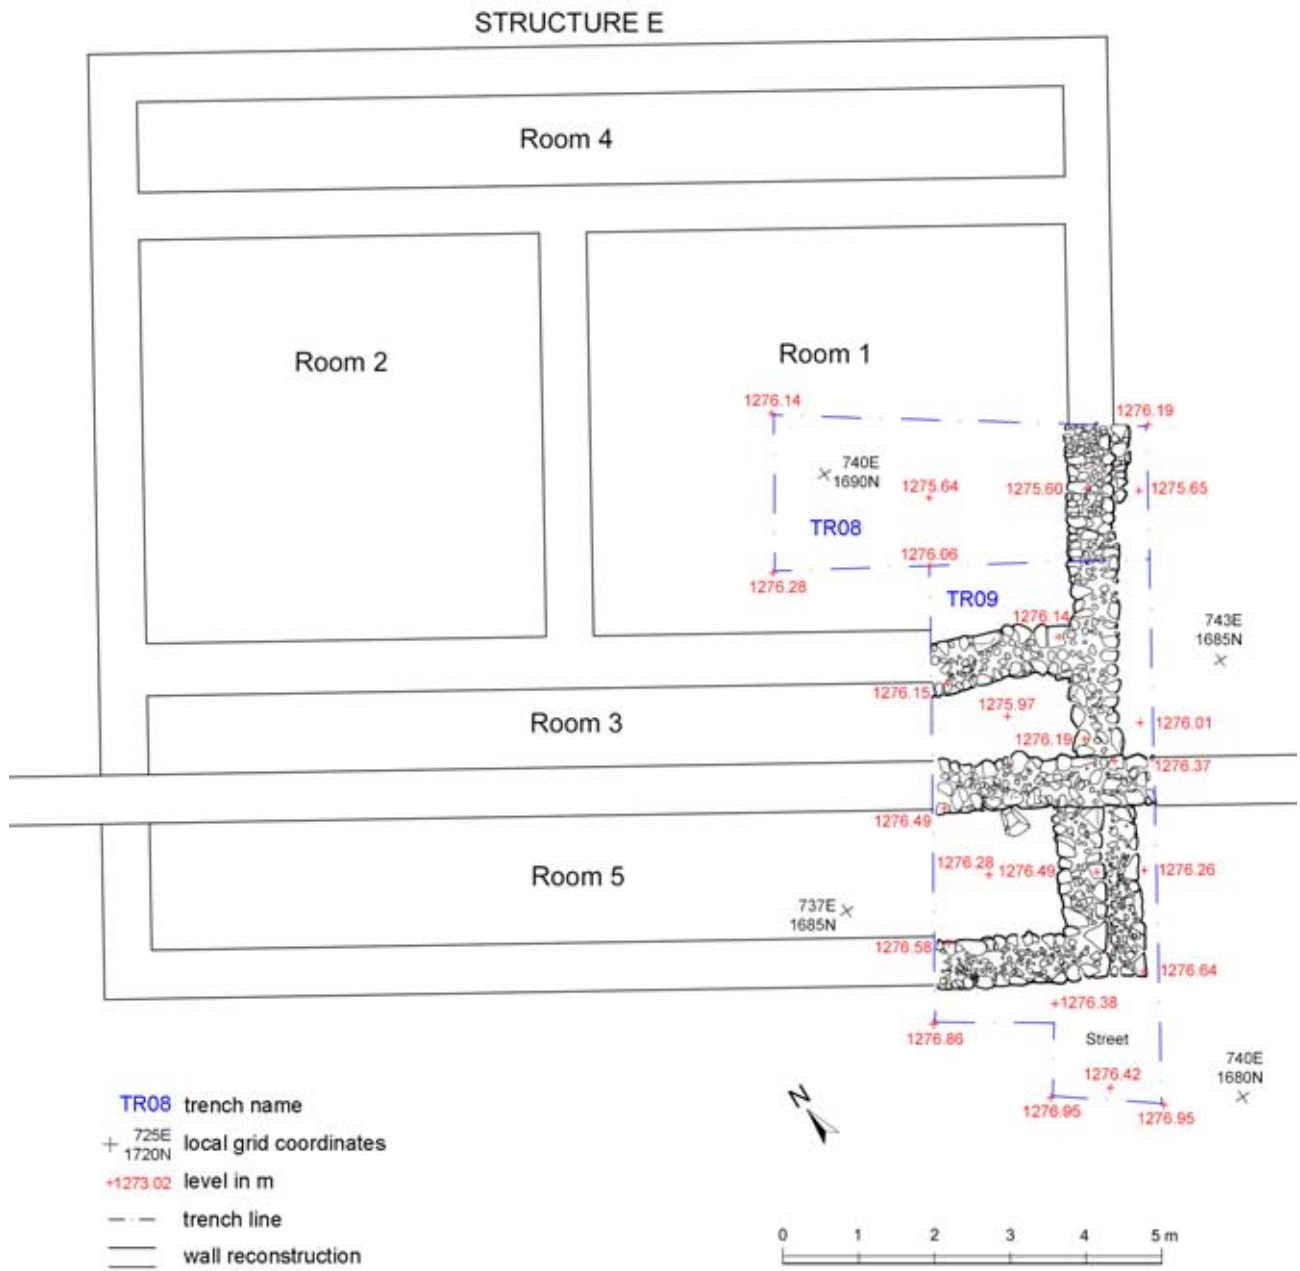
Figure 38. Plan of Structure E and TR08 and TR09.

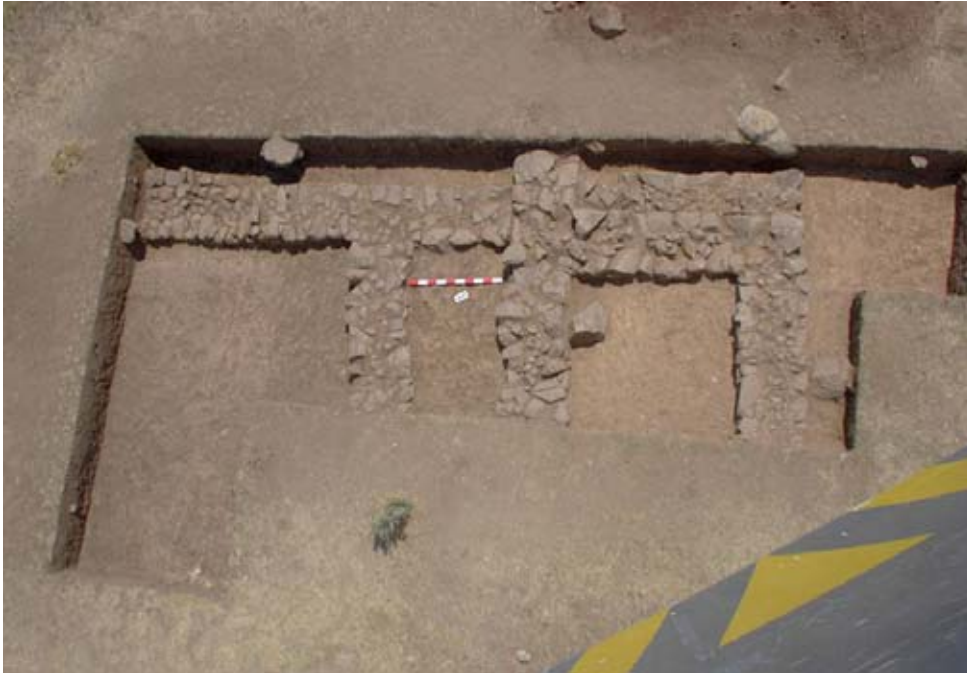
*Figure 39. Structure E in TR08 and TR09. The Compound Wall is right of the scale which lies in the eastern end of Room 3. (03dpjv4302)*
