# THE KERKENES PROJECT

## A PRELIMINARY REPORT ON THE 2003 SEASON

Geoffrey and Françoise Summers

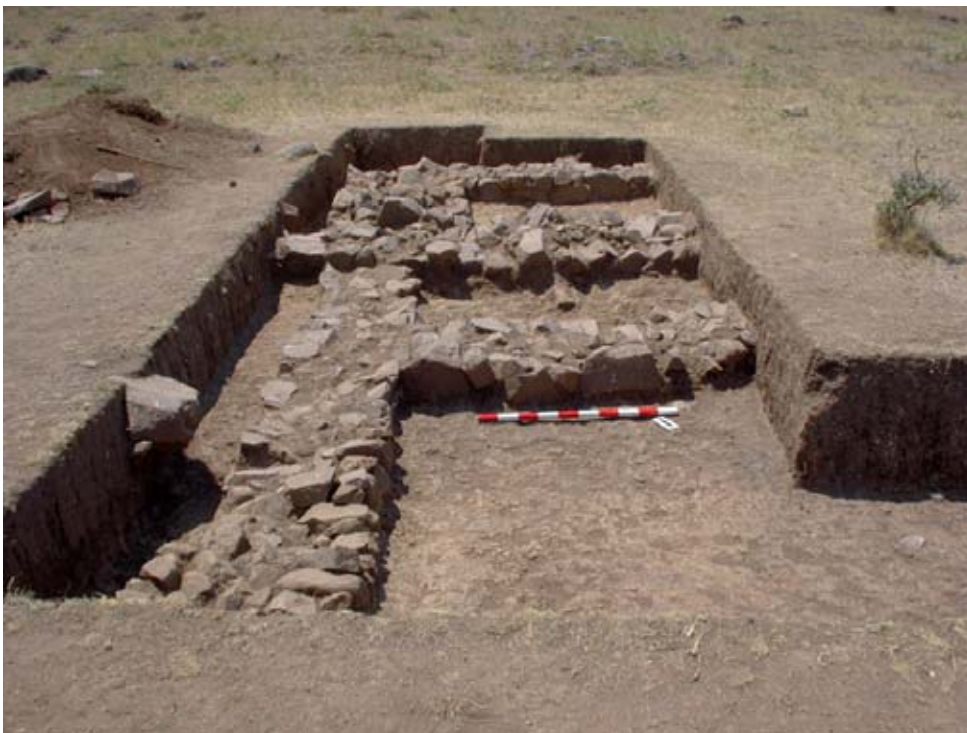
*Figure 40. Structure E with part of TR08 and TR09. The scale is in Room 1. (03dpjv4514)*

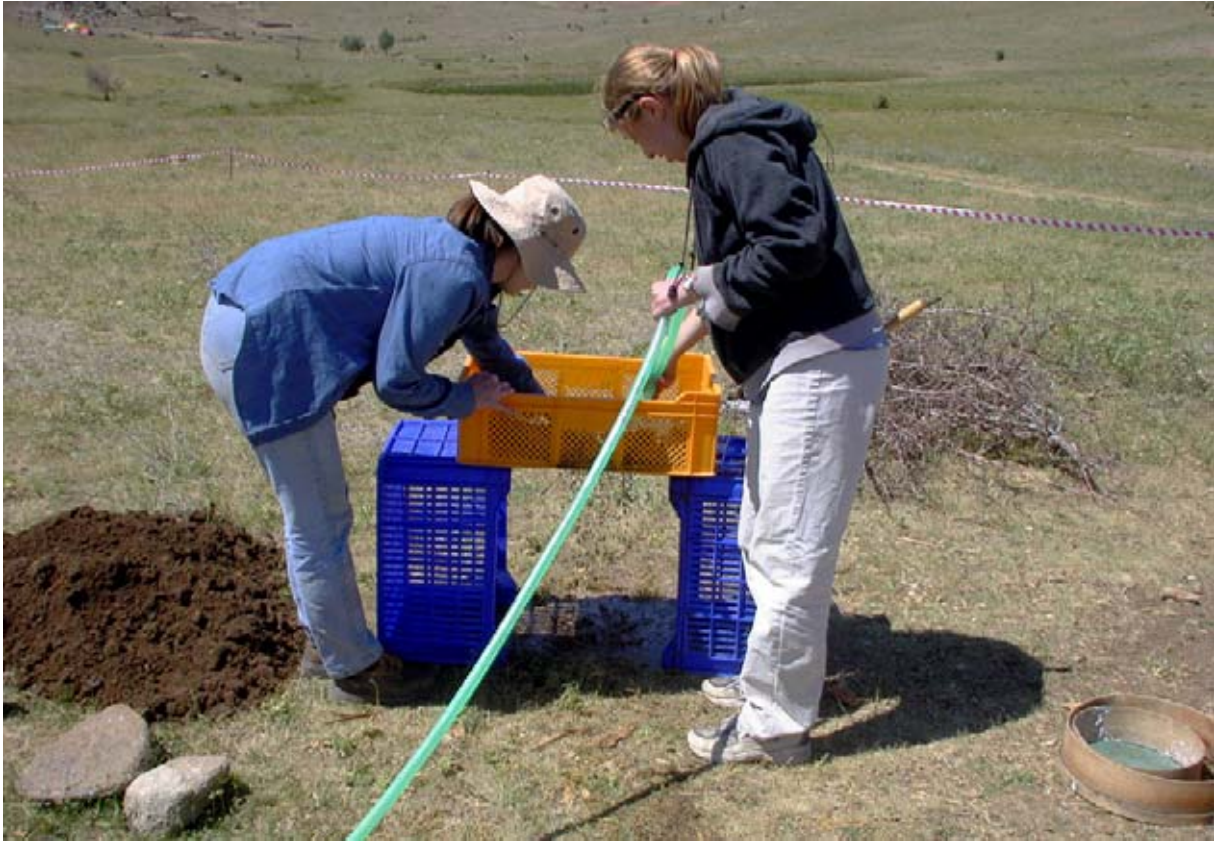
*Figure 41. Jennifer Branting and Tasha Granger experiment with gravity fed wet sieving. (03dpjv2814)*

One of the primary reasons for choosing for investigation this particular location within the lower portion of the city, apart from the seemingly exceptional buildings, was the element in the overall research design that envisaged the provision of running water, via gravity feed from a çeşme, for trench-side wet sieving (Fig. 41) and flotation as well as for dampening the soil during excavation.

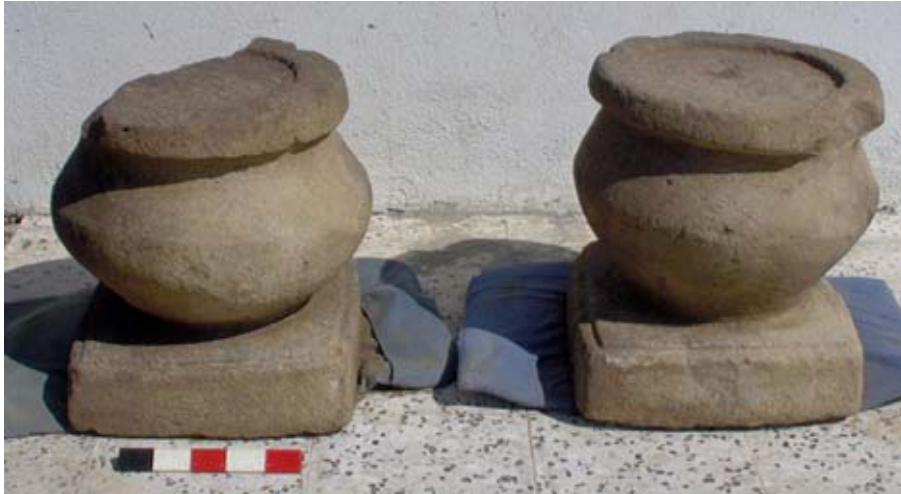
*Figure 42. A pair of ornate sandstone bases from the fill of Structure D in TR10. (03dpjv4928)*

Two ornate and unusual biconical sandstone column bases or, perhaps, offering tables, are of not inconsiderable architectural interest. The square bases have curved sides and drafted margins on the top, the drums are biconical supporting circular recessed seating. The pieces are very similar but not identical.

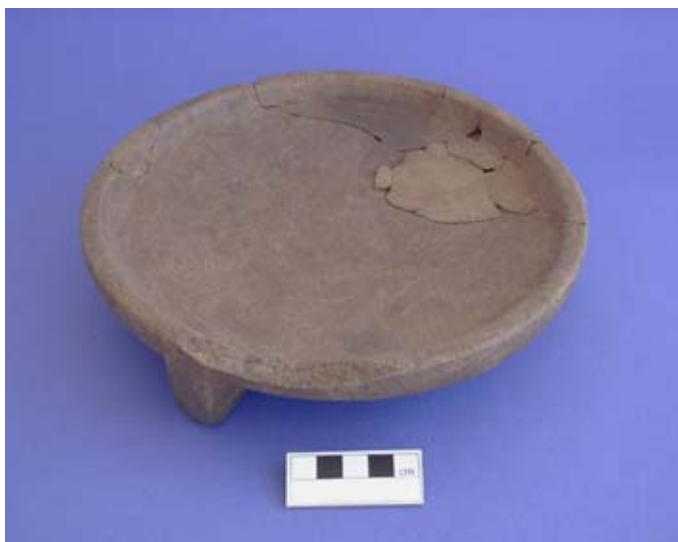
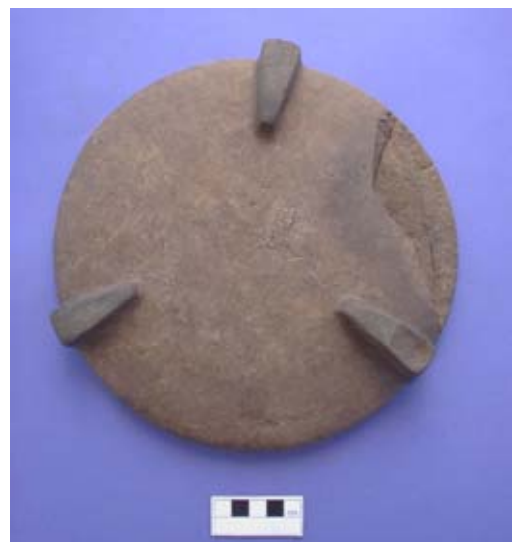
*Figure 43. Two views of a three-footed sandstone bowl from Structure C. (03dpjv6315 and 03dpjv6336)*

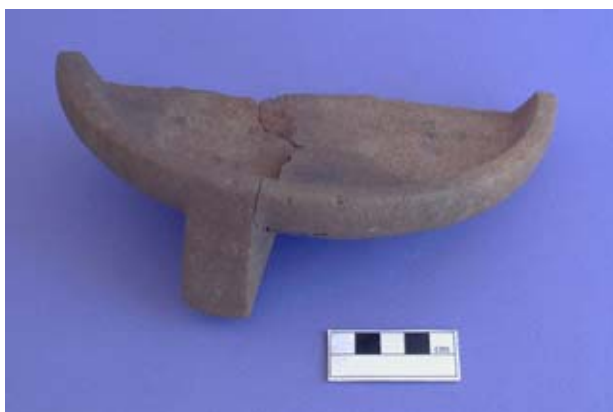
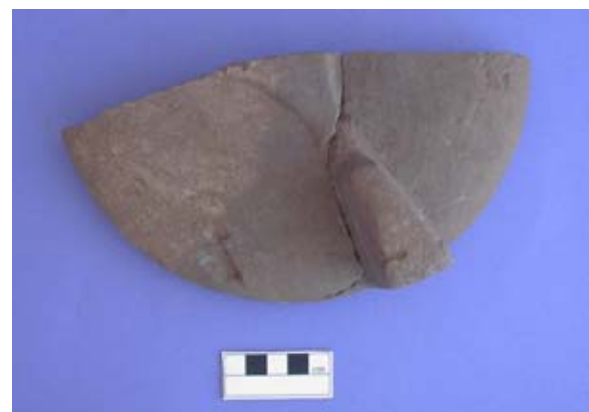
*Figure 44. A three-footed sandstone bowl from TR07. (03dpjv6736 and 03dpjv6740)*

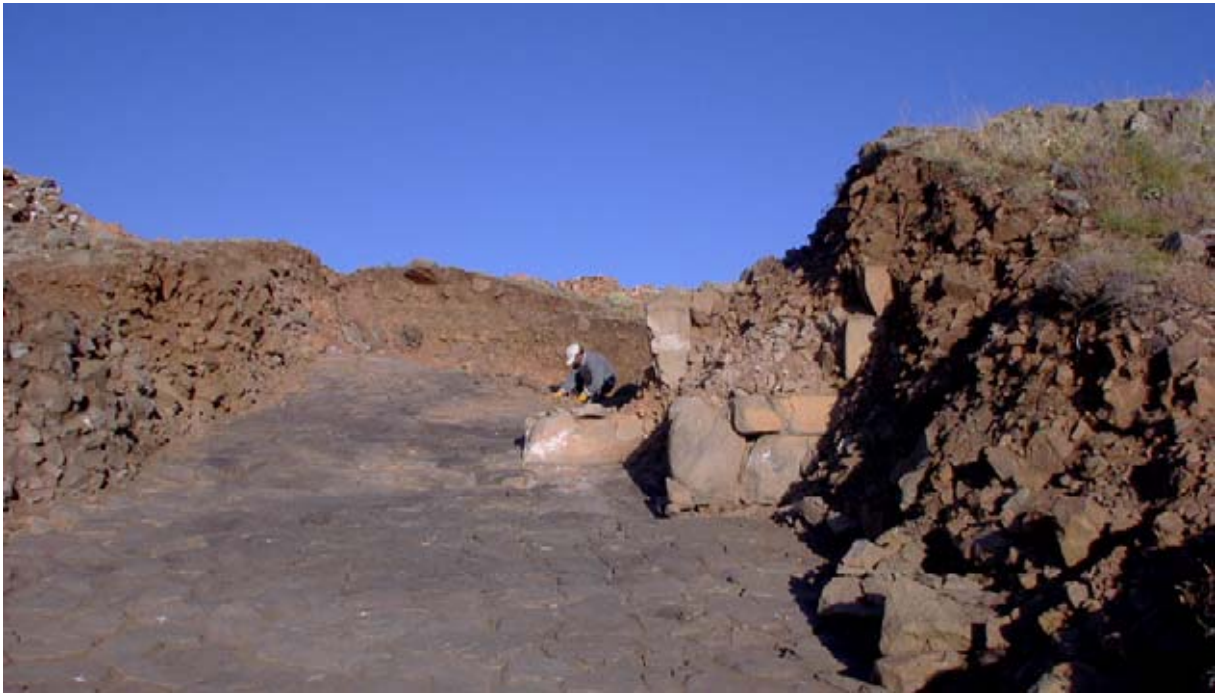
*Figure 50. The Monumental Entrance, trenches TR01 and TR11, at the end of the 2003 season. (03dpjv7035)*

The original aim of the excavation of trench TR11, following on from the successful lifting of a portion of a beam with 197 annual growth rings in 2002, was the recovery of burnt beams for dendrochronological study by Prof. Peter Kuniholm and his team at Cornell University. An additional aim was the revelation of more of the plan of the gate passage as well as the recovery of further evidence for its embellishment in the light of the discovery, in 2002, of the lower portions of two large ibex cut from sheet bronze. Trench TR11 extended Trench TR01 in a westerly direction towards where it was estimated that the inner side of the gateway might have lain. The southern edge of the trench, which was 5.00m in width, was intended to provide a section through the centre of the passage based on surface indications as to the position of the southern tower (Figs 49 and 50).

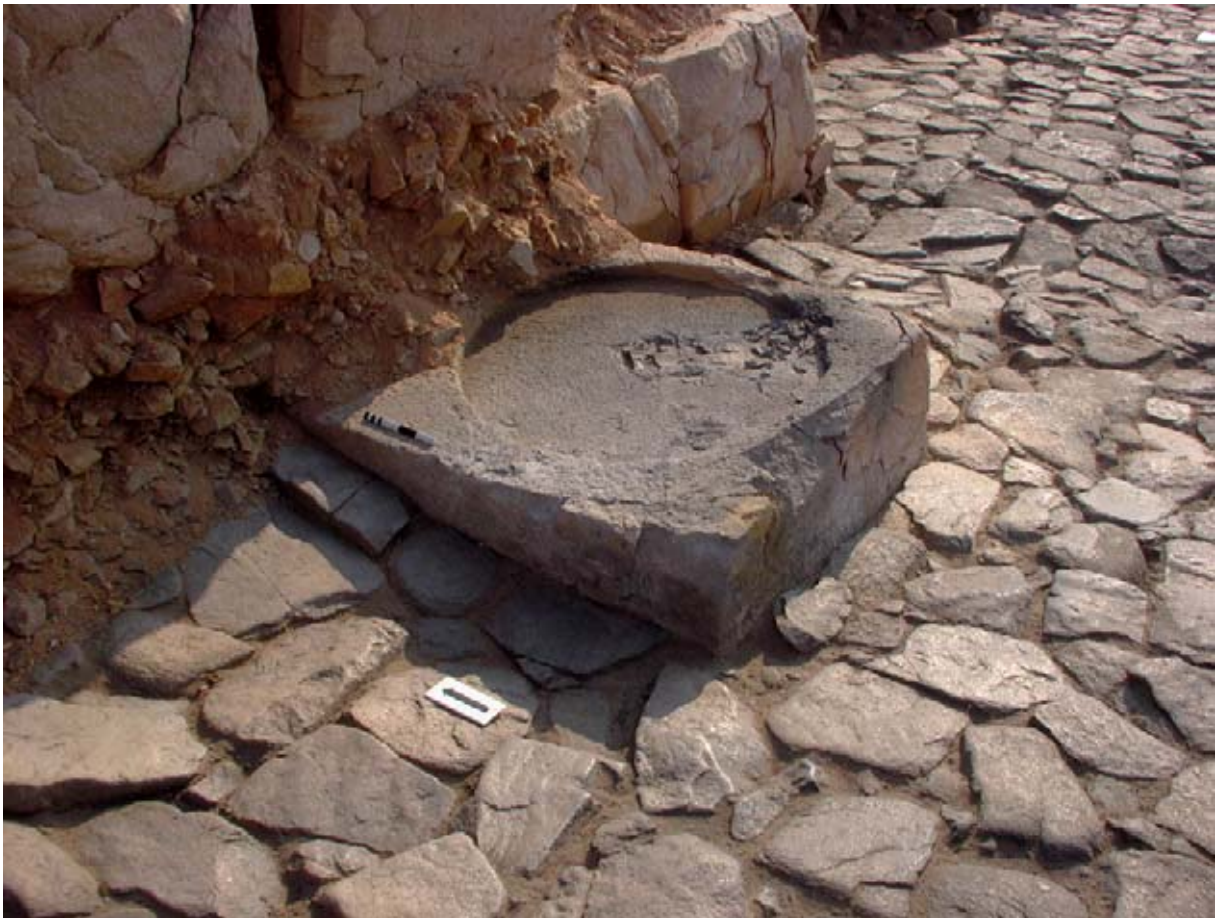
*Figure 51. The sandstone column base on the north side of the Monumental Entrance to the Palace Complex. (03dpjv6112)*

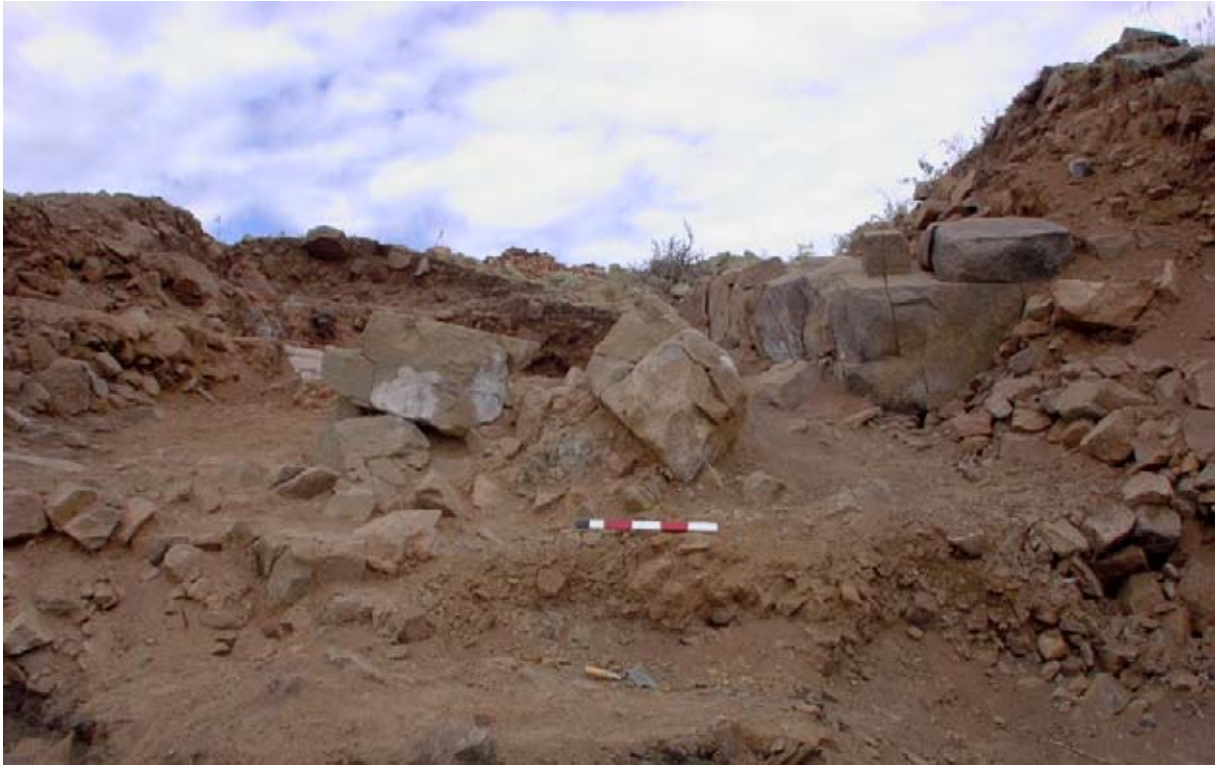
*Figure 52. Trench TR11 with the stone paving in the foreground, the granite walling on the tower on the north side of the passage at right and fallen sandstone blocks. (03dpjv5674)*

An added complication to the smooth progress of excavation was the character of the southern wall of the north tower (which formed the north limit of the trench). The lower courses of this wall comprised neatly dressed granite orthostats the tops of which had been carefully cut to form seating for a thin course of, presumably, levelling stones of granite (Fig. 56). Where the wall turned to the north, in trench TR01, there were four courses of dressed granite stones with large completely burnt out timbers between each. With regard to the north wall of trench TR11, the granites do not appear to have stood higher than when they were first uncovered. Here there was a timber, more than 25cm thick, beneath the first block above the pavement which had totally burnt away. Loose rubble had slipped into the resultant void. This void combined with the shattered nature of the granite orthostats and the fact that in both walls of the tower the blocks had slipped forward from their original positions as the timbers had disintegrated, made excavation somewhat treacherous. Eventually the corner of the tower collapsed, thankfully without causing injury.

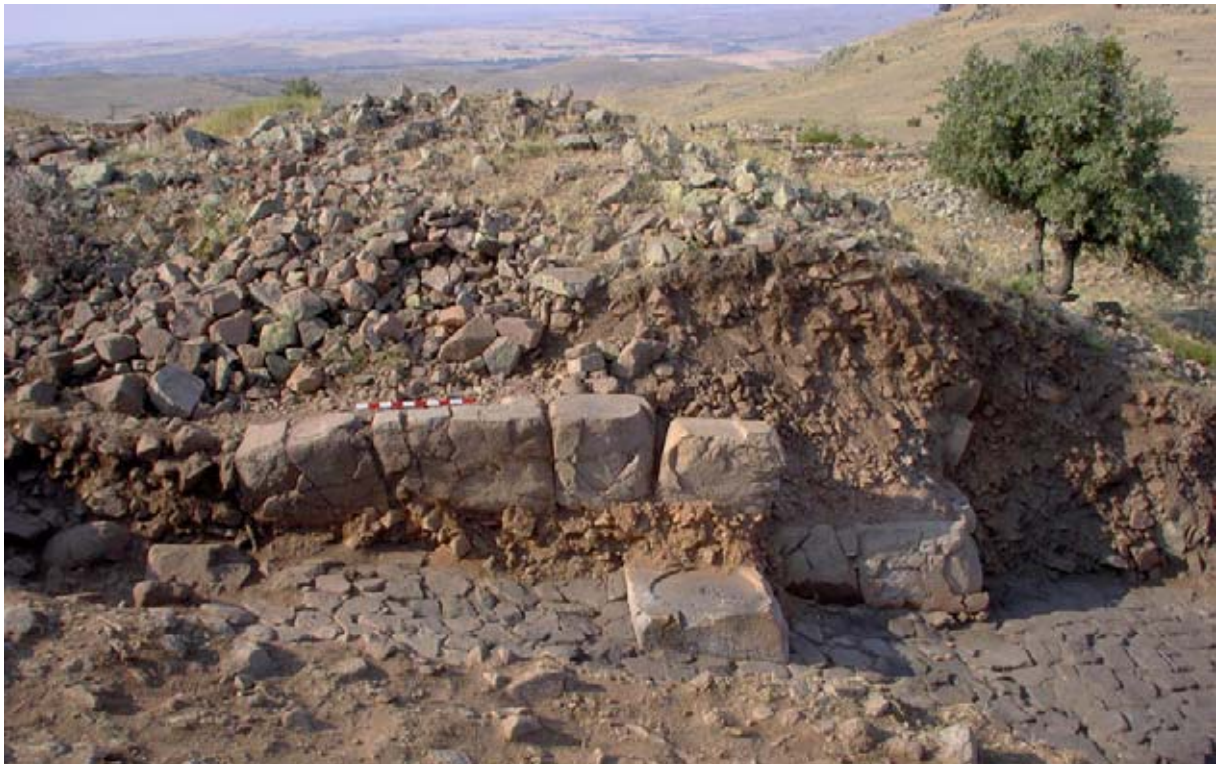
*Figure 53. The monumental entrance with debris filling the void created by the burning of the timber beams in the tower wall and the large sandstone column base. (03dpjv6018)*

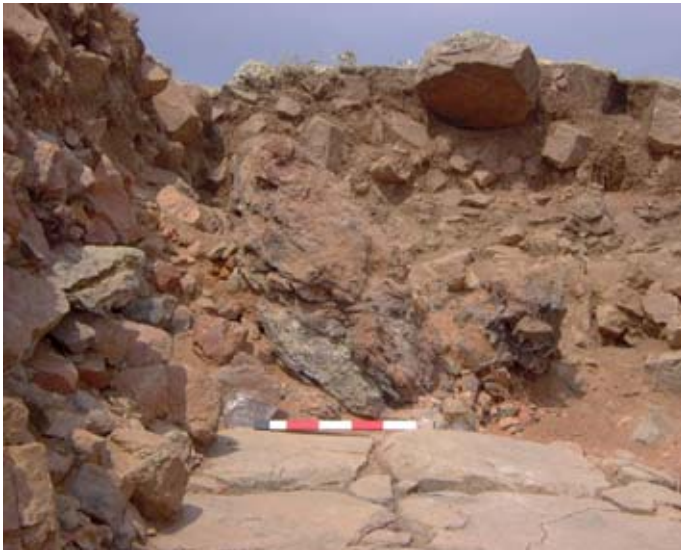
*Figure 54. The west end of the pavement with a large lump of fused and vitrified debris. Notice the very loose nature of the rubble in the section at left. (03dpjv6145)*

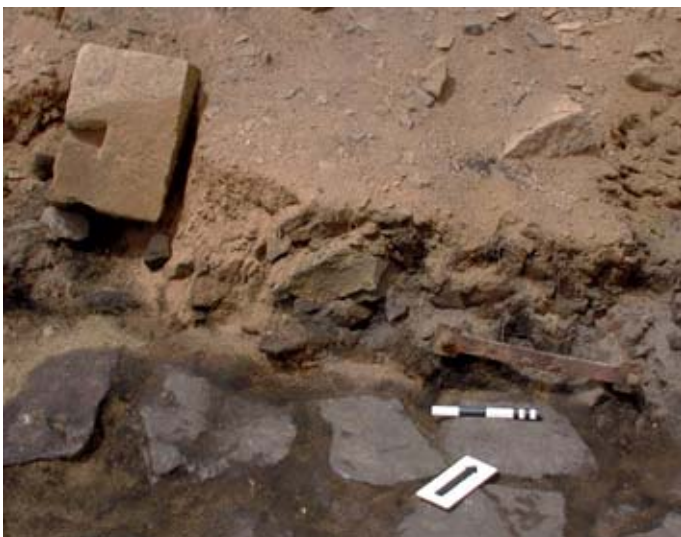
*Figure 55. The debris with a sandstone block containing a clamp cutting and a large iron bar with dome-headed nails. (03dpjv5833)*

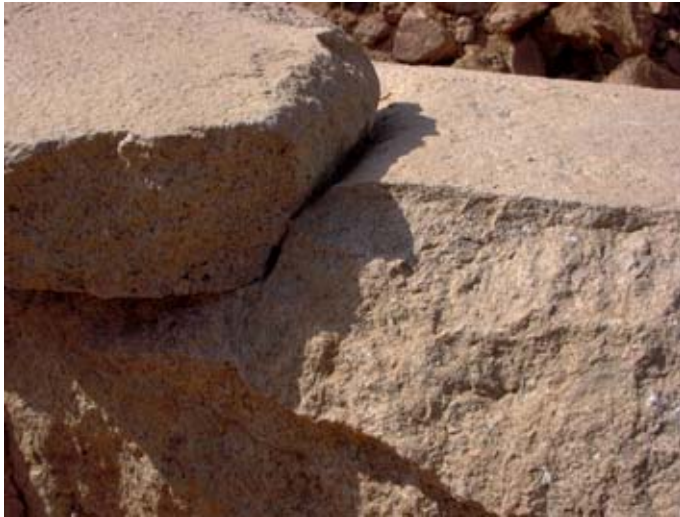
*Figure 56. The top of a granite orthostat carefully cut to seat a thinner levelling course. The face of each stone has broken away as a result of the intense burning. (03dpjv5123)*

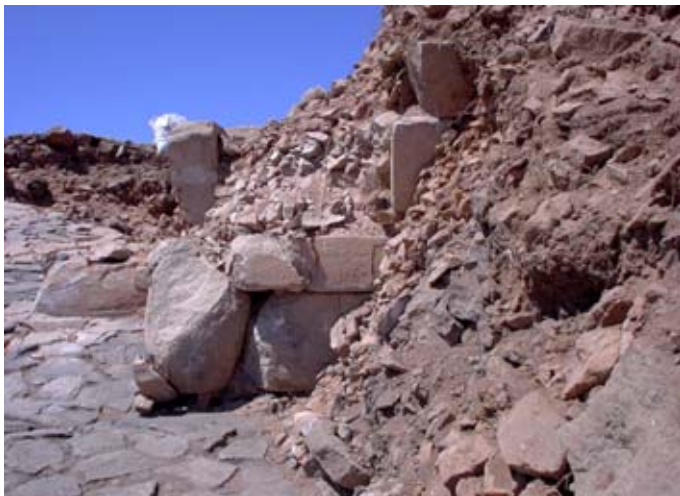
*Figure 57. The south-east corner of the tower showing four extant courses of granite in the east wall. (03dpjv7060)*

With regard to the Monumental Entrance, the south-eastern corner of the north tower has been exposed along with the surviving stretch of granite orthostats that form the north side of the gateway. The east wall of the tower, first revealed in trench TR01 in 2002 has four preserved courses of neatly trimmed granite interspersed with burnt-out timber beams (Fig. 57). The south wall comprised one course of granite orthostats beneath a levelling course of thinner stones which were tightly fitted into carefully cut seating (Figs 53 and 56). In some instances the back, hidden, side of the orthostats was as well dressed as the front. The orthostats rested on a very large timber beam beneath which is yet another course of large cut granite which, for reasons of safety, has only been glimpsed at. At the south-east corner of the tower the large lower block, which is level with the top of the pavement, is slightly offset. These granite blocks appeared to have carried another substantial wooden beam and a minimum of five large (up to 1.50 by 0.50 by 0.50m) sandstone blocks. At the south-east corner the walling would, therefore, have originally attained a height of some 5.00m.

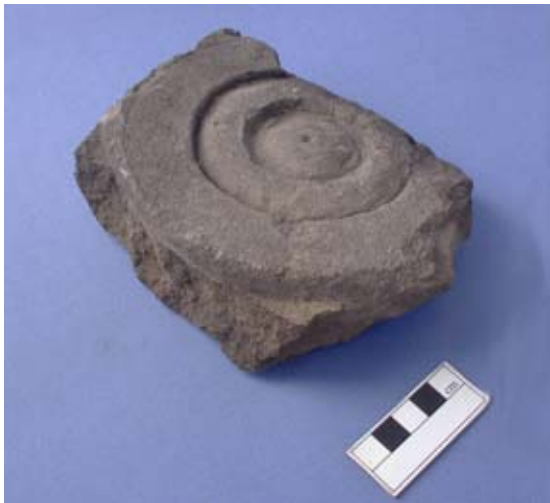
*Figure 58. Concentric circles in relief (03dpjv7208)*

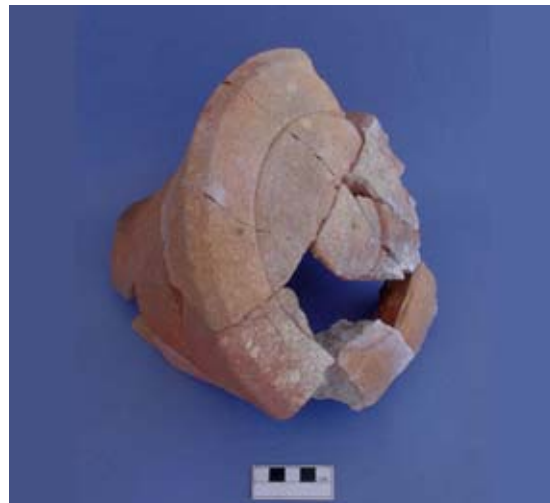
*Figure 59. Part of a bolster with compass drawn concentric circles and a bevelled edge. (03dpjv7238)*

Some of the sandstone blocks were embellished by carved three-quarter bolsters decorated with concentric compass drawn circles on the ends (Figs 59 - 60). Although no complete example of these large bolsters has been found, they were presumably symmetrical and double ended. In other instances the shallow relief carving was restricted to the ends (Fig. 58) or with just a part of a cylindrical barrel which stood slightly proud (Fig. 61). All of these blocks are badly smashed and, in some cases, partially vitrified, with the result that no complete example has yet been assembled from the many shattered fragments. Although these blocks would appear to have formed a row of architectural decoration at the top of the south-eastern corner of the north tower, it is not impossible that some of these carved elements could have come from sandstone capitals to wooden columns. It might be speculated that the exposed ends of the horizontal wall beams at the corner of the tower were carved with similar spool-shaped terminals. Some of the smooth faces of the sandstone blocks retain splashes of paint which might possibly have derived from the painting of the timber elements.

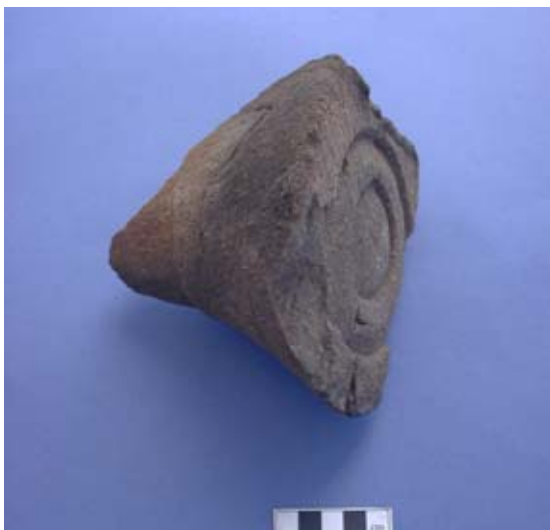
*Figure 60. A three-quarter bolster with concentric circles. (03dpjv7230)*

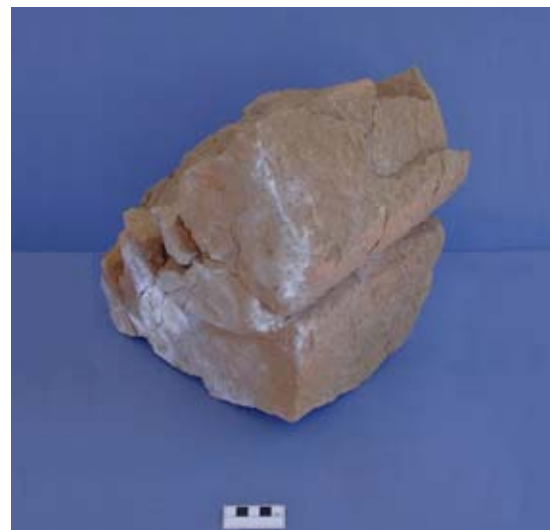
*Figure 61. A cylindrical element with concentric circles. (03dpjv7249)*

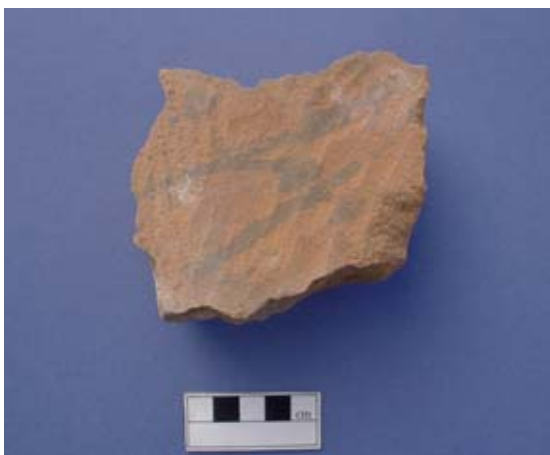
*Figure 62. Splashes of paint on the face of a sandstone block fragment. (03dpjv7204)*

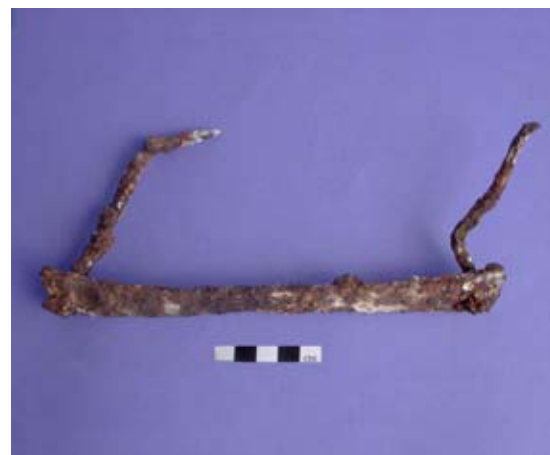
*Figure 63. Iron clamp with large nails for fixing into wooden architecture. (03dpjv7106)*

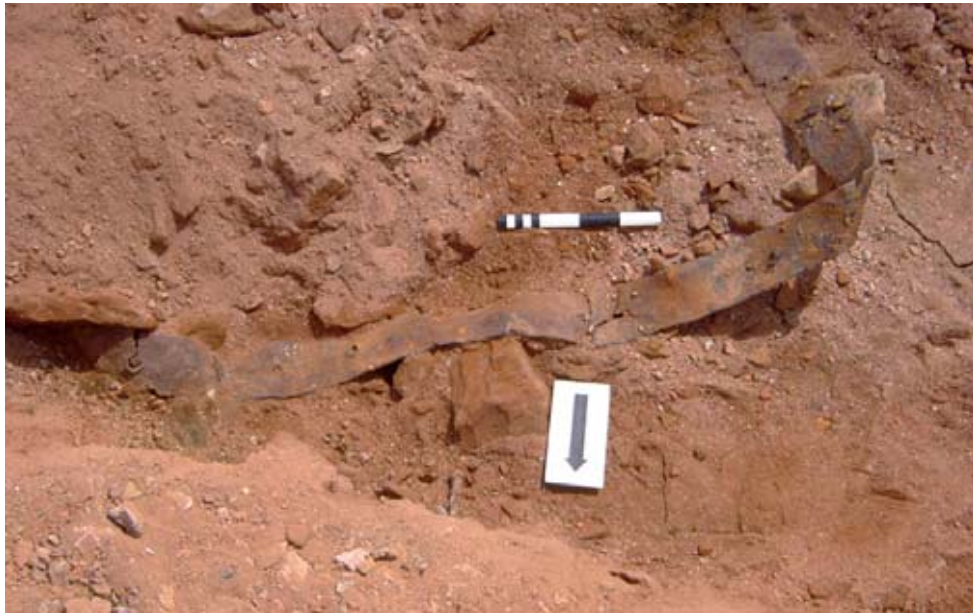
*Figure 64. Part of a large iron band with nails. (03dpjv5445)*

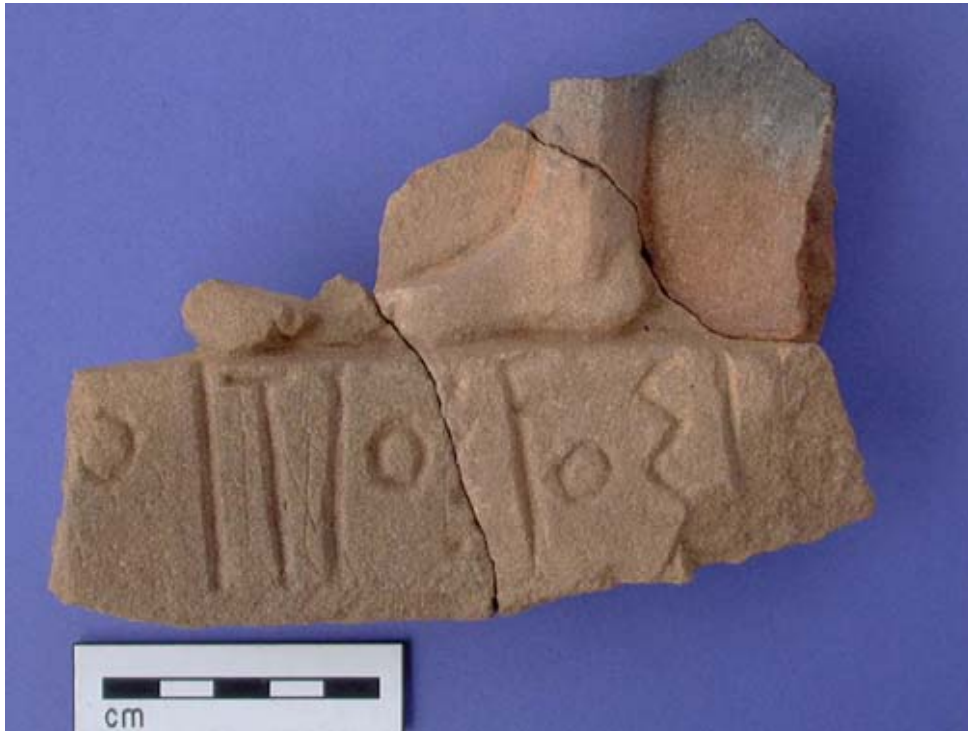
*Figure 65. A fragment of sandstone with two naked feet toe-to-toe above part of an Old Phrygian inscription. A word divider, four vertical dots, is bisected by the crack. Faint incised lines were used to mark out the inscription before it was cut. Colour difference demonstrates breakage during or before the fire. (03dpjv5407)*

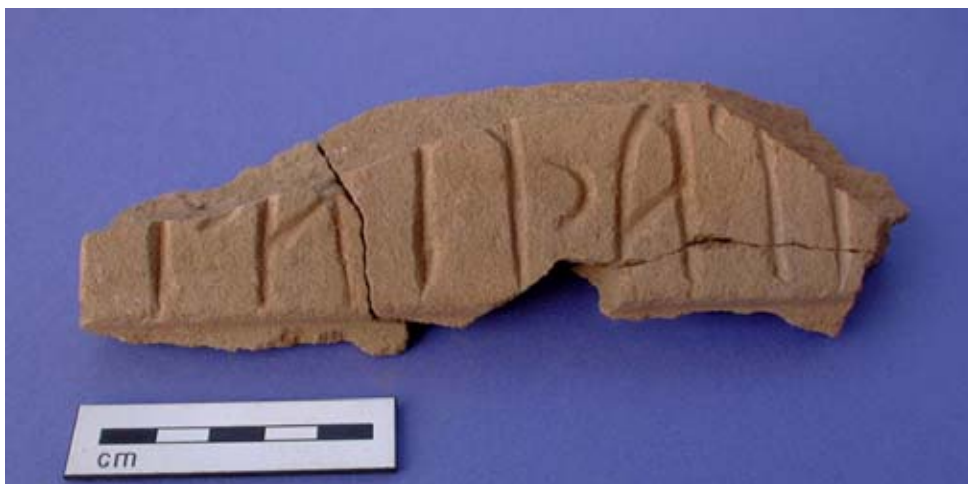
*Figure 66. A fragment of inscribed sandstone. (03dpjv5404)*

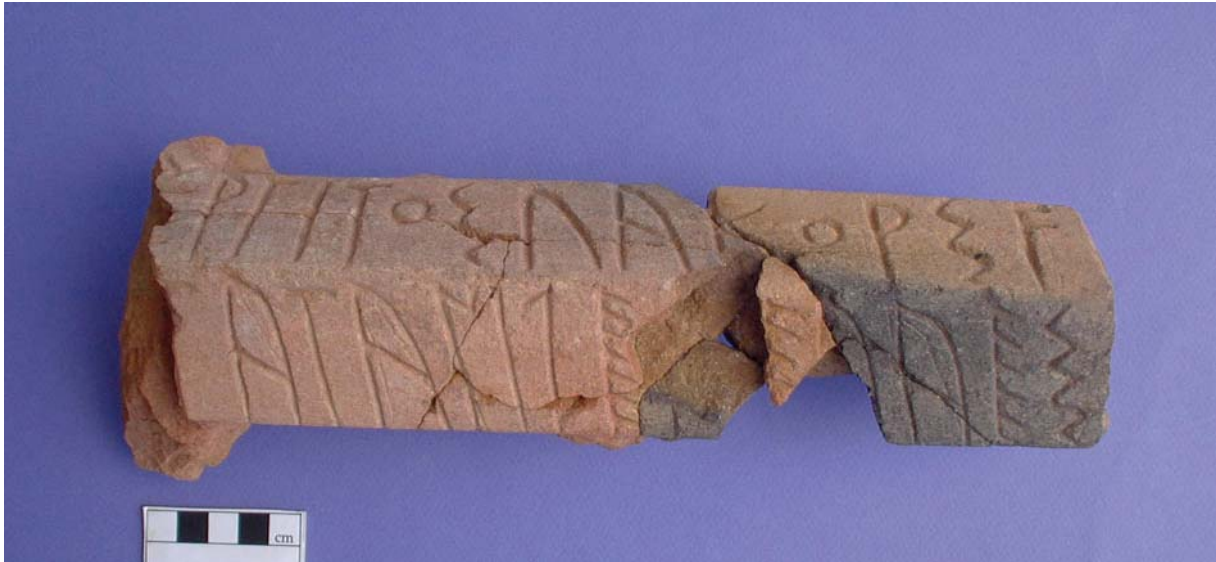
*Figure 67: The largest inscribed piece, almost certainly from the same monument as those in Figs 65 and 66. On the upper surface, also depicted in figure 9, at extreme right is one end of a vertical inscription. Faint guide lines for the lettering and the contrasting fire damage are clearly seen. (03dpjv6509)*

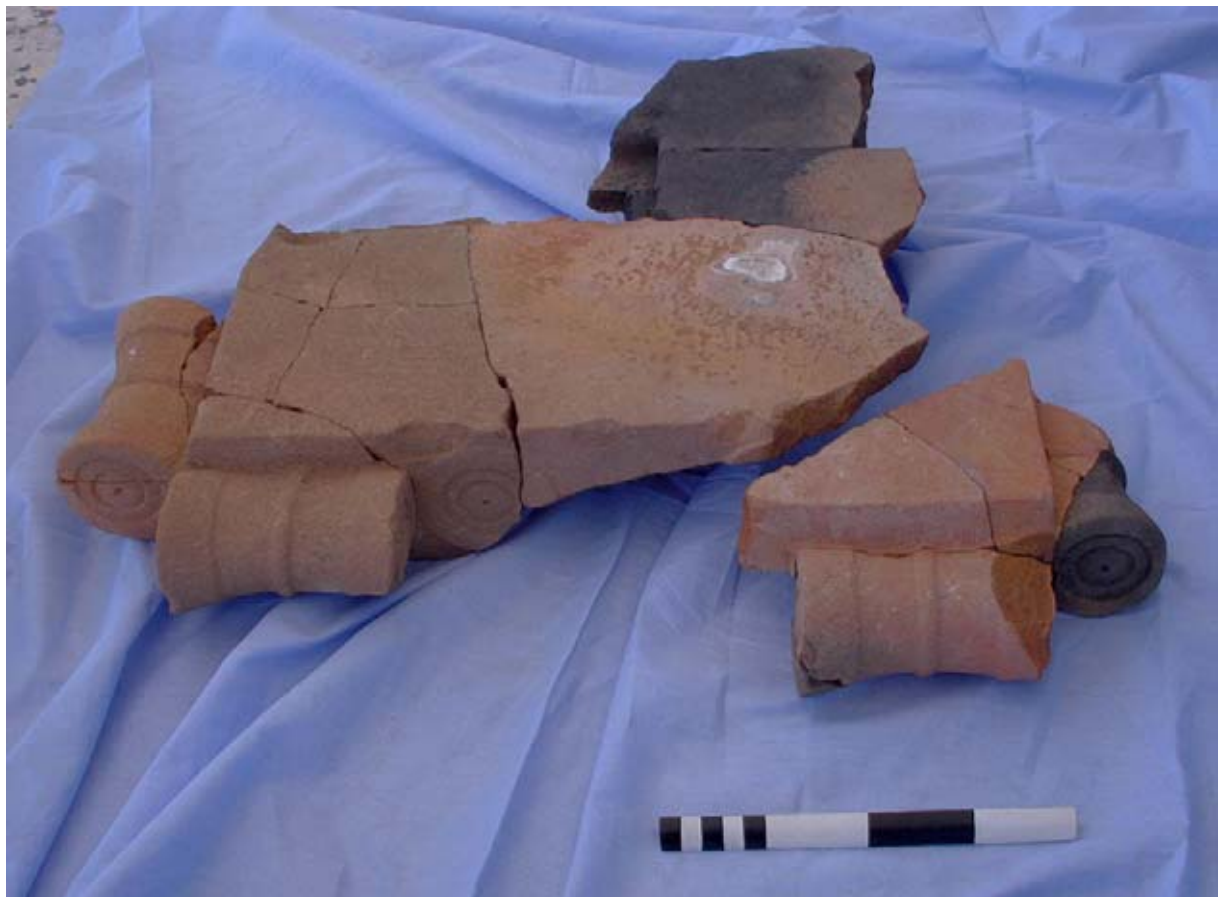
*Figure 68. A square architectural element probably from a freestanding monument. The smooth upper side has a rectangular recess in the centre. (03dpjv7262)*

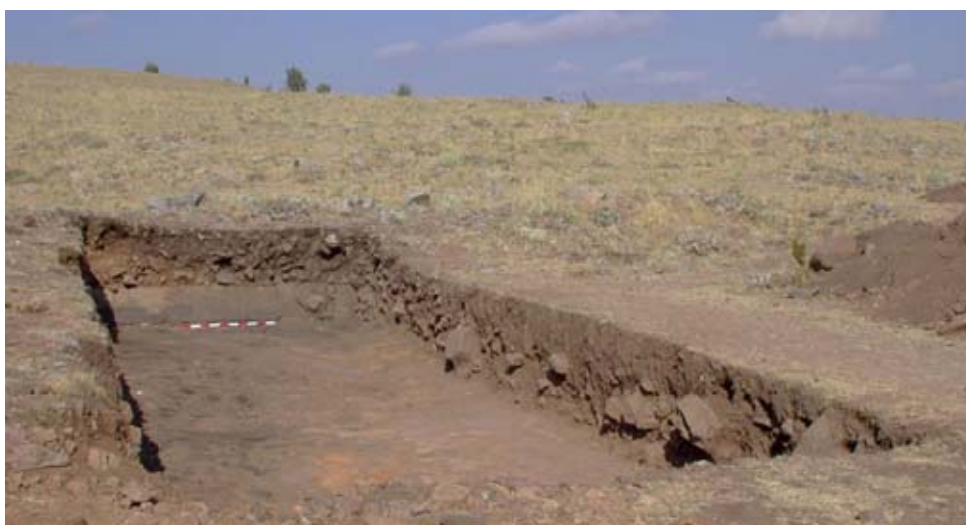
*Figure 74. Trench TR05, the southern half of the large inner room of the Ashlar Building showing the undulating floor, the southern half of the rear wall and the character of the fallen debris in the section. (03dpjv6724)*

Contrary to expectations, no internal features or installations of any kind were discovered (Fig. 74). It is, however, very significant that a straight and level line of burning was seen along all of the wall faces. This line was just above the rough, unsmoothed, lower portion of the granite blocks except in the south-west corner where, as can be seen on the left side of Figure 75, it was some 0.10m higher. This scorch-line surely represents a burnt wooden surround which would thus have formed the equivalent of the sandstone pavement in the front room that was revealed in 2002.

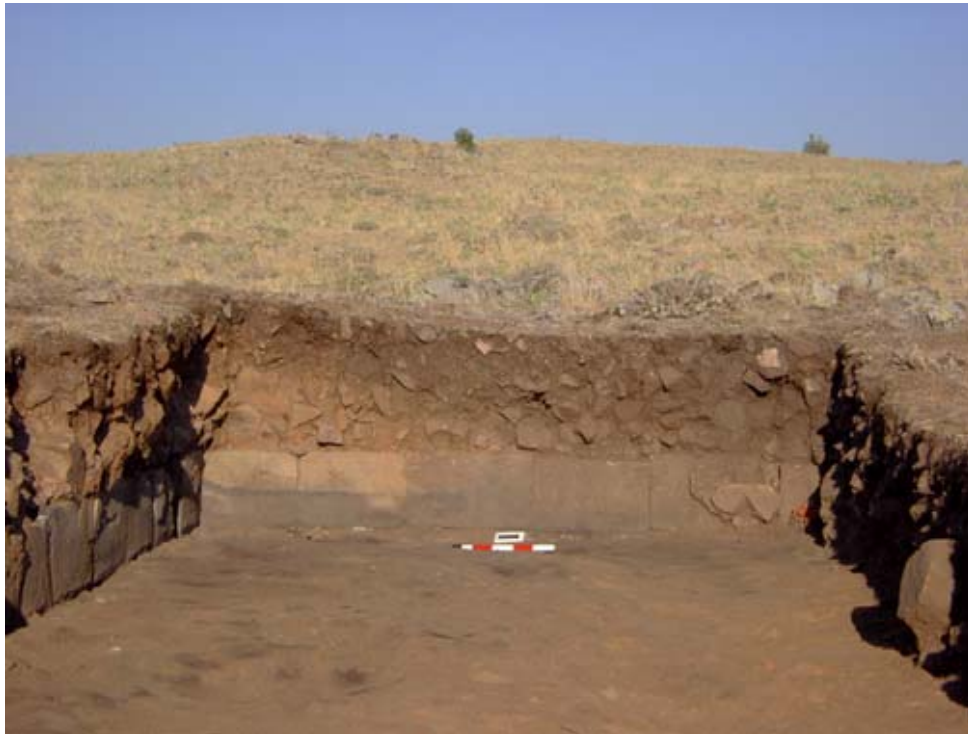
*Figure 75. The western end wall of the Ashlar building with scorch marks. (03dpjv5809)*

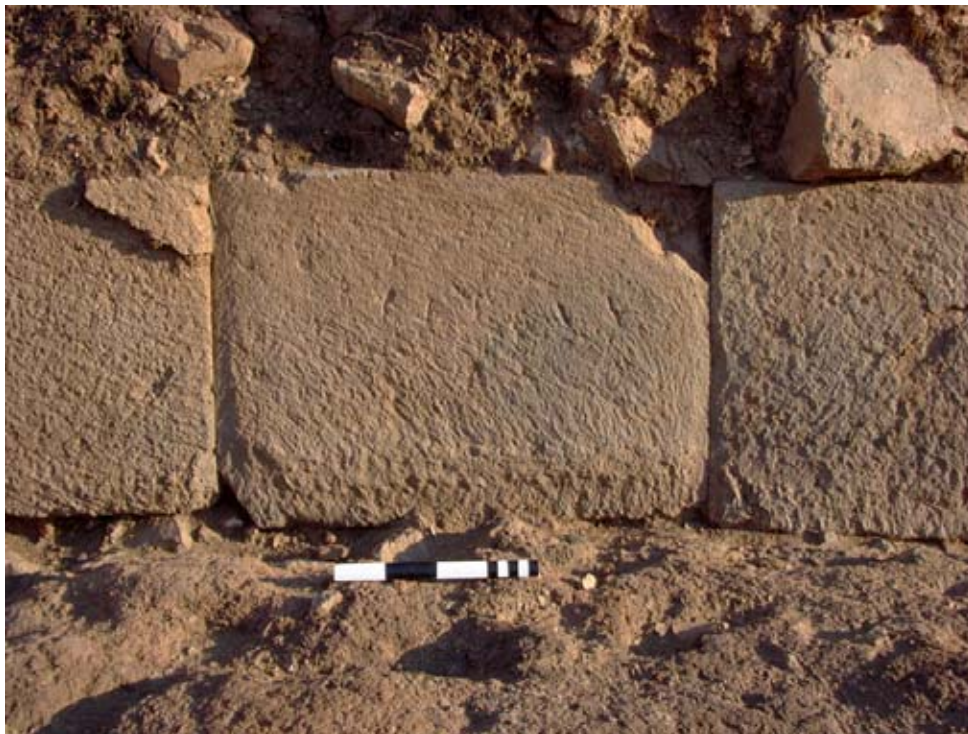
*Figure 76. Ashlar no. 14, which was not fully uncovered in 2002, was found to have a total of six incised strokes. (03dpjv6434)*

With regard to the ashlar, no. 14 (Fig. 76), which was not fully uncovered in 2002, was found to have a total of six strokes while no. 19 also bore marks, perhaps in two groups. As to finds, part of one charred wooden terminal that appears to be a miniature version of the bolsters on the sandstone at the Monumental Entrance to the Palace Complex perhaps represents all that has survived from sumptuous furniture. Otherwise there were no objects other than a few iron nails and a poorly preserved iron bracket.

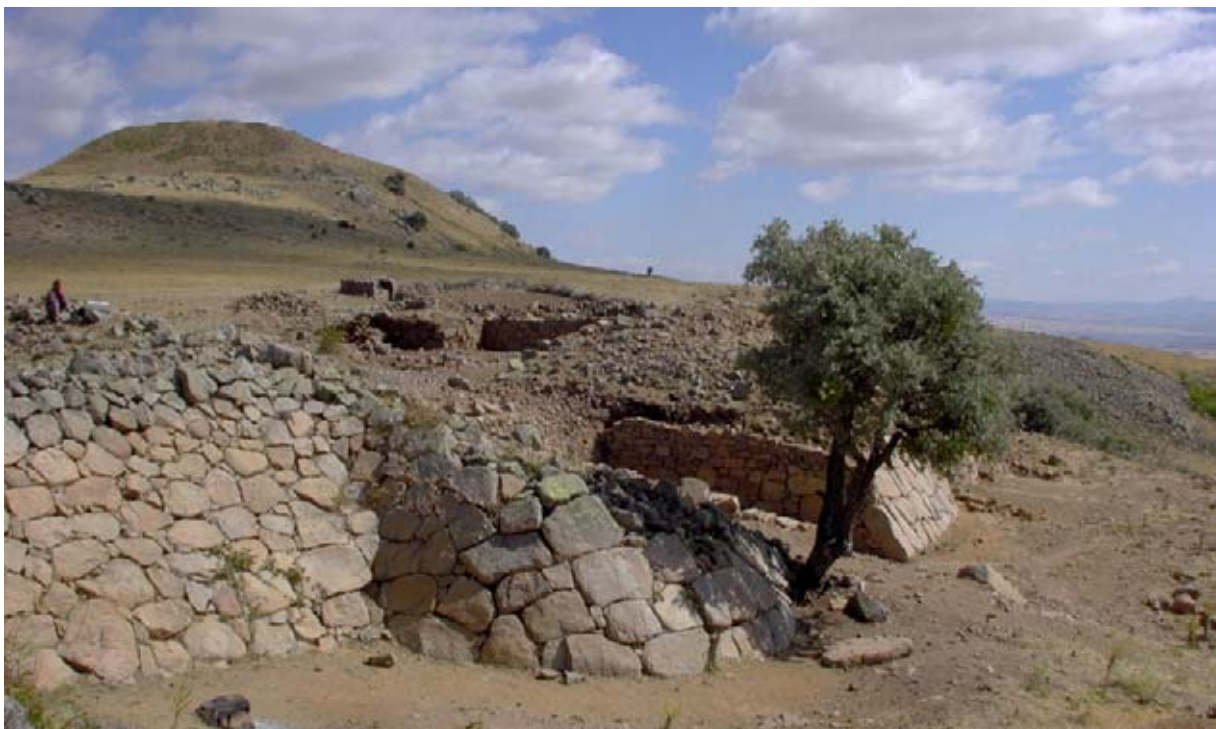
*Figure 78. A further portion of the entrance passage was cleared and the uppermost 2m of the inner gate chamber walling, at centre, was exposed. A shepherd's hut and animal pens can be seen in the middle distance with the Kale looming behind. (03dpjv6820)*

During the 2003 season essential conservation work at the Cappadocia Gate enhanced the appearance of the Eastern Tower glacis while excavations focused on two areas, the passage and the inner chamber (Figs 77 and 78). A new section was cut through the entrance passage (Fig. 77, TR 12) while the uppermost 2.00m of rubble fill was removed from the inner chamber (Fig. 77, TR 13).

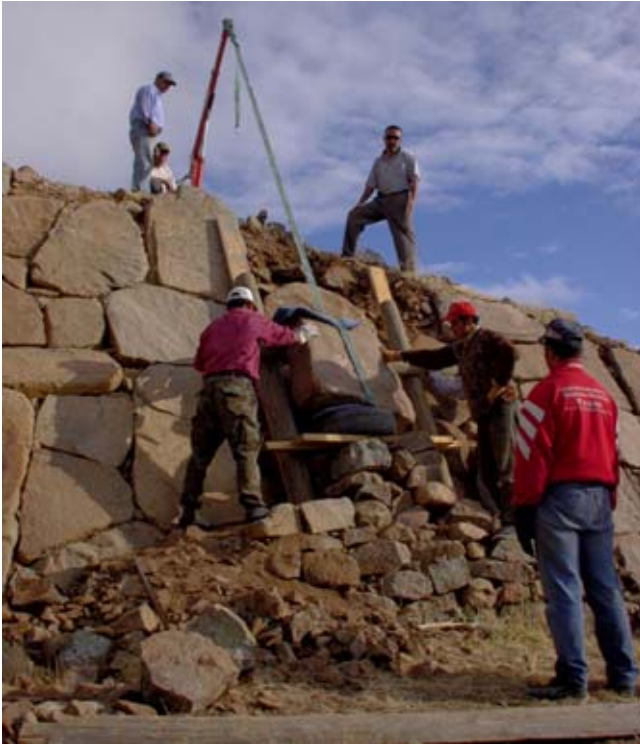
Figure 79. Using a winch to replace large stones that had fallen from the face of the glacis. Ministry Representative Mehmet Katkat skilfully supervised this operation. (03dpjv5616)

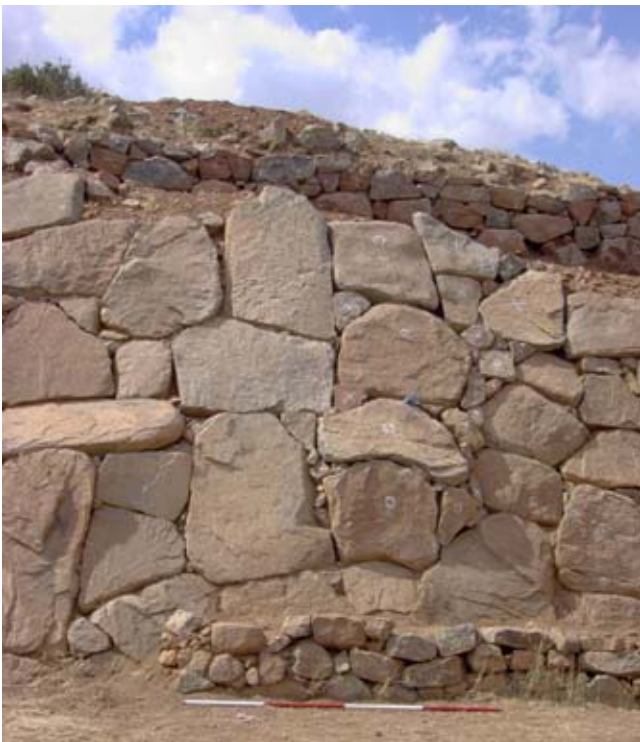
Figure 80. The glacis and the tower wall behind after conservation. A full record was made of which stones had been replaced and which were newly introduced. (03dpjv6753)

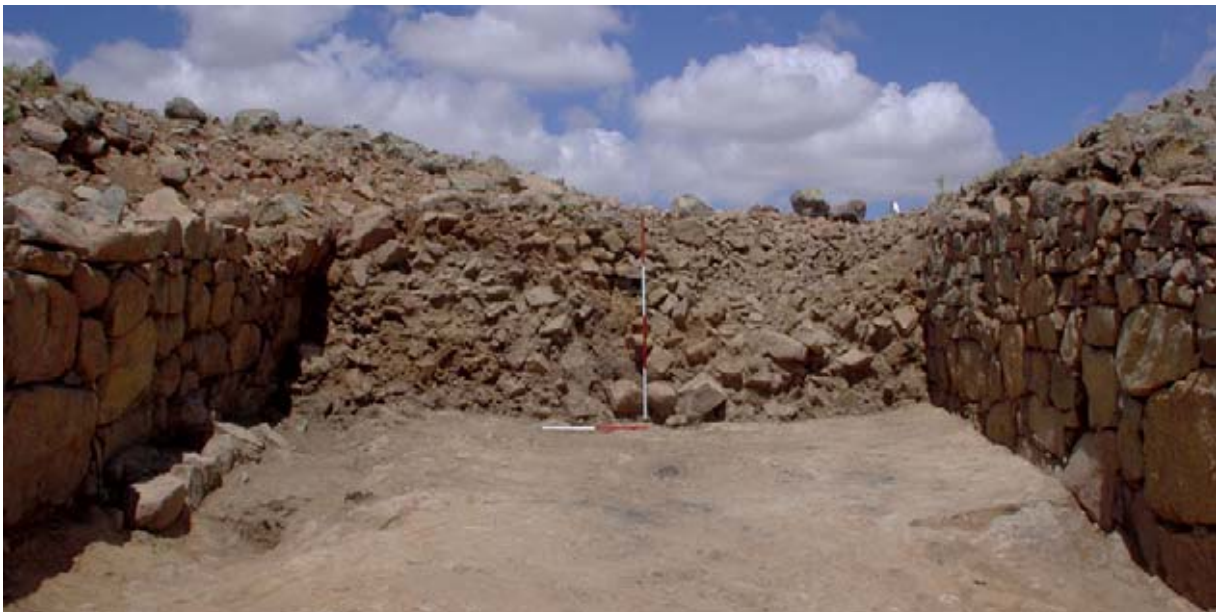
*Figure 81. The section through the Gate Passage, trenches TR03 and TR12. The upper part of the eroded gully on the left has not been fully excavated. The three inclined stones in the section immediately right of the vertical pole c. 2m above the surface, represent the later pile of retaining stones. (03dpjv6237)*

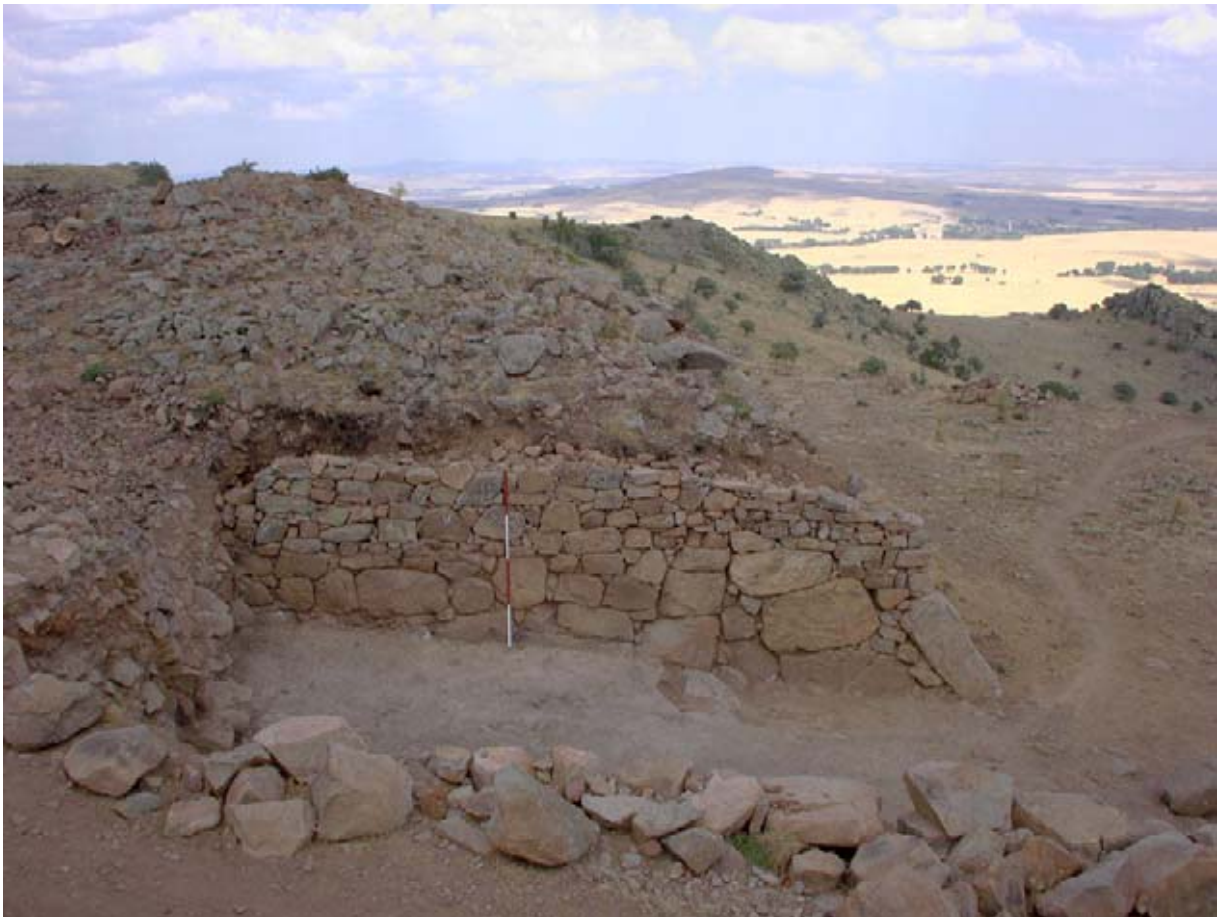
*Figure 82. The south-east wall of the Gate Passage. The junction between the glacis and the tower is clearly seen above which new stonework holds back the loose rubble. In 1999 sandstone blocks with graffiti were removed from the outer corner in order to prevent them being damaged. The intention is to cut new sandstone blocks that can be inserted in their place. (03dpjv6752)*
