# THE KERKENES PROJECT

## A PRELIMINARY REPORT ON THE 2003 SEASON

Geoffrey and Françoise Summers

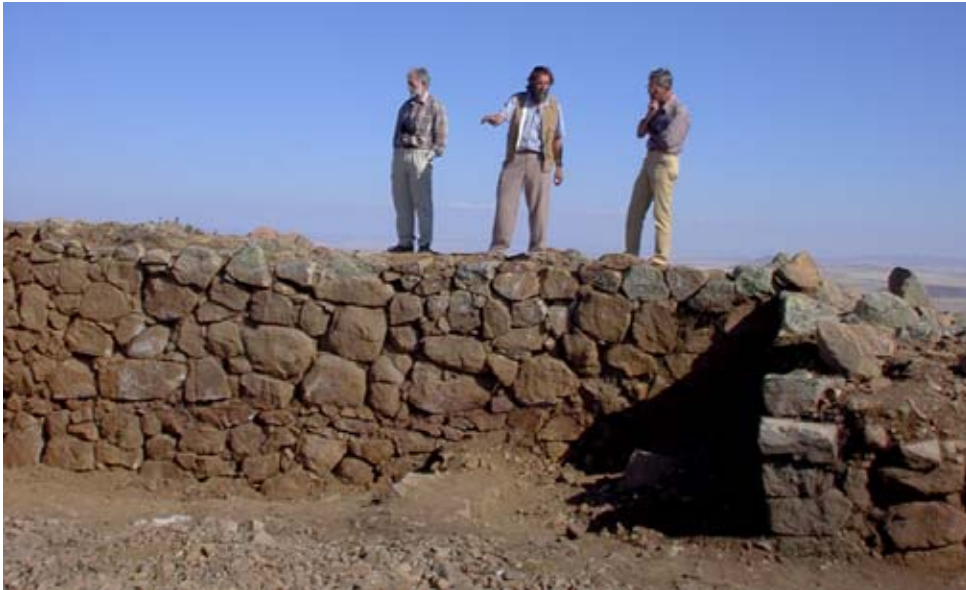
*Figure 83. Visitors from Sardis, Crawford H Greenewalt Jr and Colin Wright, view progress in the clearance of the inner chamber. (03dpjv6267)*

The stone fill of the gate chamber (Figs 83 and 84) has been lowered so that it is now more or less level with the present surface of the modern trackway that leads through the gate. This procedure has revealed some 2.00m of standing wall in the south-eastern corner of the gateway and it is estimated that a further 2.00m or remains to be exposed in the course of the next season. The only feature of note is a level row of small stones in the walling that is associated with clay and burnt debris. This structural element, which runs along the entire length of the south-western wall, part of the buttress wall at north-west and extends along some 3.00m of the north-east walling, appears to represent some form of intermediate flooring or balcony within the south-western portion of the internal gate chamber.

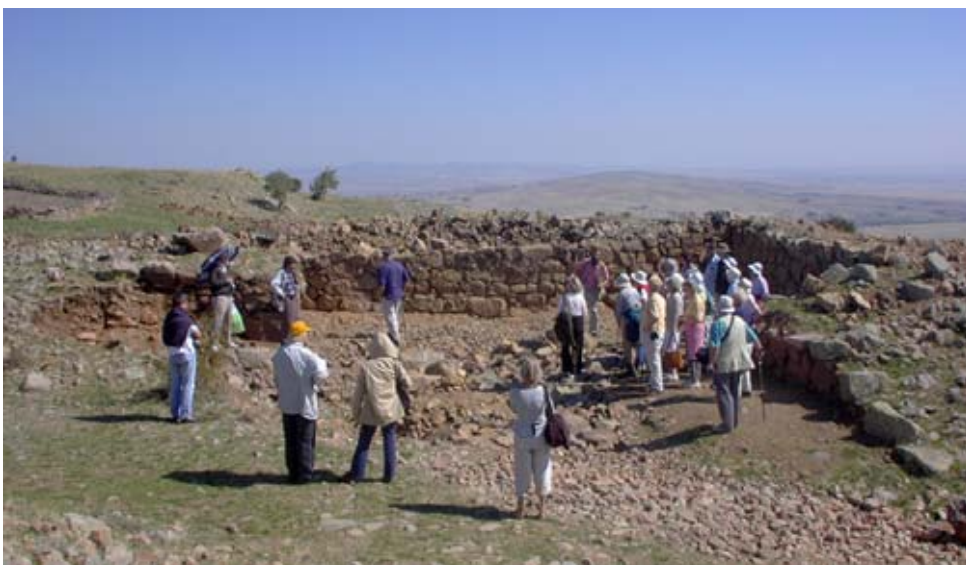
*Figure 84. Visitors in the partially excavated gate chamber provide a sense of the monumental scale. (03dpjv7514)*

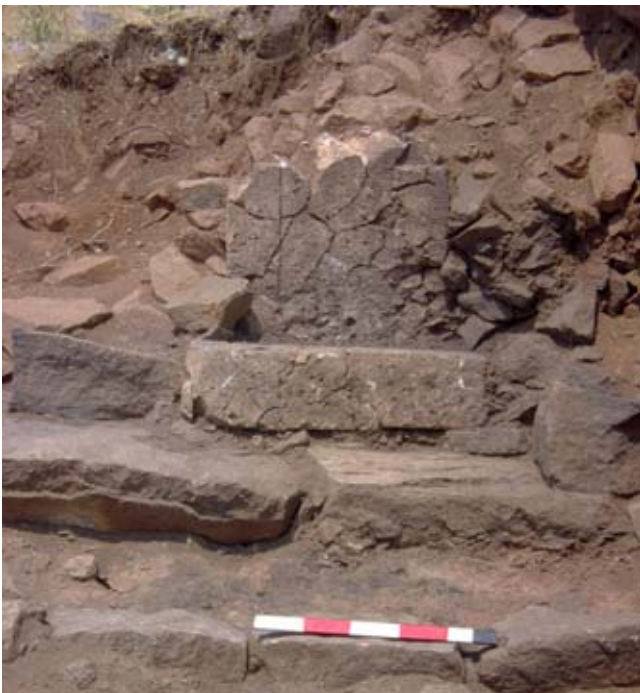
*Figure 85. The aniconic stele of a Phrygian deity and the topmost step in which it was set was uncovered in the Cappadocia Gate, see also Fig. 86. (03dpjv6171)*

Against the south-west face of the north-eastern tower, on the side of the innermost section of the gate passage, the unexpected discovery was made of a stepped monument supporting a partially preserved aniconic stele (Figs 85 and 86). This stele, which faces outwards, was removed although the stepped monument has not been fully exposed and problems concerning access to it remain to be investigated in 2004. As to the stele itself, it is carved from a very soft chalky limestone. The stone is not only badly shattered but many roots were seen to have penetrated into the cracks. Some of the interior of the stone has turned pink as a consequence of the fire. The back of the stele itself and the rear upper slab into which it was fitted are missing, presumably broken during the destruction of the gate. The uppermost step, which was recessed on top so as to retain the stele, was cut from the same chalky stone and has likewise shattered. The two lower steps that have been exposed are very rude and uneven and it seems probable that they were originally covered with mud plaster or perhaps wood. The stele was carefully lifted and awaits a detailed assessment of its condition and possible reconstruction in the Kerkenes laboratory in 2004.

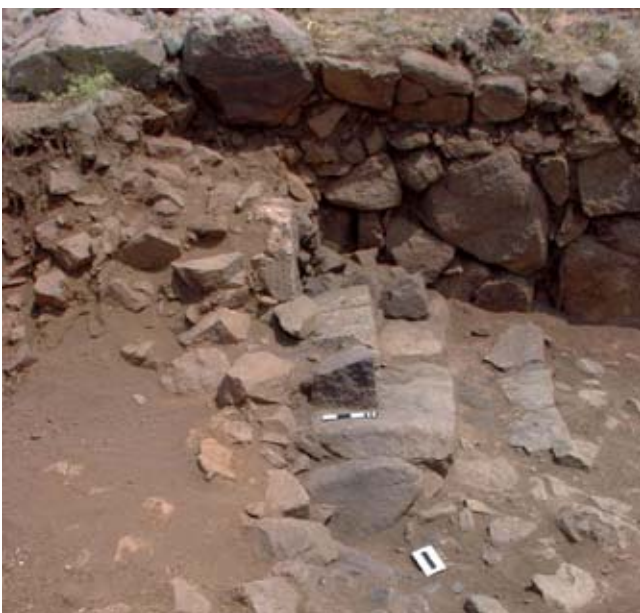
*Figure 86. The partially excavated stepped monument in the rear of the Cappadocia Gate Passage. The stele and the topmost step are both made of a soft chalky stone and very badly cracked. (03dpjv6167)*
