# THE KERKENES PROJECT

## A PRELIMINARY REPORT ON THE 2010 SEASON

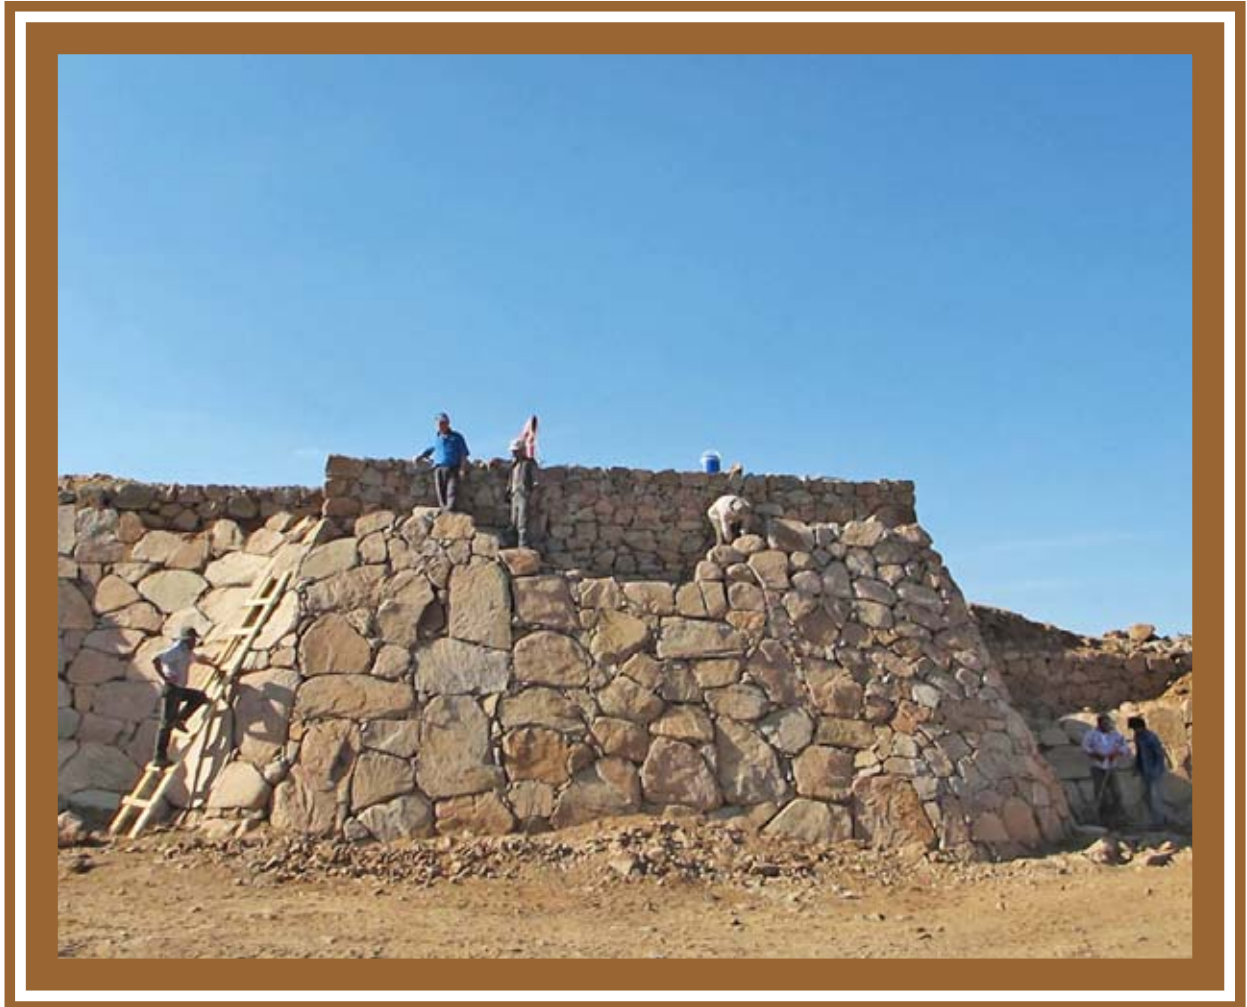
*Figure 1. Restoration of the Cappadocia Gate glacis in progress. (10dpcg0425)*

In 2010, commencement of restoration at the Cappadocia Gate (Fig. 1) and excavation of the ‘Temple’, a large public hall situated on the Central Spur, were the two new initiatives at the Iron Age capital on the Kerkenes Dağ overlooking the village of Şahmuratlı (Figs 2, 3 and 4). In addition, excavations inside the Cappadocia Gate revealed unexpected results while the spring campaign of geophysical survey added to our understanding of urban dynamics within the southern zone. Finally, two large stone idols were restored and installed in the Yozgat Museum.

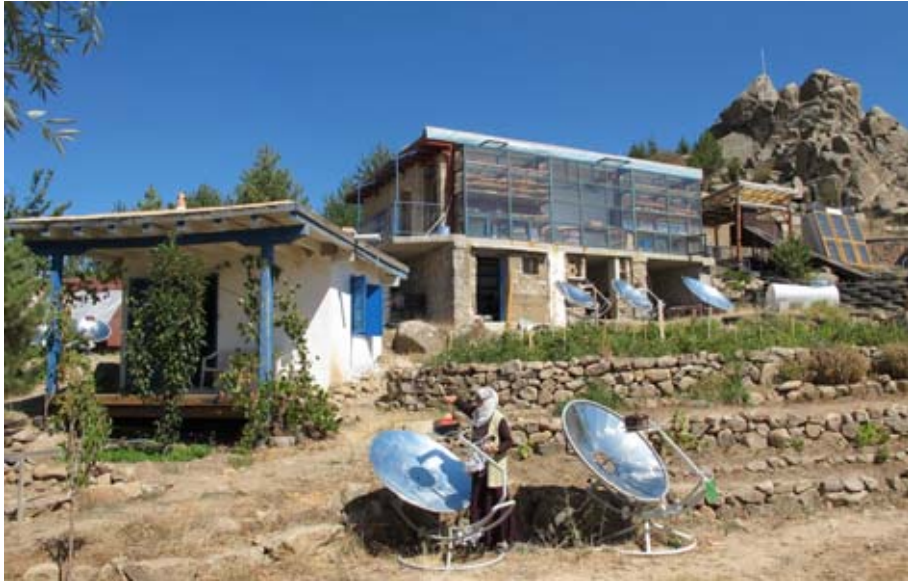
*Figure 6. The Solar Building and solar cookers are part of the facilities provided by the Kerkenes Eco-Center. (10kecg0301)*

Thanks to the generosity of sponsors and friends, the Kerkenes Project is provided with facilities such as the Erdoğan Akdağ Center for Research and Education which can accommodate large groups of visitors and students (Fig. 5). The Kerkenes Eco-Center Project has thus evolved and a team based at METU works in collaboration with ŞAHDER, the Kerkenes and Şahmuratlı Village Association for Public Relations, Prosperity, Help and Support, to promote sustainable rural development and to involve villagers in the daily running of the expedition. The Kerkenes Eco-Center promotes sustainable rural life through the development of renewable energy, drip-irrigated organic gardens, and building with appropriate materials and energy efficient designs (Figs 6, 7 and 8).

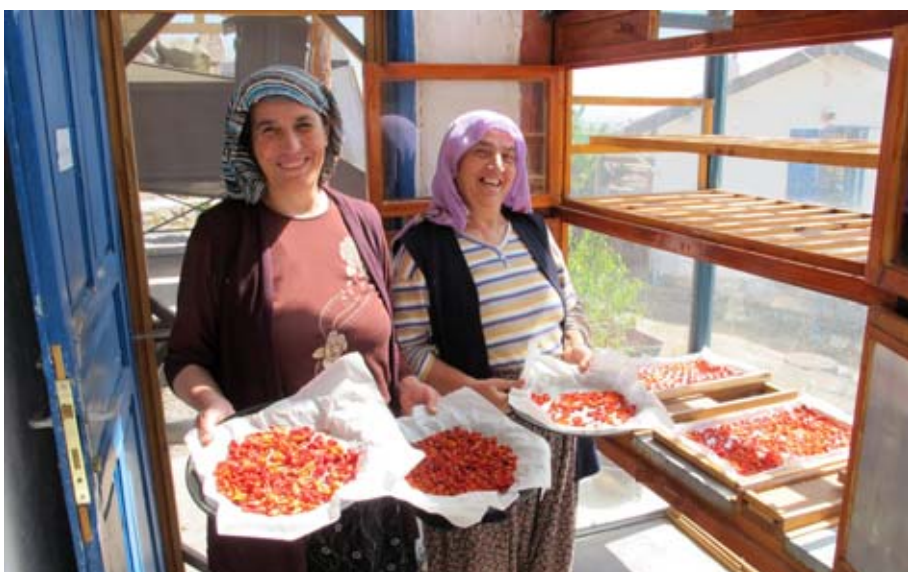
*Figure 8. Hanım Arslan and Nurdan Erciyas working in the solar space where built in shelves have been provided to facilitate solar drying of tomatoes and other fruit and vegetables. (10kecg0314)*

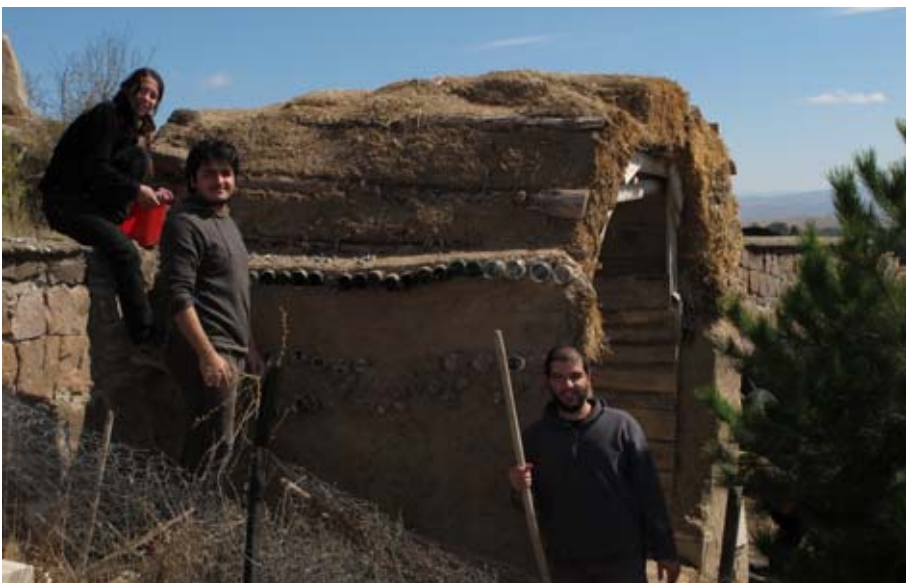
*Figure 13. Working in groups, students build with straw bales, mud, and recycled bottles and cans. (10kecg0622)*

Students from the Middle East Technical University come to the Kerkenes Eco-Center to take part in the 'Hands on Building' sessions of the elective course Arch 325, 'Architecture *in situ*' (Figs 9, 10 and 11). With the emphasis being on environmental design and recycling, students have selected mudbricks, straw bales, old tyres, recycled bottles and other suitable material to realise their projects while at the same time adding to the amenities of the Kerkenes Project compound (Figs 12 and 13).

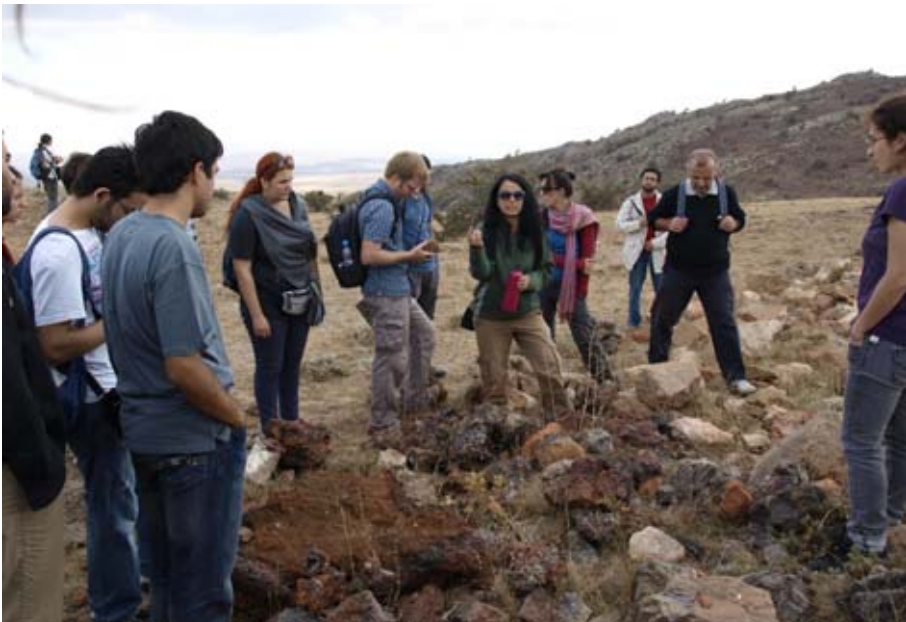
*Figure 38. Yasemin Özarıslan showing burnt debris that contain vitrified granite attesting the intensity of the fire that destroyed the Iron Age city. (10dpkc2711)*

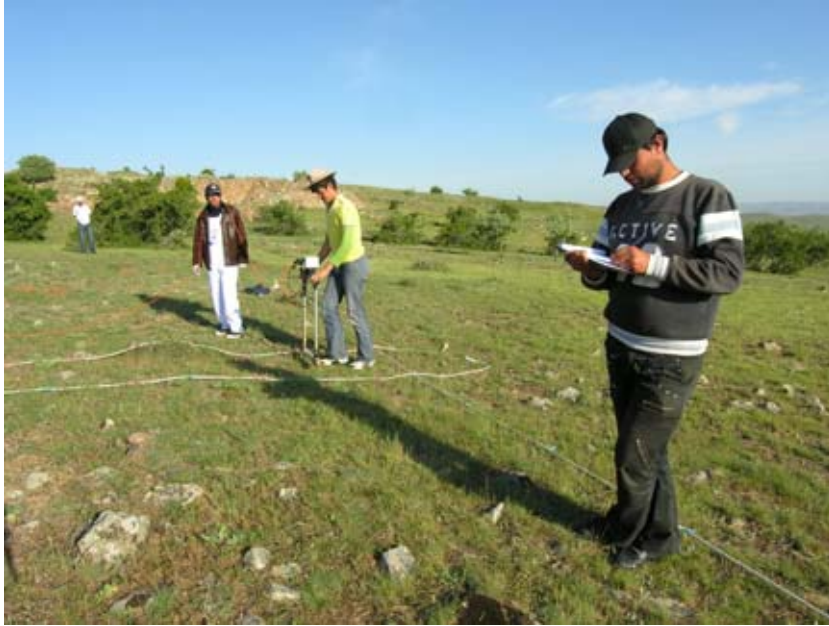
*Figure 41. Mehmet Baştürk, Cafer Babayiğit and Muhammed Babayiğit collecting data with a Geoscan RM15 resistivity meter over Area A between the Cappadocia Gate and the Palatial Complex while Fatih Arslan fills grid forms and draws a sketch of each grid. (10dpnc1028)*

Adverse weather conditions notwithstanding, 27 days of survey were done while the soil was still sufficiently damp for electrical resistance survey to yield good results. A GEOSCAN RM15 resistivity meter was operated, as in previous years, by three workmen from the village of Şahmuratlı (Fig. 41) under the supervision of the geophysical survey team. As each 20 x 20m grid was surveyed, forms were filled and a small sketch of what is visible on the surface was drawn for each one. Where it was not possible to relocate the grid corners set out and marked with powdered lime in previous years, the points were relocated using a total station (Fig. 42).

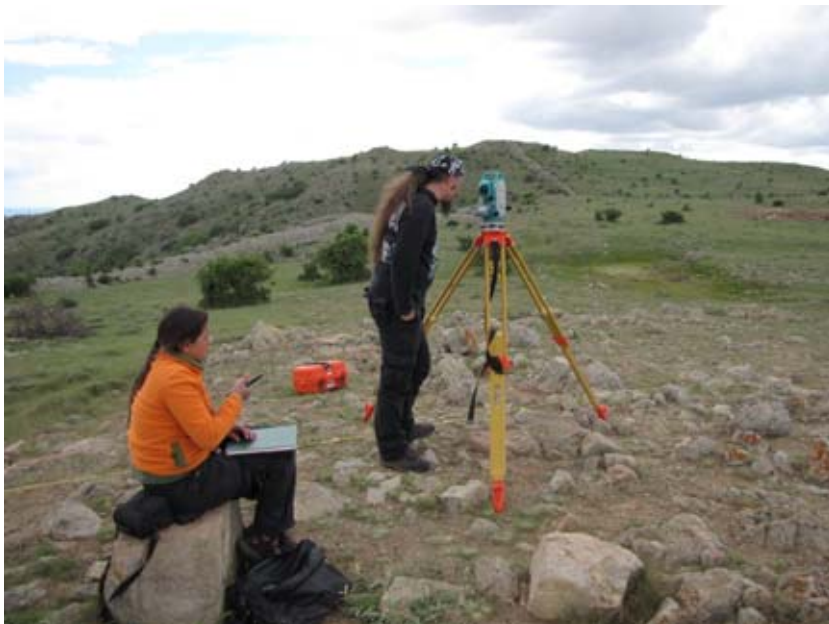
*Figure 42. Güzin Eren and Ferhat Can using the total station to relocate unmarked grid corners for the electrical resistance survey. (10dpcp0614)*

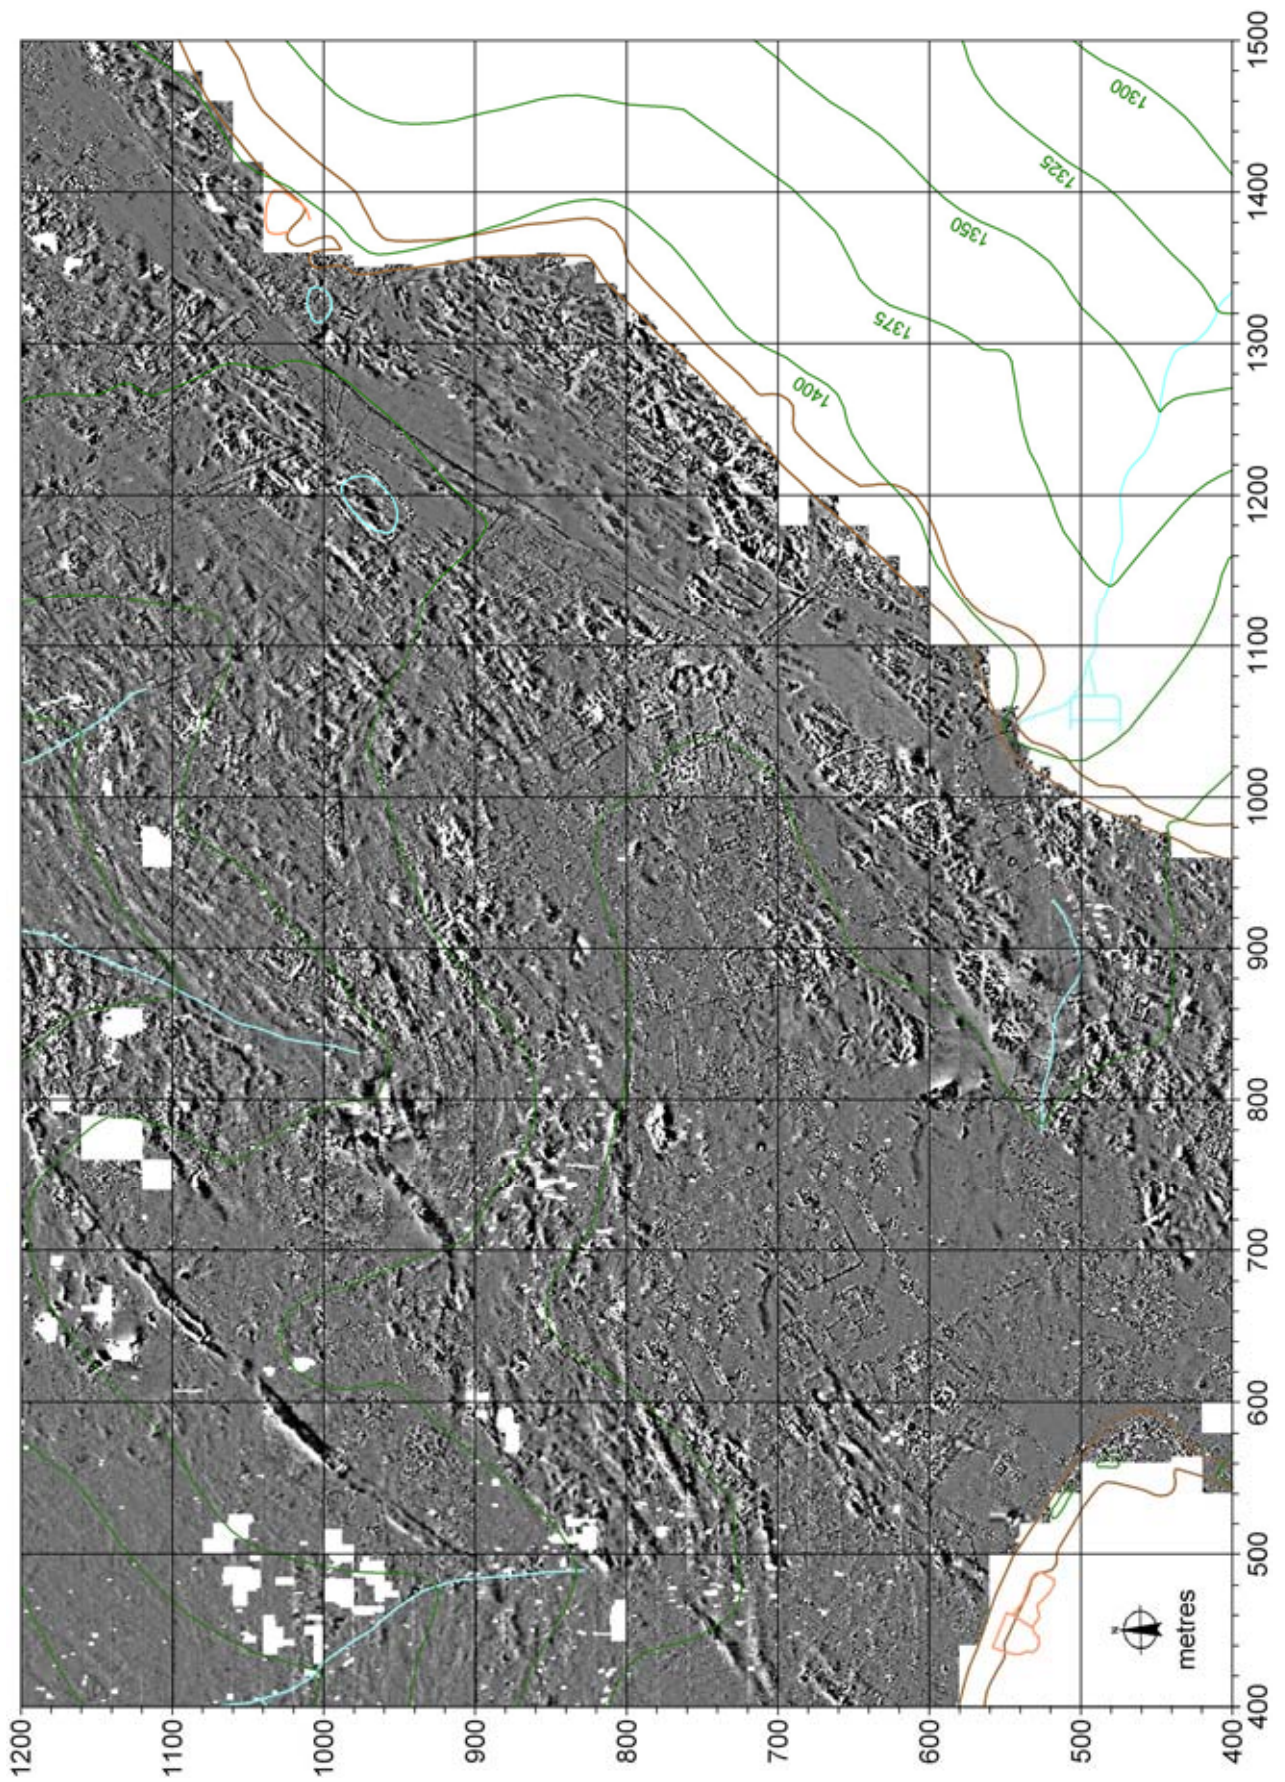
Figure 45. Geophysical image of subsurface features along the Southern Ridge made by survey with a Geoscan fluxgate gradiometer.

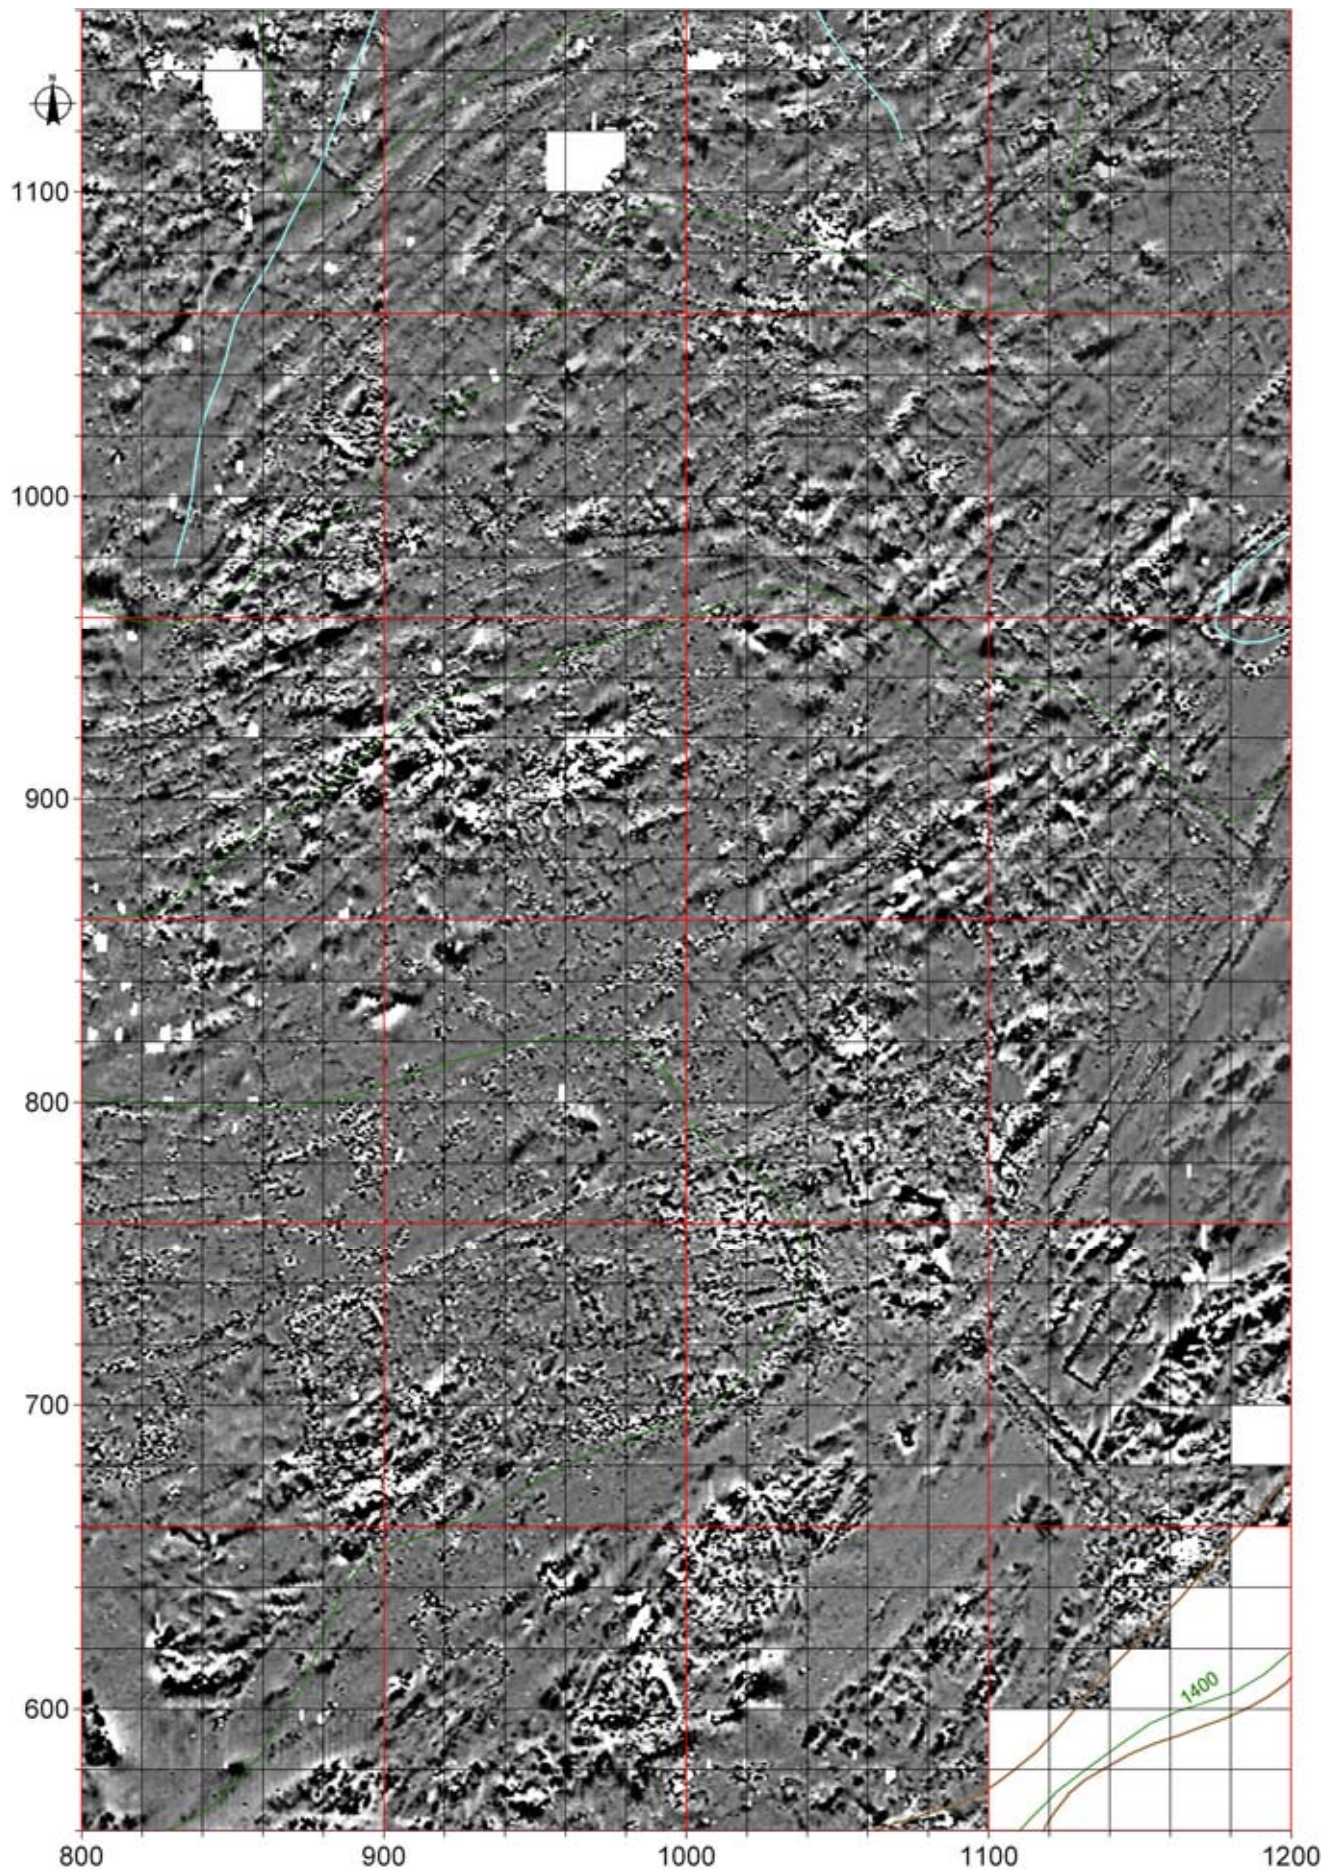
*Figure 49. Gradiometer survey of the Palatial Complex and surrounding area. Compare with Figure 50.*

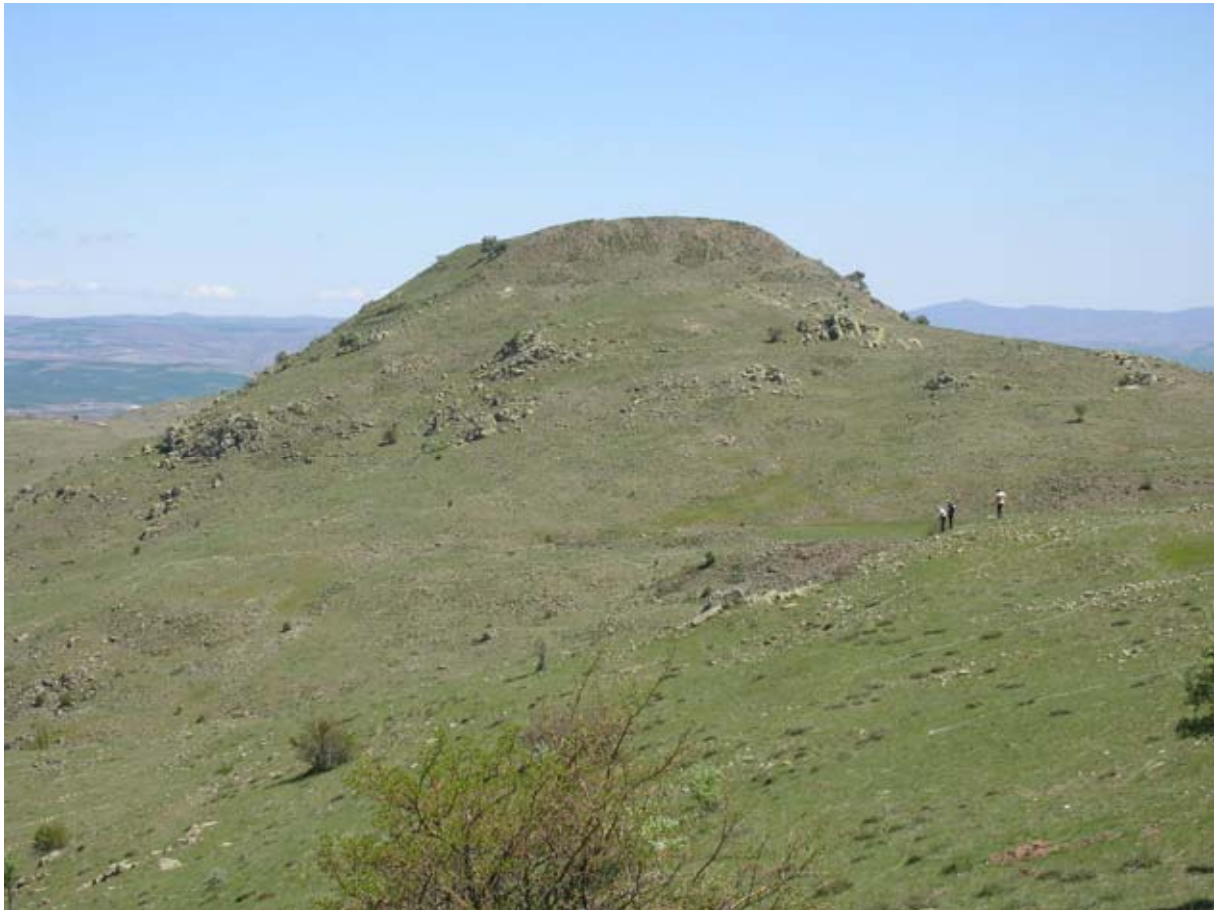
*Figure 54. Area F, with the Kale in the background. The surveyors are more or less in the middle of the Field (the southeast end of which is obscured) and below the northwestern end of the terraces. (10dpnc0119)*

Area F, beyond the southern slopes of the Kale (Fig. 54), was surveyed with a gradiometer in 1999 and 2000 and a resistivity meter in 2008 and 2009. In 1996, test trench TT19 (Fig. 53) was excavated to investigate long structures partly visible on the surface of the terraces above the Field. This trench revealed parallel walls of structures that are thought to be 'Royal Stables', as discussed below. Geophysics also revealed associated structures such as might be expected to store bedding and fodder. The so-called Field, a flat area below these terraces, perhaps functioned as an exercise and training ground amongst other purposes.

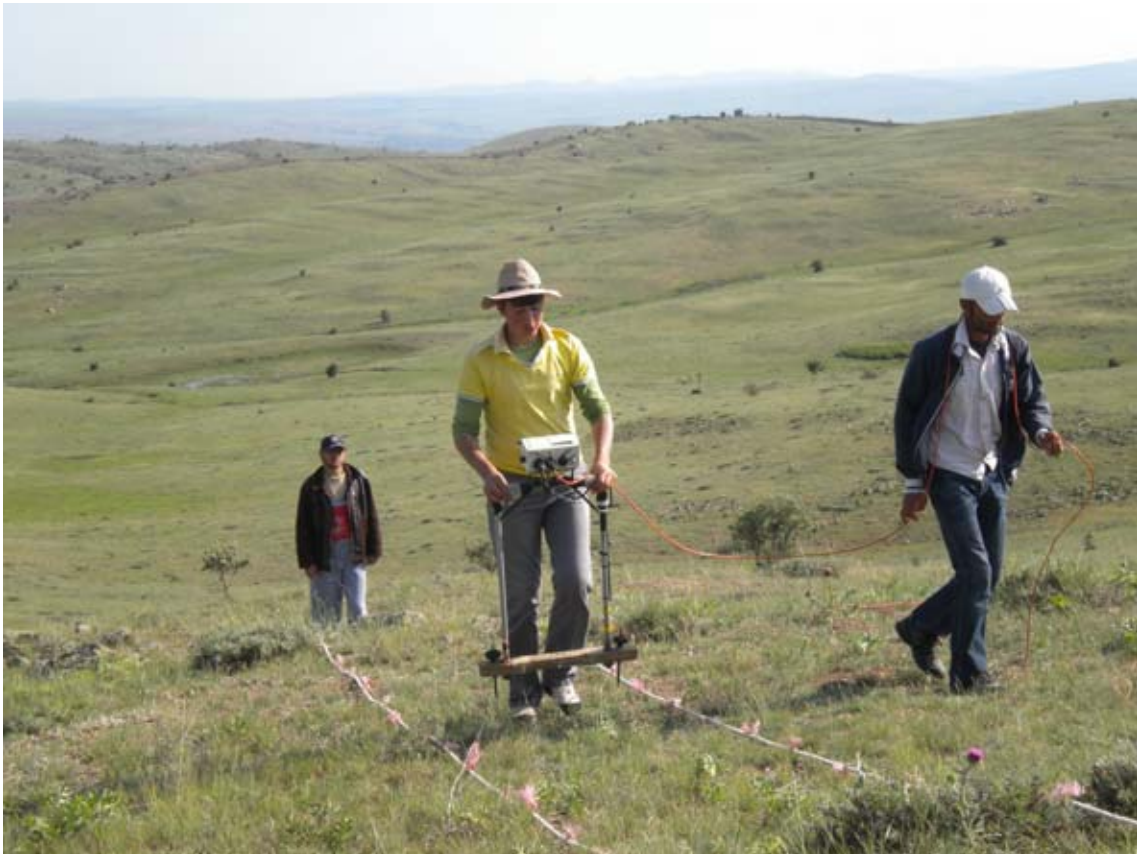
*Figure 55. Electrical resistance survey of the 'Temple' area by a team of three, Cafer Babayiğit, Muhammed Babayiğit and Mehmet Baştürk. (10dpkc0111)*

At the end of the 2010 spring survey season, when there was still enough moisture in the ground, it was possible to resume the electric resistance survey of the 'Temple' area over the Central Spur (Figs 55 and 56). The large burnt two-room building on the Central Spur (Fig. 57) was tentatively named the 'Temple' when first revealed by the gradiometer survey. The electric resistance survey showed up, with great clarity, the smaller structures around the larger building.

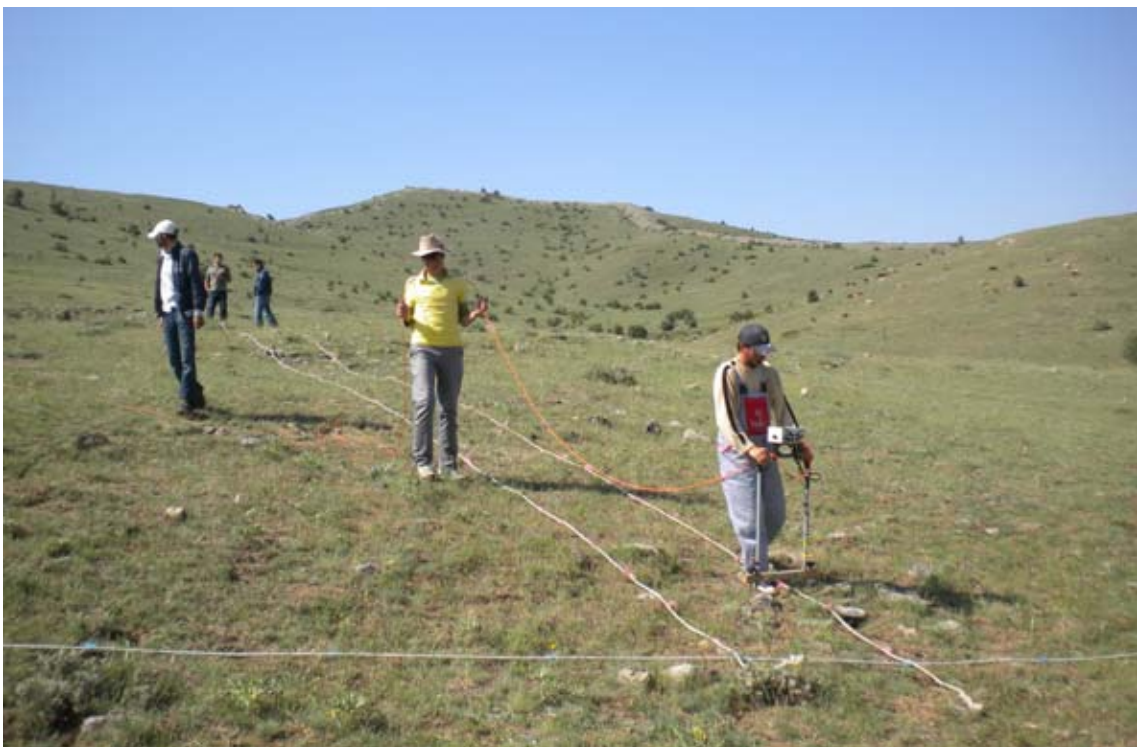
*Figure 56. The survey around the 'Temple' revealed many smaller structures which are not visible on the surface. The defences running towards the furthest southern limit of the site can be seen in the background. (10dpkc0119)*

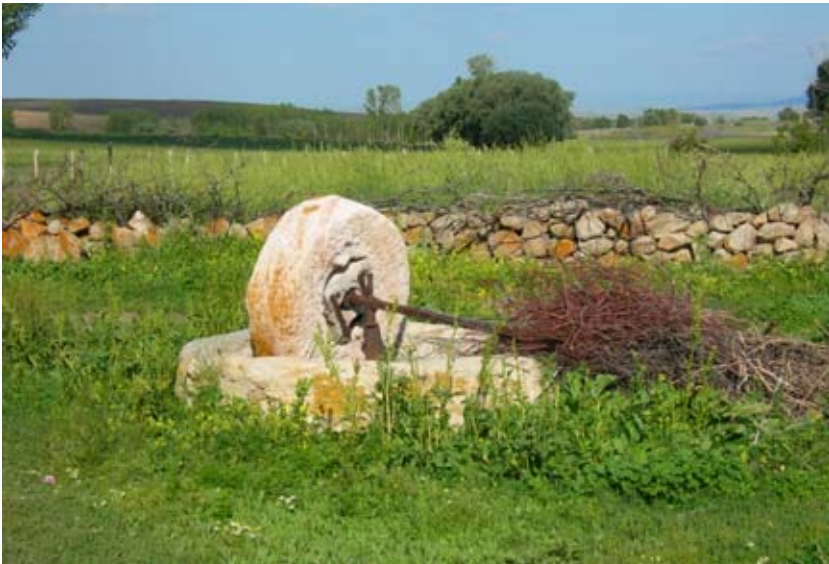
*Figure 62. A disused donkey-mill in Şahmuratlı village. (08dpng0312)*

Attesting the long tradition of horse breeding in Cappadocia, a statue in the town of Esenli (Fig. 61), commemorates famous racehorses from the village of Dedik now drowned by the waters of the Gelingöllü Dam. A disused animal powered mill in Şahmuratlı village points to the importance of equid power a generation ago (Fig. 62). In nearby Emirhan, a donkey mill is still used to crush grain (Fig. 63).

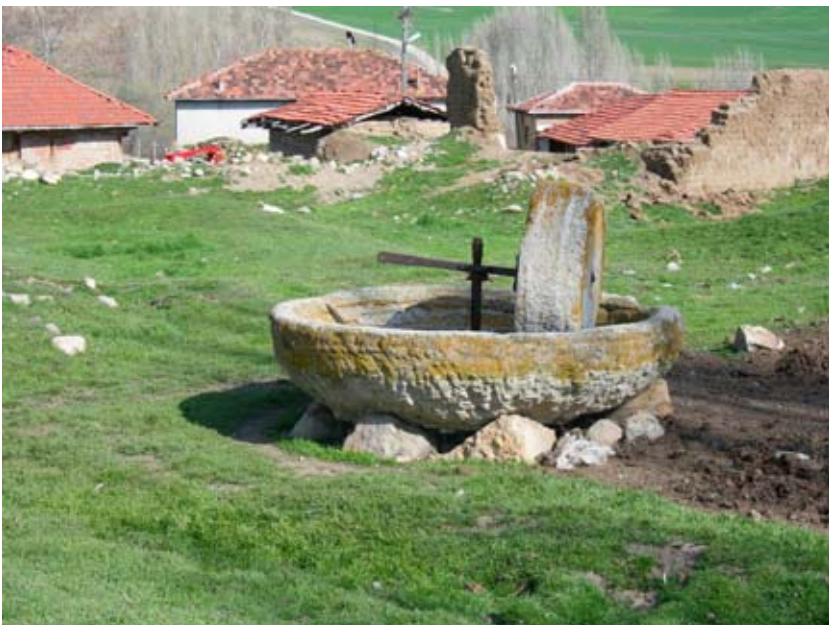
*Figure 63. A donkey-mill in nearby Emirhan is still used to crush grain and legumes. (09dpng0418)*

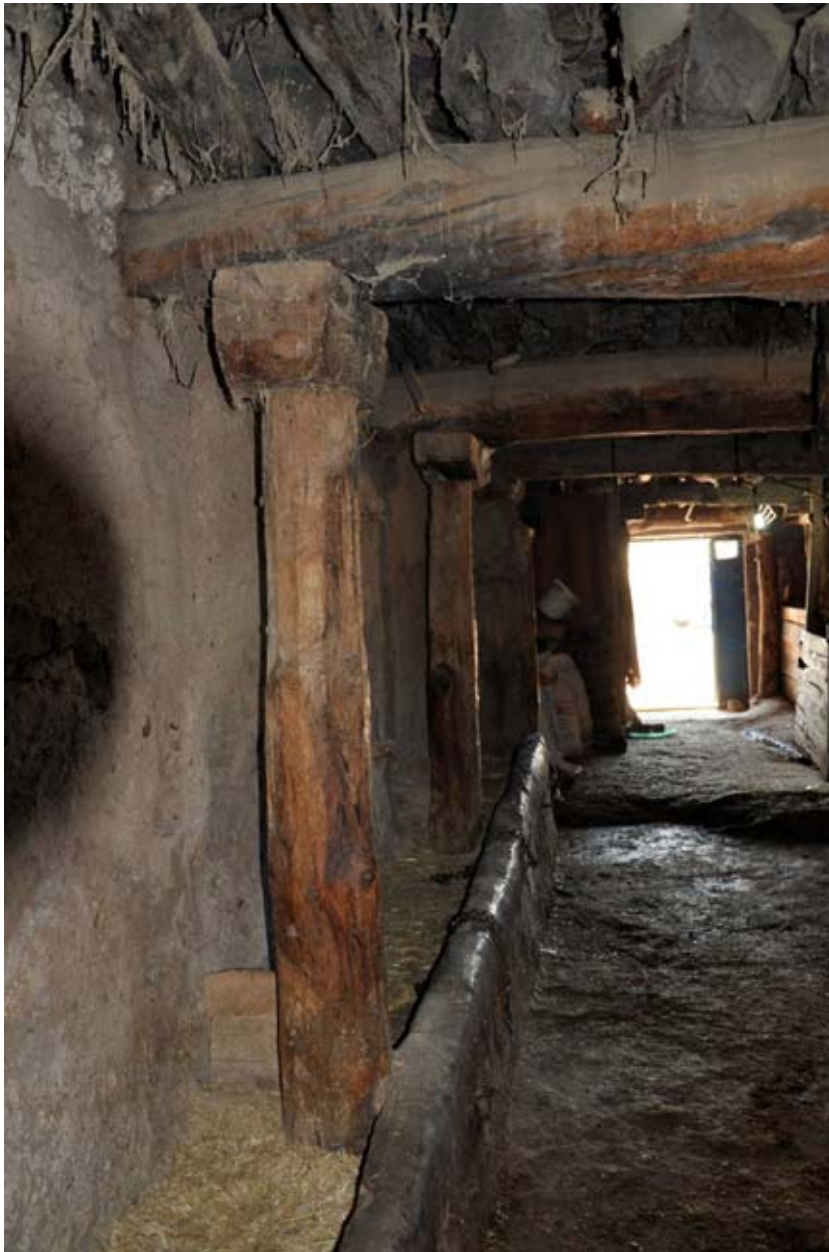
*Figure 64. Detail of wooden pillars, capital and roof beams with mud-plastered wall and food troughs. (10dpnd1907)*

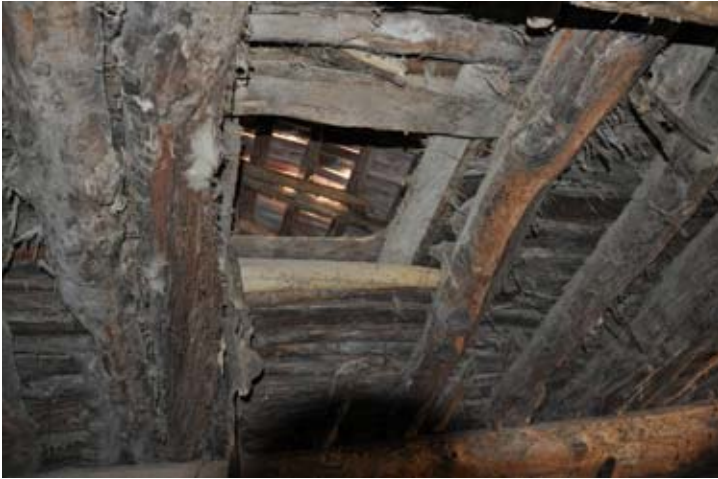
*Figure 65. The original flat roof was constructed of beams supporting rafters covered with split branches and a thick layer of mud. A trap door cut through the original roof provides a glimpse of the recently added clay tile pitched roof. (10dpnd1905)*

Kara Mehmet Erciyas was the last man in Şahmuratlı village to own a horse. Fifty years ago, however, at a time when the village had a considerably larger population than it does today, almost every family owned a pair of horses for ploughing. These horses were stabled in the same animal sheds as the cattle and donkeys but were separated from each other as well as from other animals by wooden stalling. The width of the building, erected by Kara Mehmet's father perhaps 65 years ago, is 5m. Stalls were sufficiently wide for the animals to lie down and straw bedding changed more or less weekly as long as sufficient was available. Floors were of hard-packed earth rather than stone with a central drain running the length of the building. The large juniper roof timbers were probably reused from an older building and feeding troughs line one of the walls (Fig. 64). The original flat roof was constructed of beams supporting rafters covered with split branches and a thick layer of mud. A trap door cut through the original roof (Fig. 65) provides a glimpse of the recently added clay tile pitched roof. Today Kara Mehmet uses the same stable (Fig. 66). Although the floor is now of concrete, the central drain is retained and wooden stalling used to separate calves from their mothers (Figs 67 and 68).

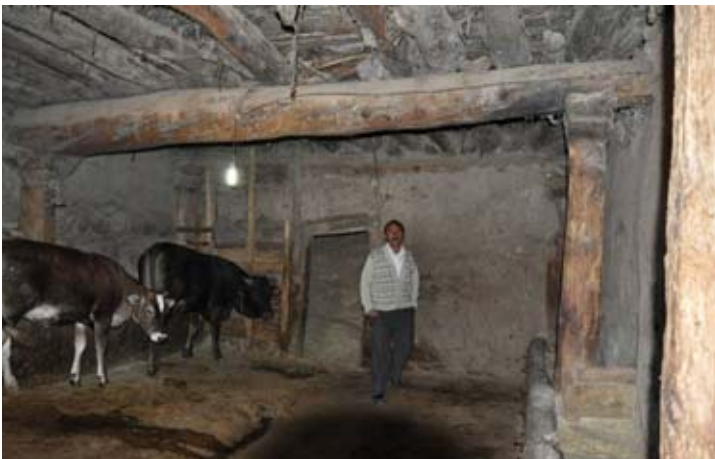
*Figure 66. Kara Mehmet in his stable, now used as a cowshed, at Şahmuratlı village. A central drain runs the length of the concrete floor while food troughs run down either side. The doorway at the far end leads into a dry store for fodder. Note the size of the juniper roof beams which are no longer available in the immediate region today. (10dpnd1904)*

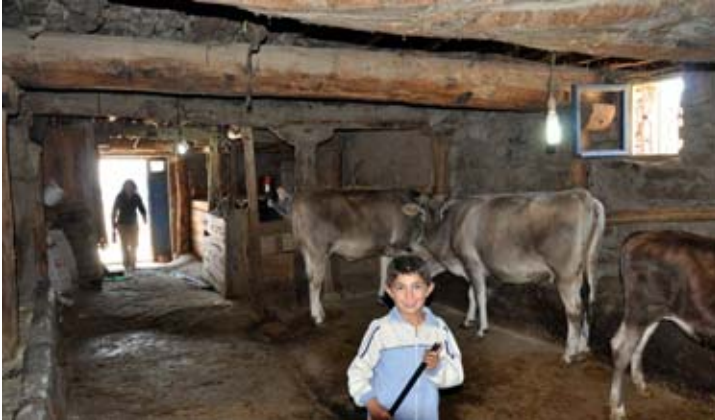
*Figure 67. METU Graduate Student Yasemin Özarslan enters next to the corner partitioned for calves. Similar wooden partitions would have been used for horse stalls. (10dpnd1908)*

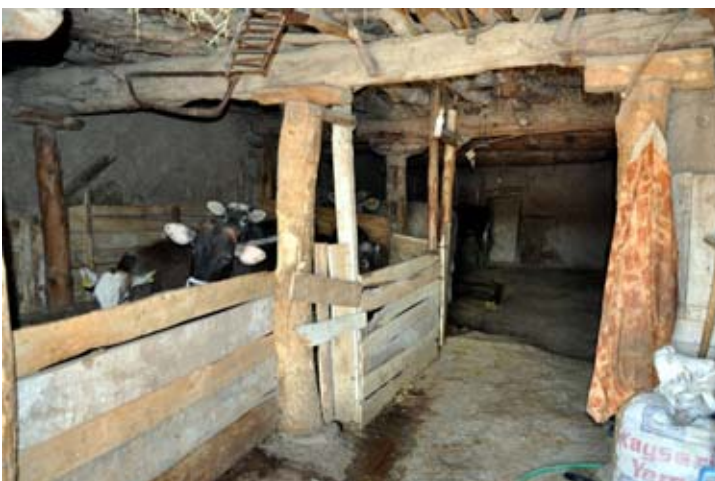
*Figure 68. Detail of temporary wooden partitions, here used to separate calves from their mothers. (10dpnd1915)*

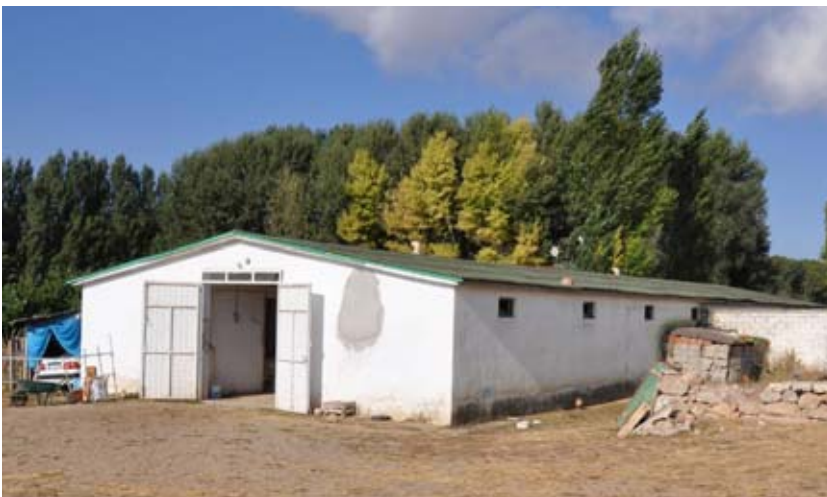
*Figure 70. Modern racehorse stable at Mehmetbeyli village. (10dpnd1710)*

In the neighbouring village of Mehmetbeyli racehorses are bred and raised (Fig. 69). The modern stable is built of bricks and concrete, preferred contemporary building materials that do not demand as much maintenance as timber and mud (Fig. 70). The building is roofed with a low-pitched reinforced concrete slab covered with corrugated sheeting to keep the slab dry. The structure is 9m wide and divided into three along its length with a central nave flanked by cubicles each measuring 3 by 3m (Fig. 71). There are high windows providing ventilation without a chilling draft. The total length is over 20m, only about one quarter of the combined length of the Kerkenes Stables as drawn in Figure 53b.

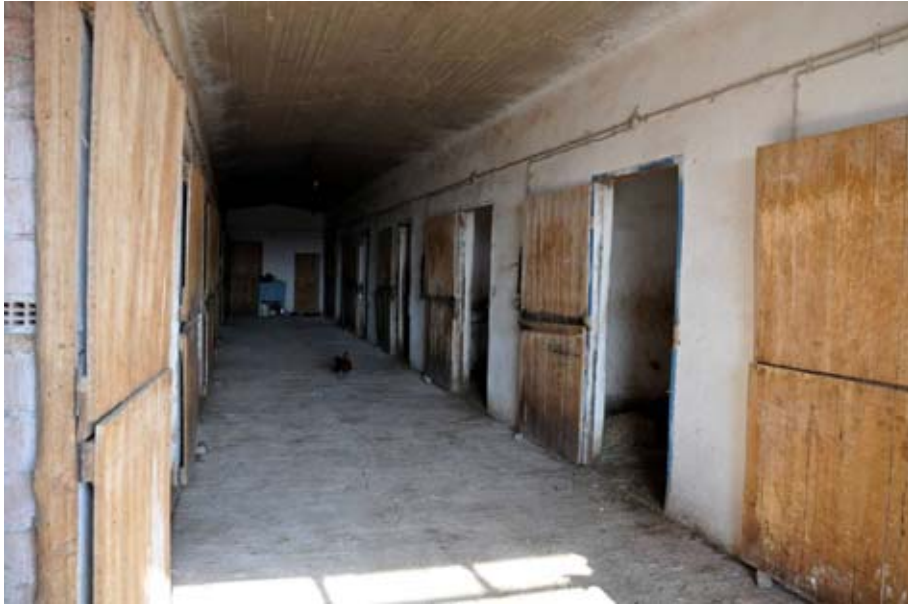
*Figure 71. Interior of the modern stable at Mehmetbeyli village. The central aisle, down which a rooster runs, is flanked by individual stalls. (10dpnd1702)*

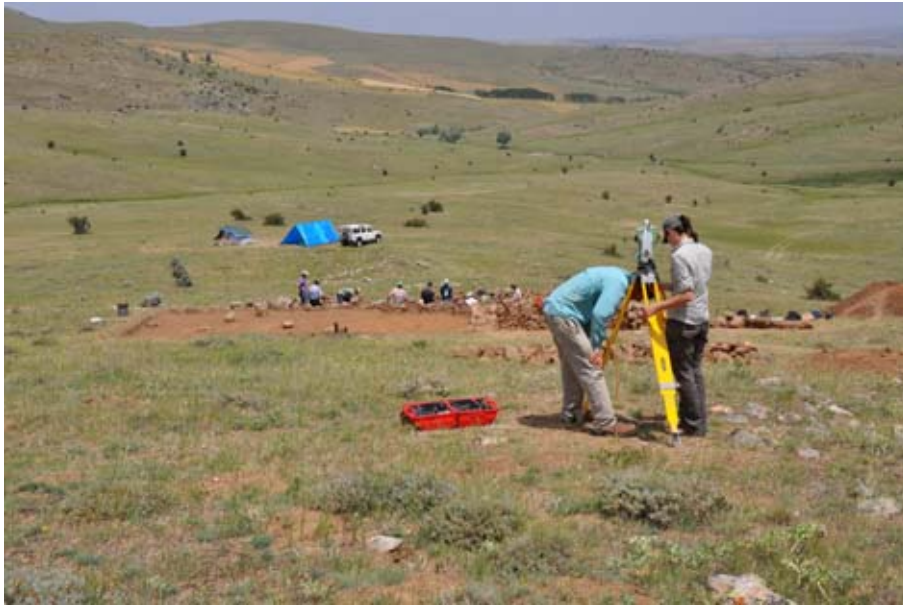
*Figure 77. A total station was used to plan the new trenches, walls and features.  
(10dpnd0438)*

During June and the first half of July, two trenches were excavated in the south-central portion of the city (Fig. 74). These trenches, TR27 and TR28, were positioned to uncover significant portions of a large two-roomed building (Structure A) and an attendant smaller building (Structure B) revealed by the geophysical surveys in 2002, 2004 and 2010 (Figs 75 and 76). It had been suggested that the 26.5m x 12.5m Structure A might be a temple or other public building due both to its size and its position outside of a proper urban block. It had also been suggested from analysis of the geophysical data that Structure A had been intentionally set on fire in the final destruction of the city. The reasons for excavating these two trenches were therefore to confirm the reconstructed plans of these structures, to investigate their construction and destruction, and if possible to recover material evidence related to their functions (Figs 77, 78 and 79).

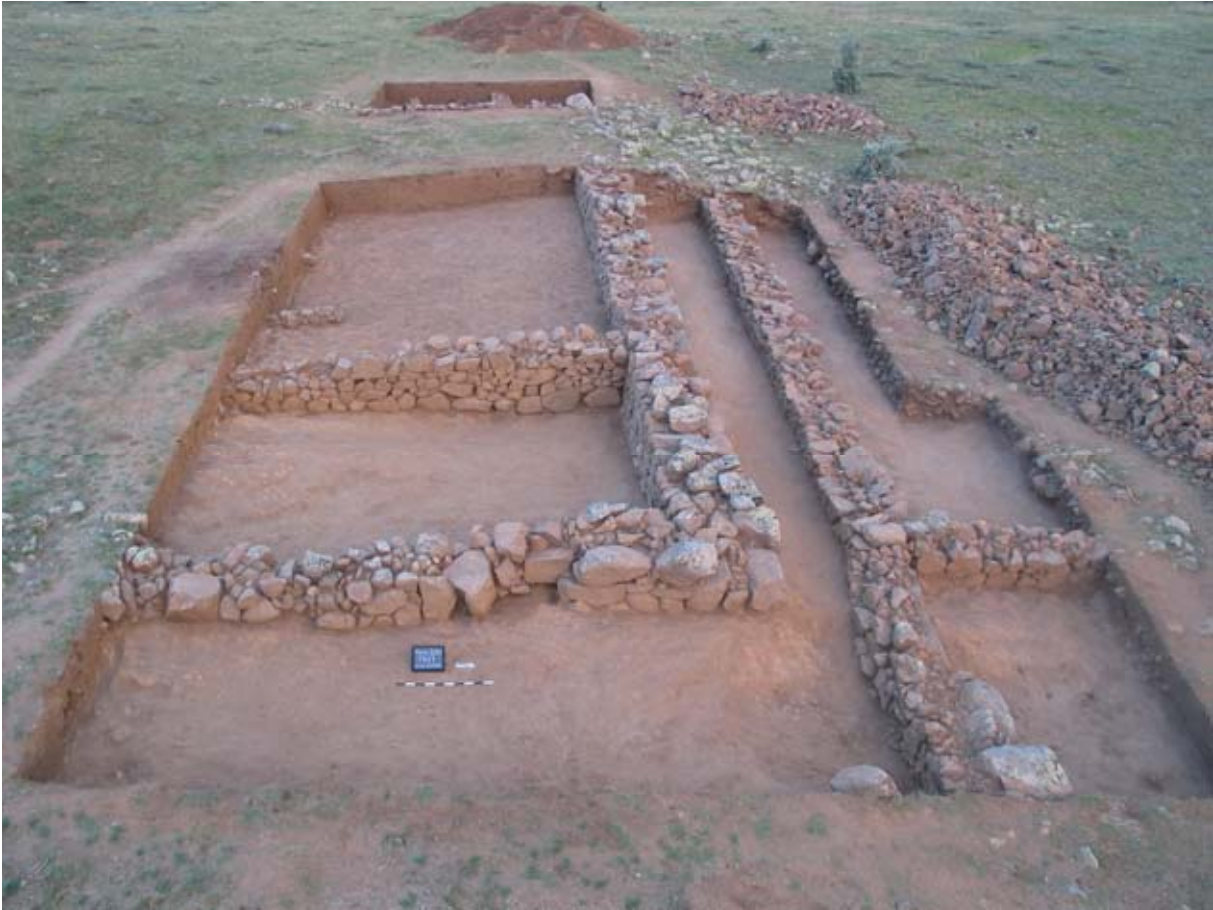
*Figure 81. Photograph of trench TR27 after excavation. (10dpkc0729)*

Trench TR27 was 20m in length and between 11.5m and 11m in width, exposing a total area of 220.5m<sup>2</sup> (Fig. 80). It was situated to expose the north-eastern quarter of Structure A, a portion of the area in front of Structure A, and a majority of the collapse from the walls of Structure A down the slope to the north. As the rubble collapse was removed to the north of Structure A, a portion of the southern wall and south-eastern corner of the urban block to the north of Structure A were also revealed along with a retaining wall abutting the corner of that urban block wall and extending to the east (Fig. 81). In the narrow area between the northern wall of Structure A and the southern wall of the urban block evidence was found for an unpaved passage surface running along the northern side of Structure A.

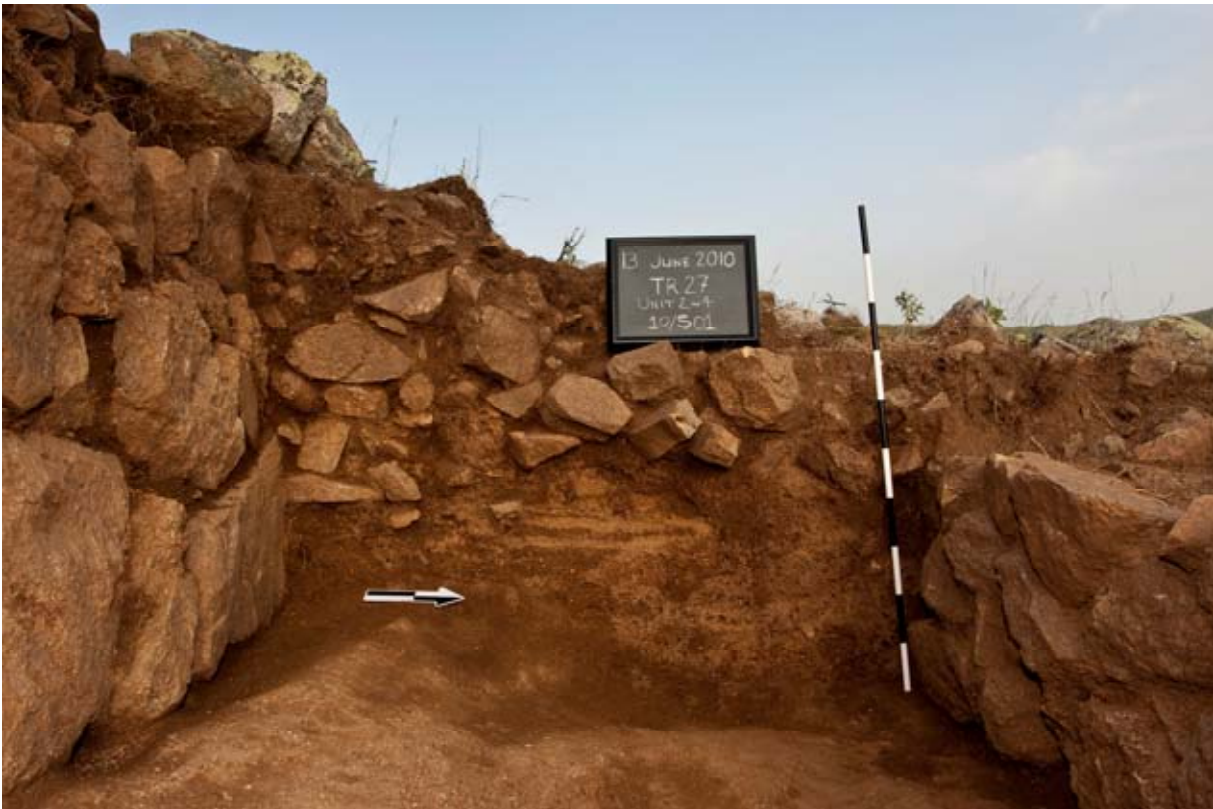
*Figure 82. Photograph of a section through the passage. (10dpkc0305)*

Between the northern wall of Structure A and the external face of the urban block wall a narrow passageway 1m to 1.5m in width was uncovered. Preserved here beneath the collapse from Structure A was a sandy layer (Fig. 82) identical to unpaved street surfaces encountered during excavations of streets at Kerkenes Dağ in 2004 and 2008. Several micromorphology and loose soil samples were taken from this passage and shipped for analysis at the University of Cambridge in England as part of the ongoing project to test the results of computer simulations of ancient traffic patterns in the city.
