# THE KERKENES PROJECT

## A PRELIMINARY REPORT ON THE 2010 SEASON

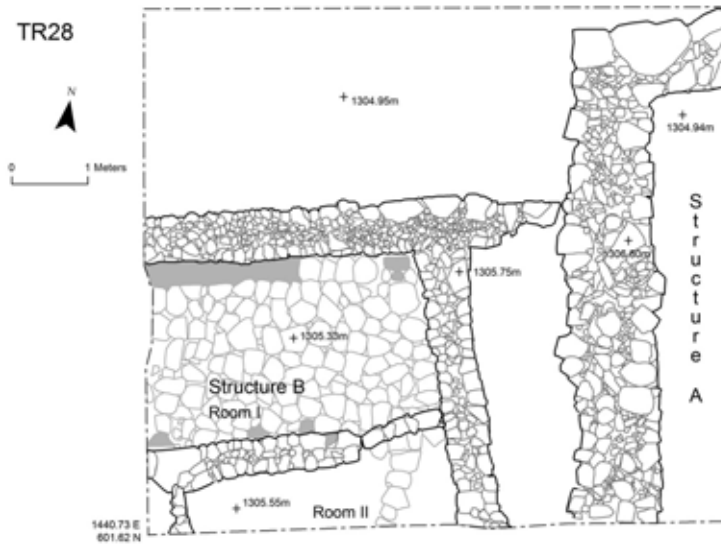
*Figure 83. Plan of trench TR28.*

Trench TR28 was located 7.5m beyond the western edge of TR27. It was 7.5m in length and 7m in width, exposing a total area of 52m<sup>2</sup> (Fig. 83). It was situated to expose half of the western wall of Structure A as well as a quarter of Structure B behind it. Just as in TR27, no floor surface or interior features were found within the narrow slot at the back of Room II in Structure A. The west wall of Structure A was slightly wider and higher than the north wall of the building. The increased width of the west wall of Structure A may be related to a significant drop in the bedrock beneath the wall and in the space adjacent to it between Structure A and Structure B. Sandy occupational material, similar to the passage surface found in TR27, was also noted running under the lowest course of the northwestern corner of Structure A and into exterior space to the north of Structure B.

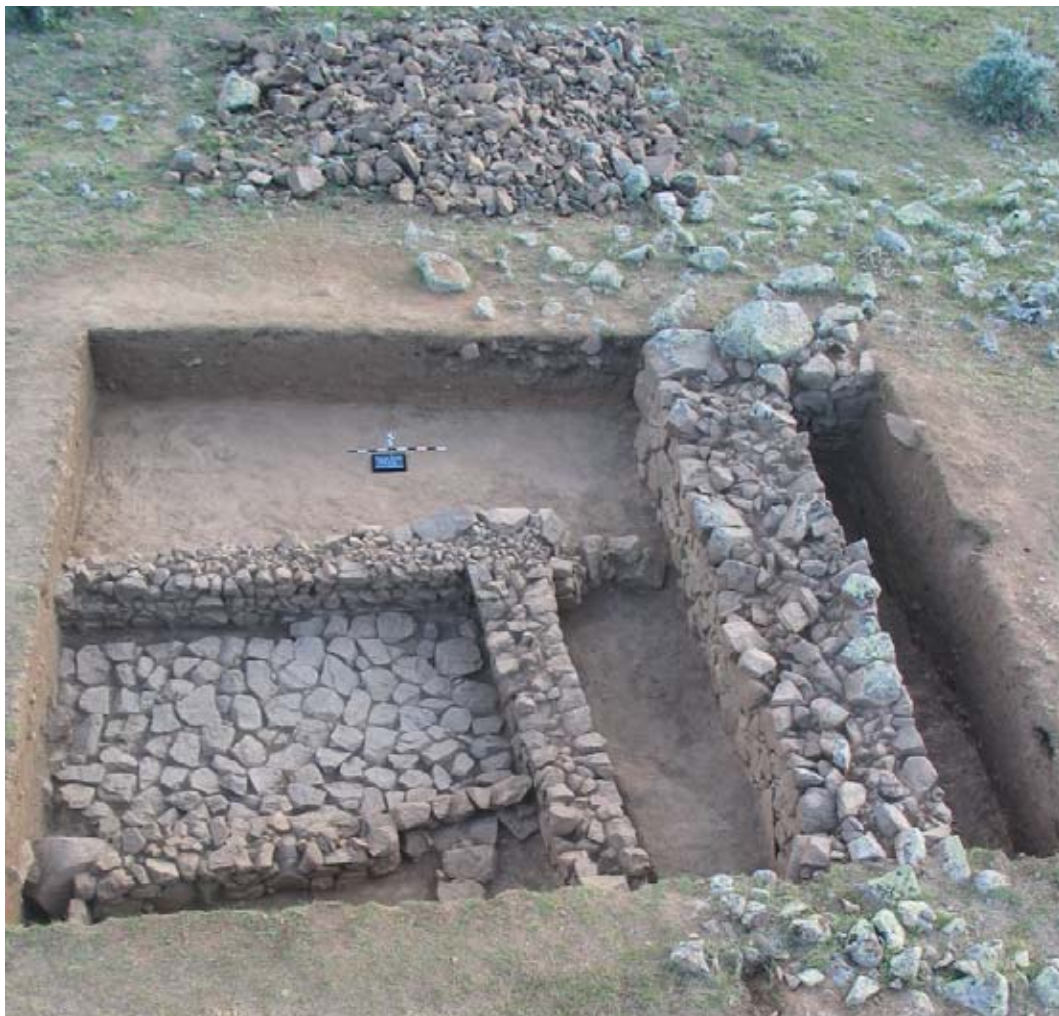
*Figure 84. Photograph of trench TR28 after excavation. (10dpkc0807)*

The exterior walls excavated along the north and east of Structure B are notably smaller than those of Structure A (Fig. 84). The north wall of the building continues to run beyond the northeastern corner of Structure B, falling just short of the west wall of Structure A. This extension may have been built to retain fill within the half-meter drop in the underlying bedrock just to the south of this wall, thereby preventing erosion from undercutting the west wall of Structure A and the east wall of Structure B. A shallow foundation trench for the eastern wall of Structure B, perhaps to provide additional stabilization, was noted along the southern portion of this wall up to the point at which the bedrock drops considerably.

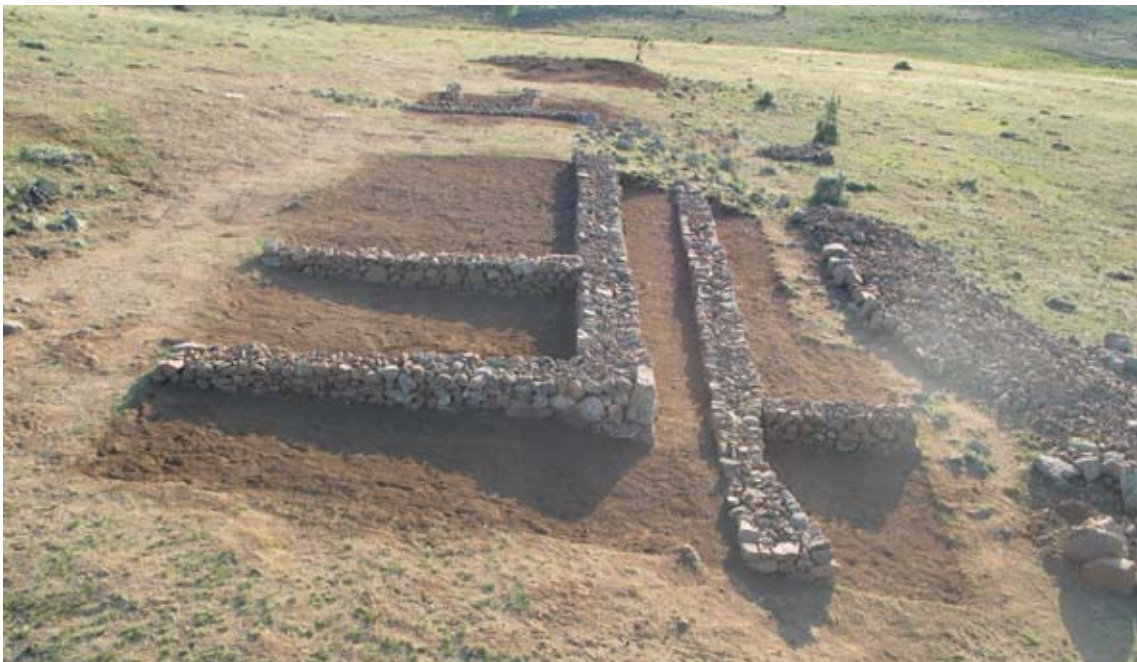
*Figure 90. Photograph of trenches TR27 and TR28 after backfilling and restoration. (10dpkc0730)*

Following the excavation and recording of both TR27 and TR28, geotextile was laid over the tops of the exposed walls and surfaces. Both trenches were then backfilled to the level of the modern ground surface. Each wall exposed within the excavations was also built up to a level three courses above the modern ground surface to show visitors where the ancient walls and structures are buried while at the same time protecting the preserved Iron Age walls from damage (Fig. 90).

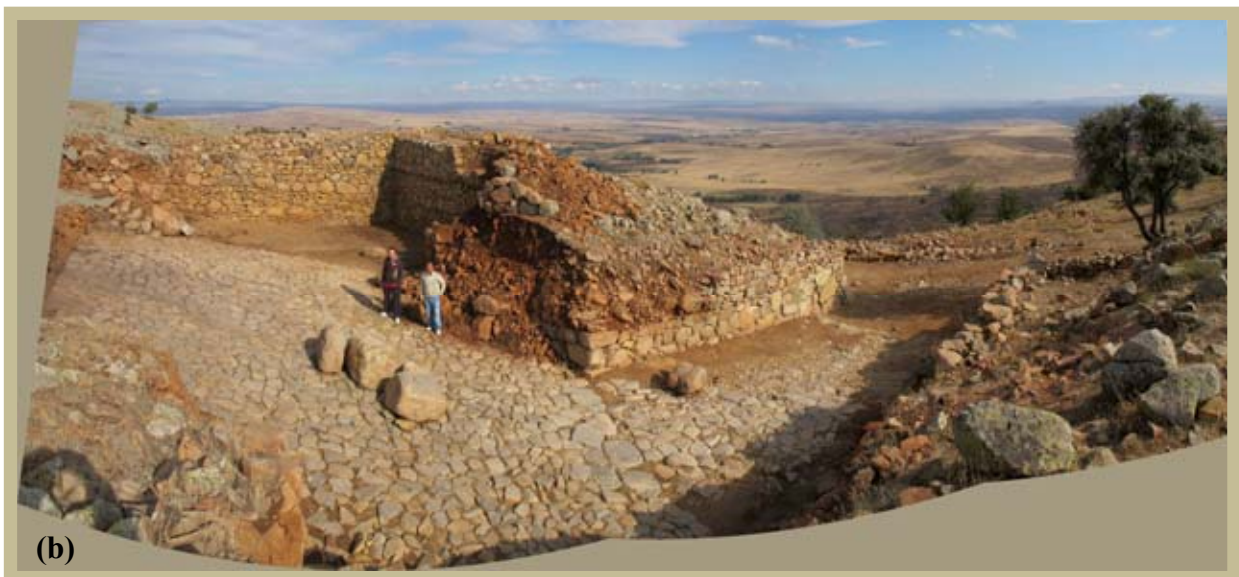
Figure 91. (a) Key plan of the Cappadocia Gate;  
(b) Panorama of the Cappadocia Gate passage and inner court,  
looking east, after excavation in 2010. (10dpcg0903pan)

The aim of completing excavations at the Cappadocia Gate in 2010 (Fig. 91) was thwarted by two unexpected discoveries. The first, in the 11m wide rear passage, was the edge of the stone pavement butting against the base of a massive timber structure which incorporated a pair of large wooden doors. The second was a victim of the fire and collapse in the Gate Court which will require very careful recording and lifting in 2011.

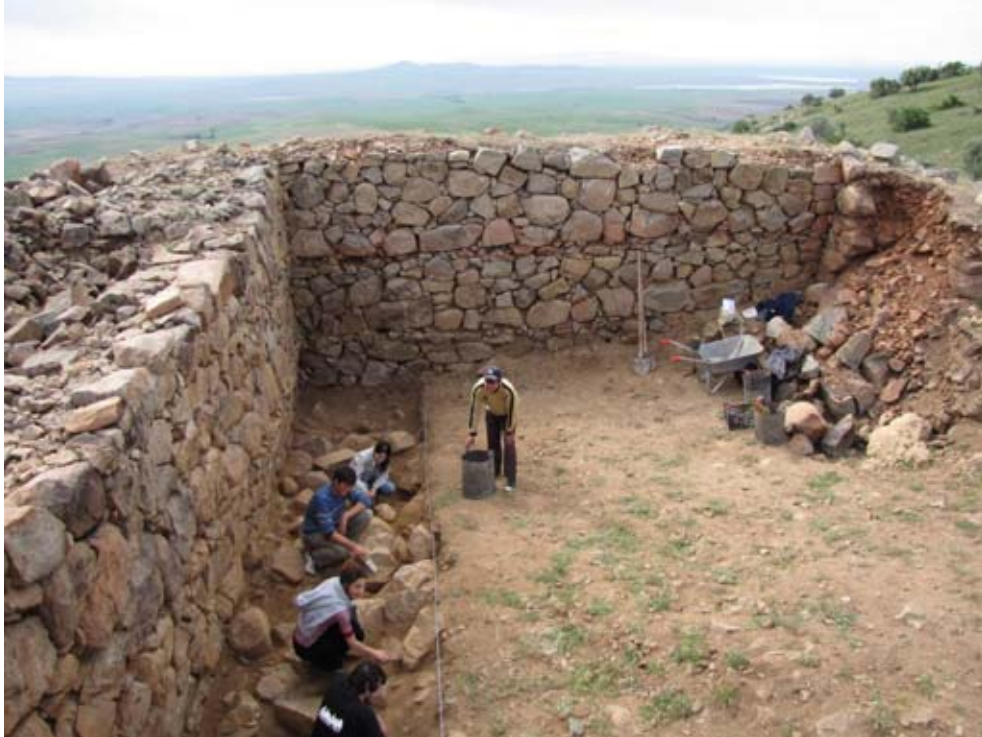
*Figure 92. A few days of excavation in May helped assess the remaining depth of deposit to be removed. (10dpcp0703)*

In May, it was possible to excavate a strip parallel to the northeastern wall of the Gate Court so as to determine the depth of the remaining deposit (Fig. 92). The larger stones that had collapsed from the walls of the Gate Court onto the floor (Fig. 93) were carefully articulated to facilitate the recovery of what might have been crushed on the floor during the destruction.

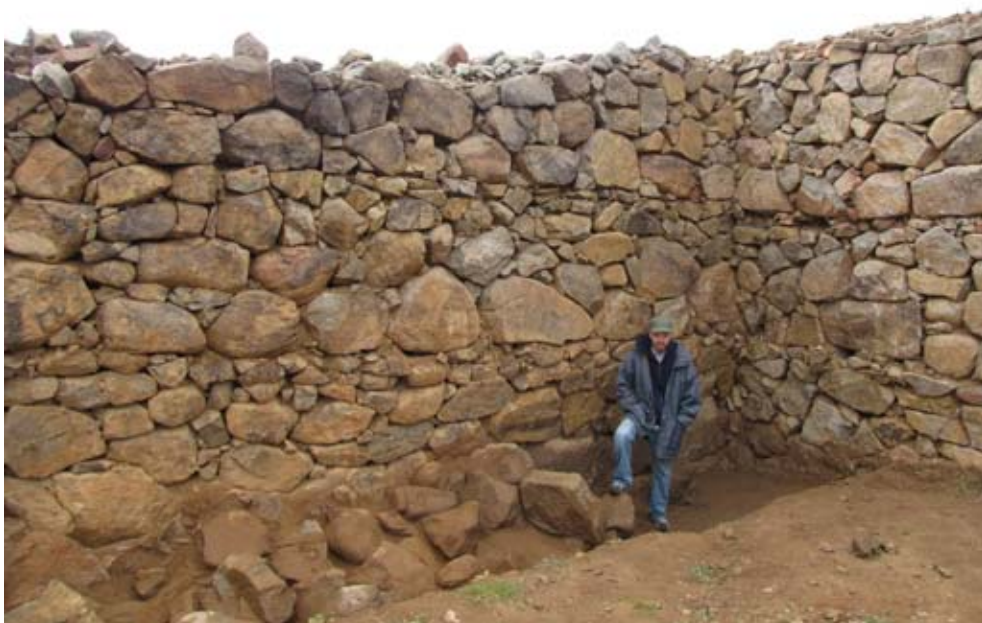
*Figure 93. Trench supervisor James Osborne standing in the strip excavated in May. Larger stones have collapsed from the surrounding walls onto the floor of the Gate Court. (10dpcp0905)*

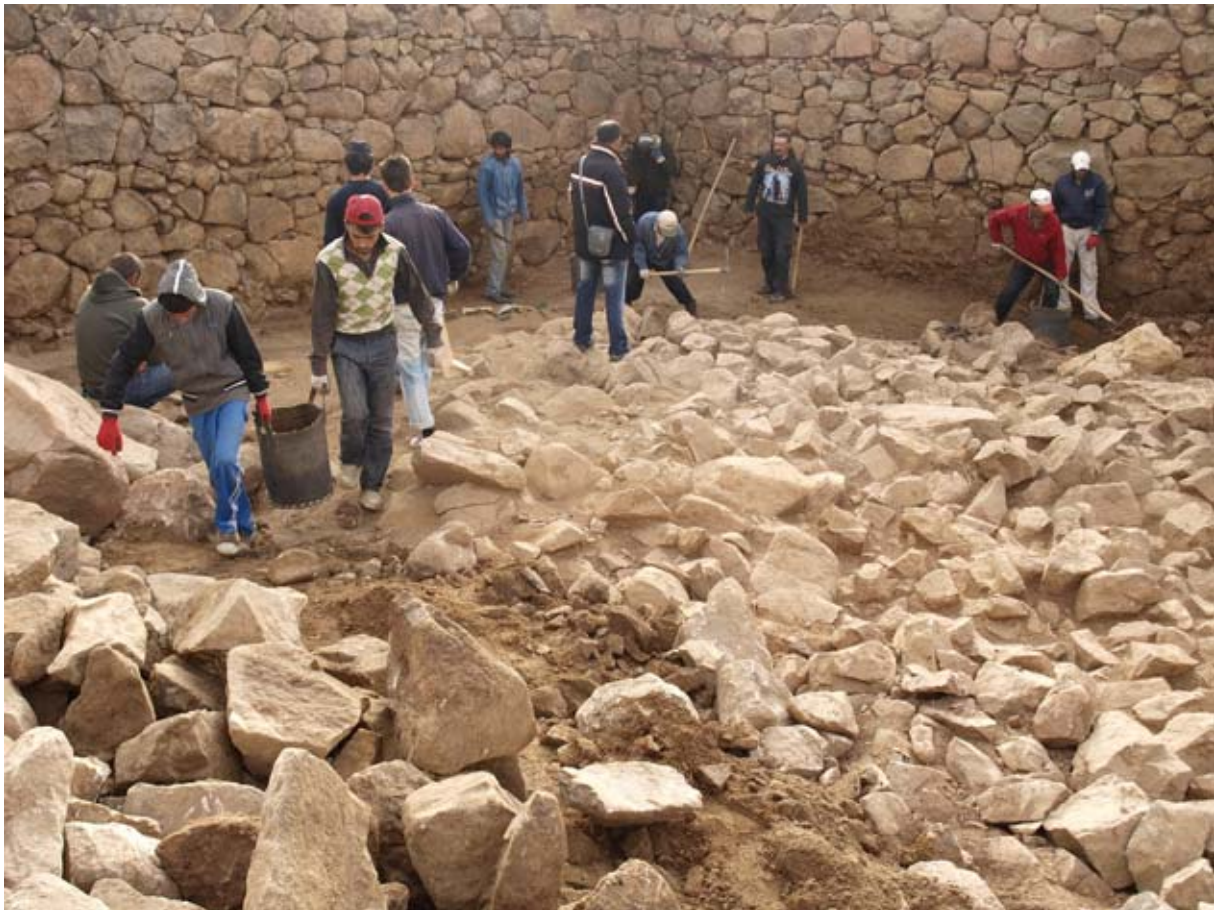
*Figure 94. Cleaning the last of the fallen stone in the Gate Court. (10dpkc2227)*

Excavation of the Gate Court was resumed at the end of September and the aim was to complete removal of the remaining fill. The operation was made difficult by the very large size of some of the stones together with the way those first to fall had deeply embedded themselves in the silt (Fig. 94). Stones were piled up by hand at the north end of the trench from whence they were lifted by means of a mechanical digger, either hoisted individually or manually placed into the digger bucket. In this way it was possible to avoid taking any heavy equipment onto the pavement. Much of the stone was utilised in the restoration work with the remainder being piled up for future use in restoration or the construction of protective walling.

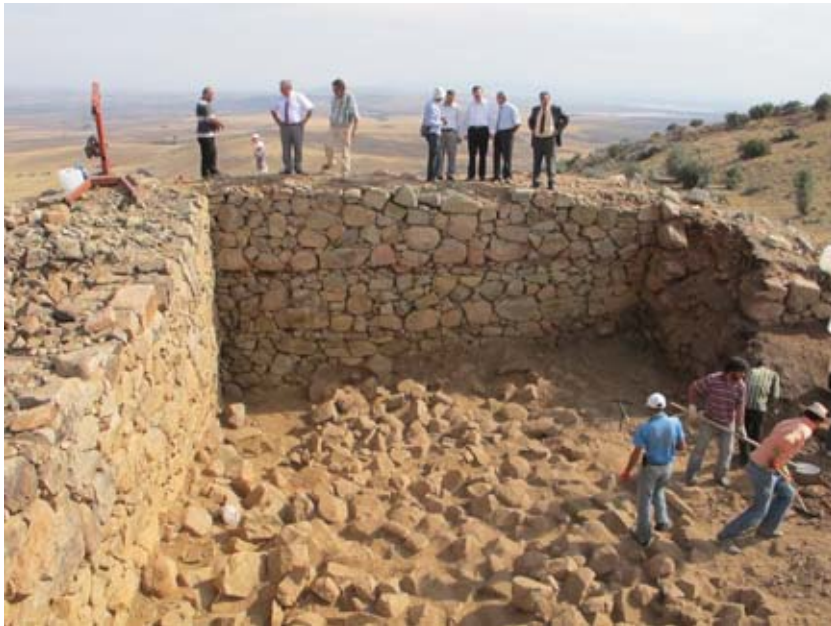
*Figure 95. The base of the collapse from an elevated vantage point. At centre right the corner of the Middle Tower from which sandstone blocks fell on the surface during the destruction. (10dpcg0357)*

In as far as was practicable, when excavation was resumed in September (Fig. 95), stone collapse was removed across the entire area in such a way as to leave in place only the lowermost stones. This procedure was followed in order to record the location of sandstone blocks fallen from the top of the Middle Tower, to ensure that any installations that might have been set up in the court would be recognised even if they had been badly damaged by the fire and collapse and, finally, so that the bottommost stones of the collapse could be carefully removed with as little disturbance as possible to what might lie in the initial destruction immediately beneath (Figs 96 and 97).

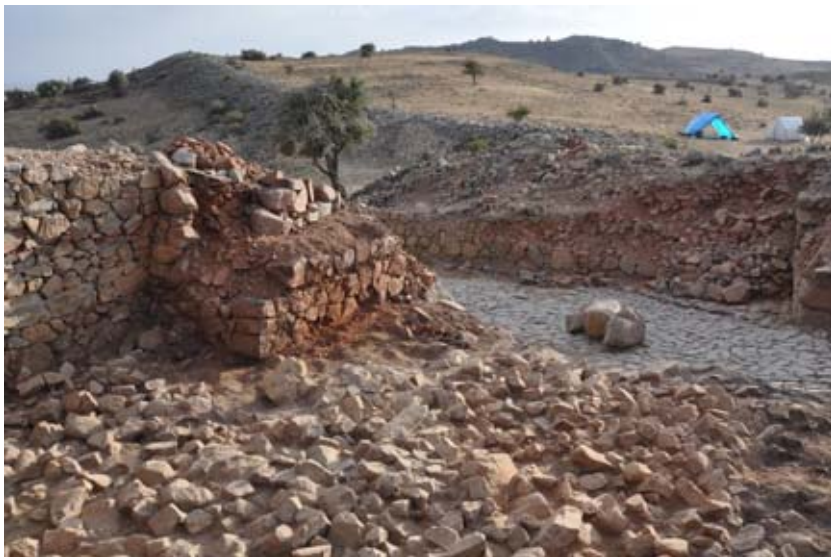
*Figure 96. The base of the collapse in the Gate Court with a portion of the paving revealed in 2009. The locations of sandstone blocks fallen from the Middle Tower were carefully recorded. (10dpnd1388)*

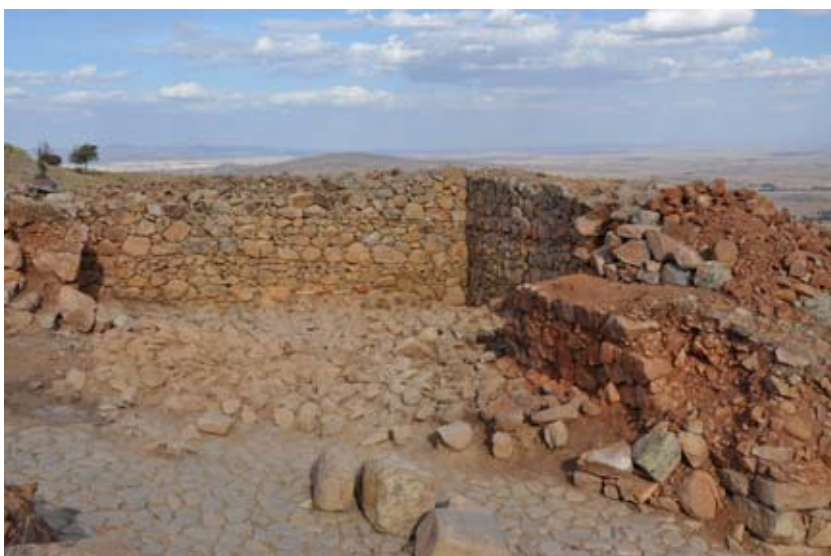
*Figure 97. The base of the collapse looking east. (10dpnd1434)*

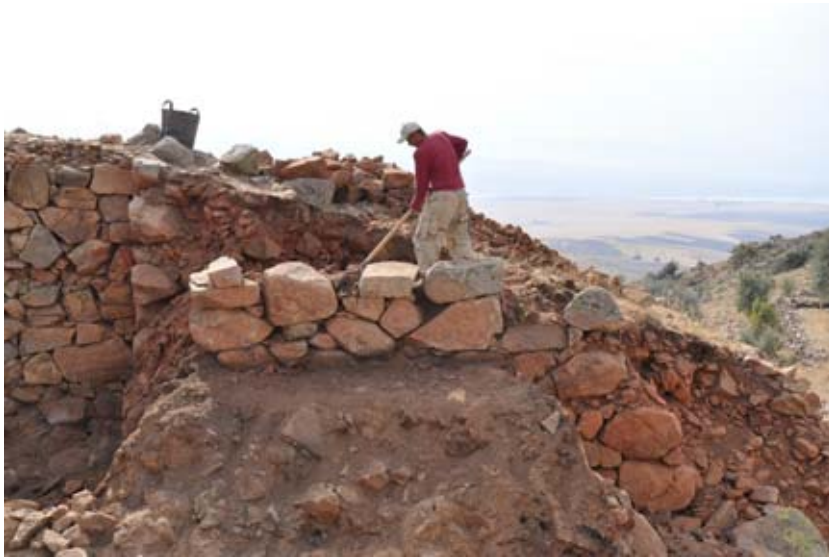
*Figure 98. Once fully recorded, the upper courses of stones from the northeastern wall of the Middle Tower were moved back before the remaining fill was removed. (10dpnd1245)*

Clearance began in the innermost, southeastern corner and proceeded to the northwest limit of the trench. As excavation progressed around the Middle Tower it was necessary to move back the leaning upper courses before removing the fill that was supporting the wall (Fig. 98). The exposed portion of the wall was carefully photographed and recorded before the stones were moved. The stability of the wall was compromised by the gap left where a wooden horizontal beam burnt out during the destructive fire (Fig. 99).

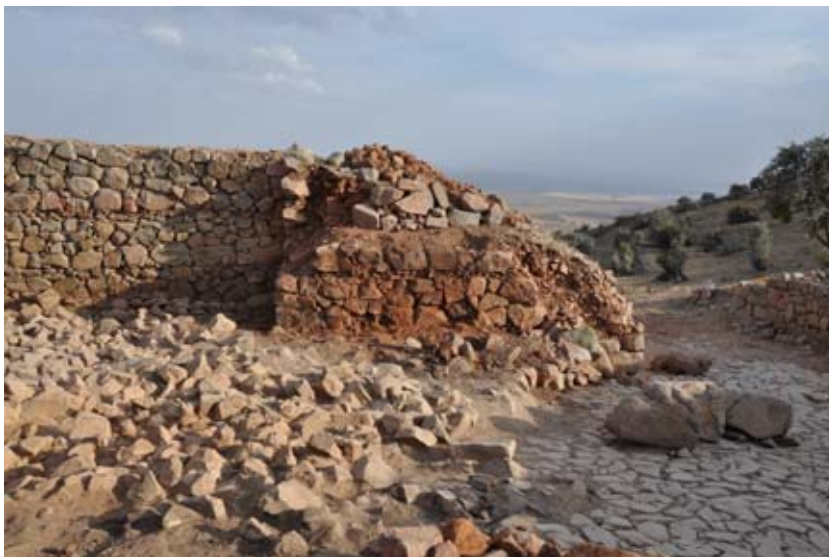
*Figure 99. The wall's lack of structural stability is a result of the gap left by the horizontal timber beam after it burnt out. (10dpnd1390)*

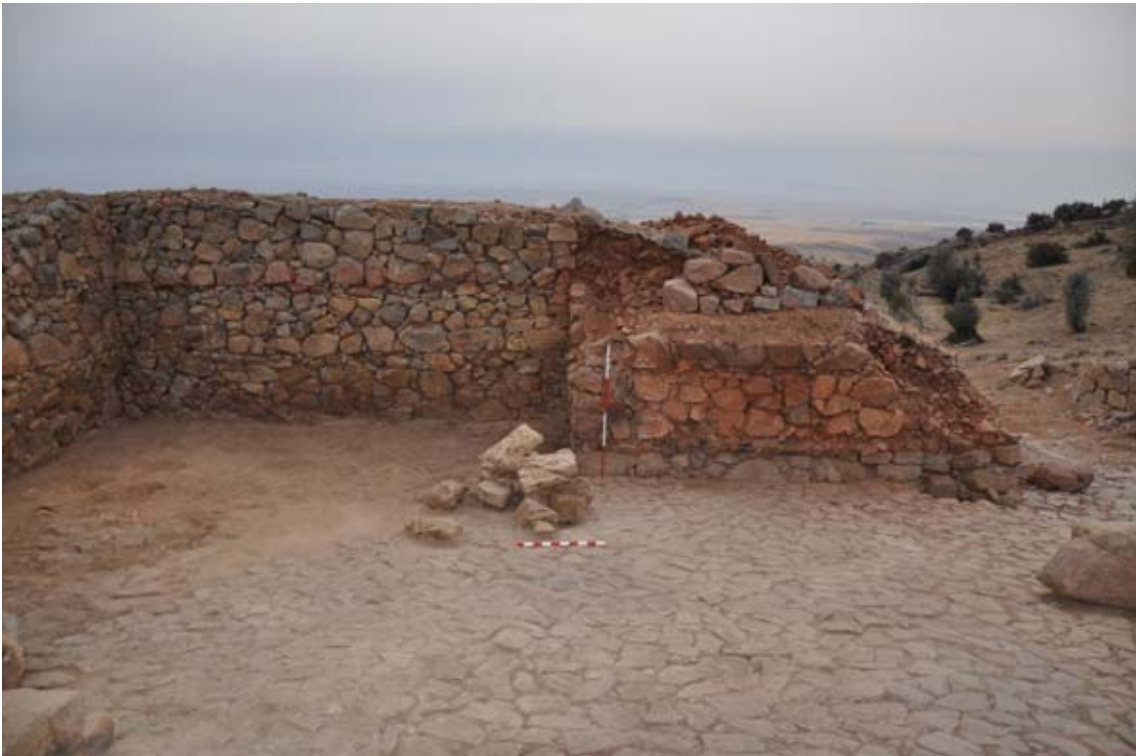
*Figure 100. The location of the sandstone blocks that had fallen over the stone pavement was carefully recorded. (10dpnd2204)*

The entire Gate Court fill was cleared to the layer of large stones that had collapsed onto the floor. Granite boulders were then carefully removed but blocks of sandstone were left in position and recorded (Fig. 100). A single course of yellowish sandstone was found to have fallen from the corners of the Middle Tower. Burning indicates that the sandstone blocks rested on timbers. Neither the size of the blocks nor tool marks and surface finishes provided any indication of the way these stones were assembled.—The stone pavement extended to a slightly curved edge running from the north corner of the Middle Tower to the south corner of the North Tower (Fig. 101). The destruction layer itself amounted to no more than a very thin scatter of burnt matter impressed into the silty surface below when the walling fell. Towards the northern extremity of the excavated area there were fewer large stones and little or no accumulation of silt.

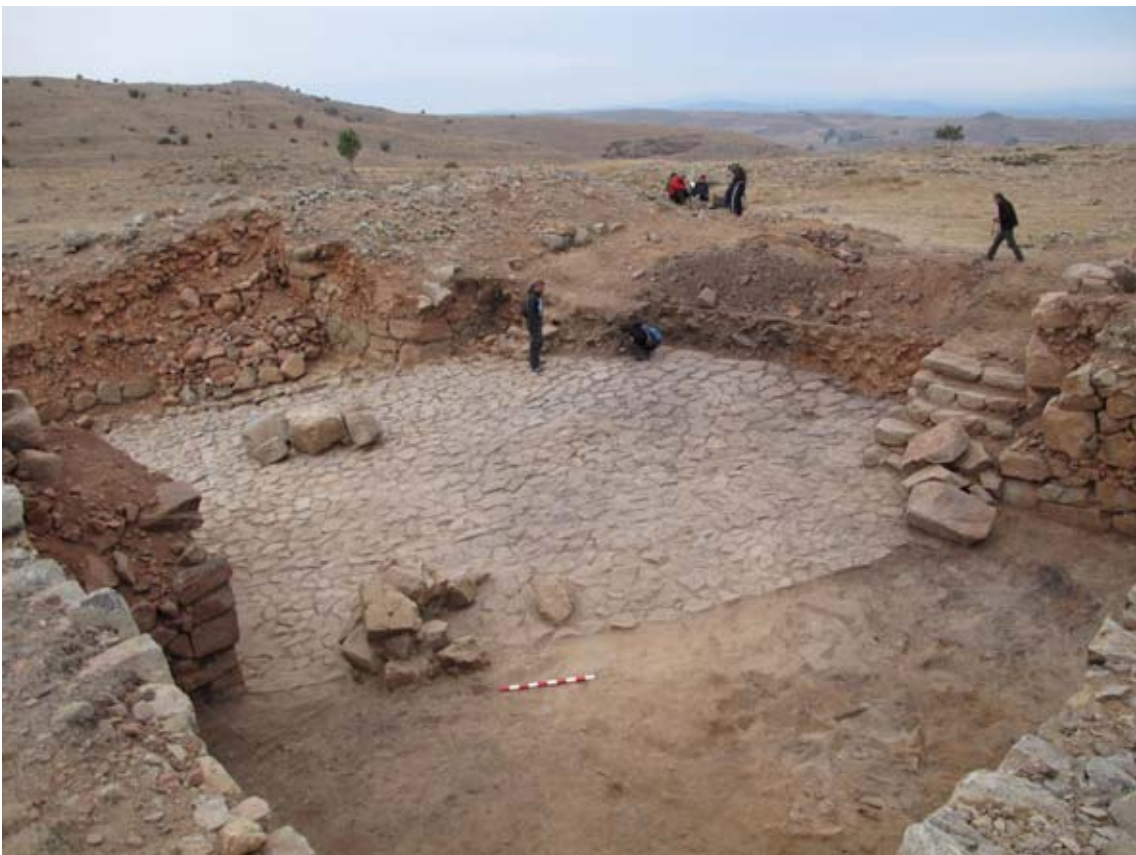
*Figure 101. Indentations in the silty clay were made by large falling stones when the wall collapsed, crushing one victim of the destruction. The curved eastern extension of the paving to the corner of the North Tower is at centre. Stones from the tower corner fell onto the steps during the previous winter. (10dpcg0719)*

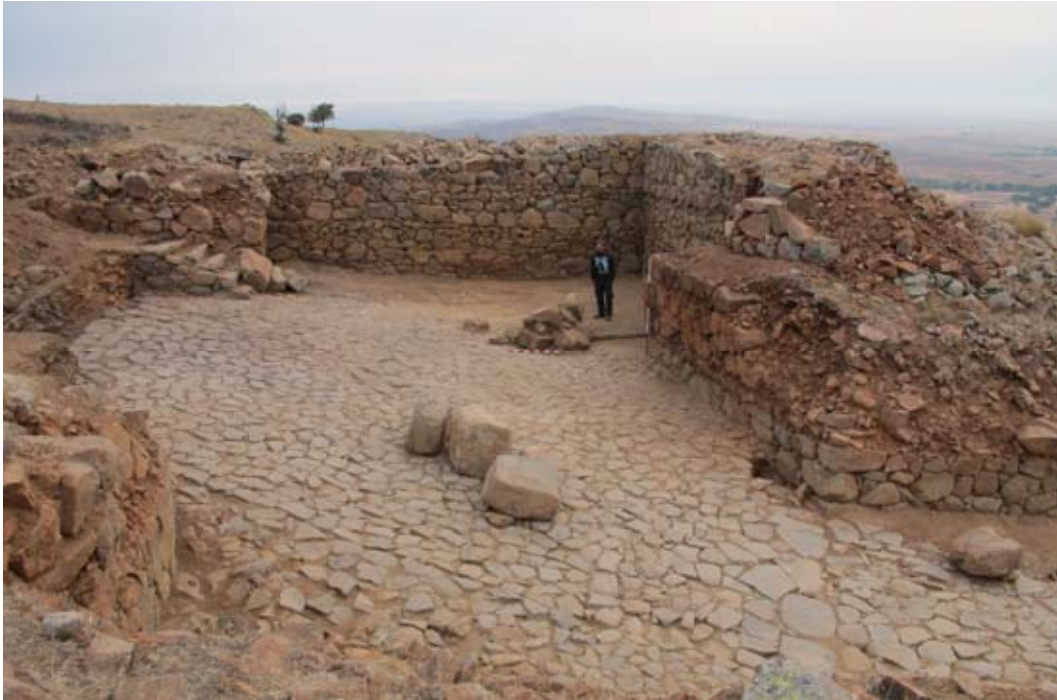
*Figure 102. Further clearance in the Gate Court exposed the northern limits of the stone pavement, at centre left, beyond the rear of the stepped base on which the stele stood. (10dpcg0704)*

All work in the Gate Court was conducted within trench TR13, which was extended northwestwards, past the rear of the stepped base on which the stele stood, by approximately 1m in order to reveal the northern limit of the stone pavement (Fig. 102). The pavement terminates at the foundation for a substantial, burnt, timber edifice in which a pair of wooden doors would have been housed (Fig. 103).

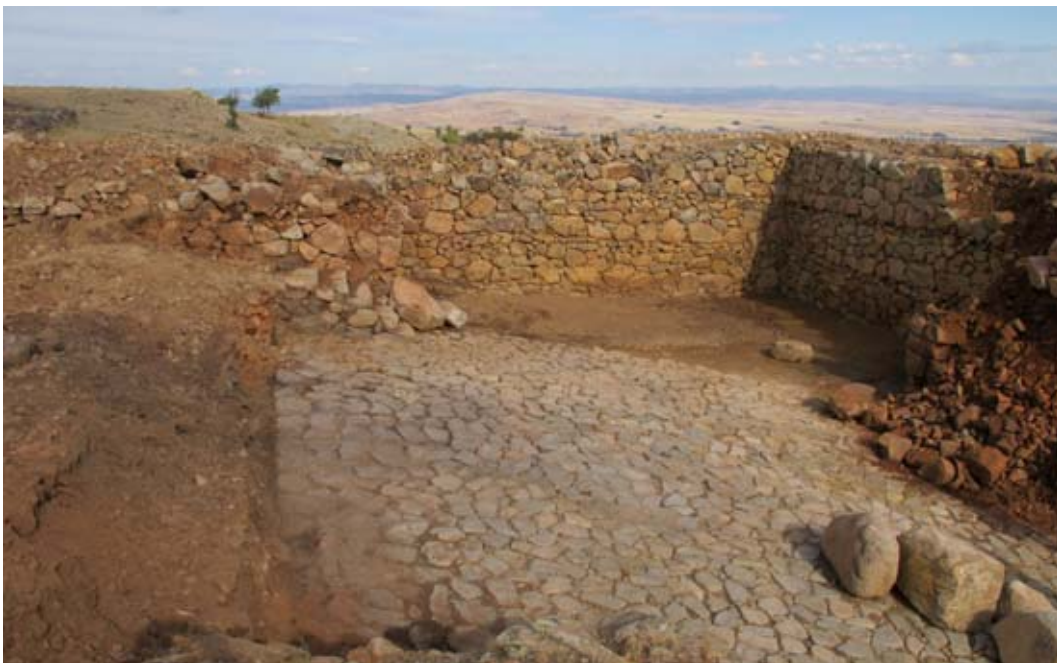
*Figure 103. The northern edge of the pavement butts against foundations for a timber structure where large wooden doors would have been housed. (10dpcg0910)*

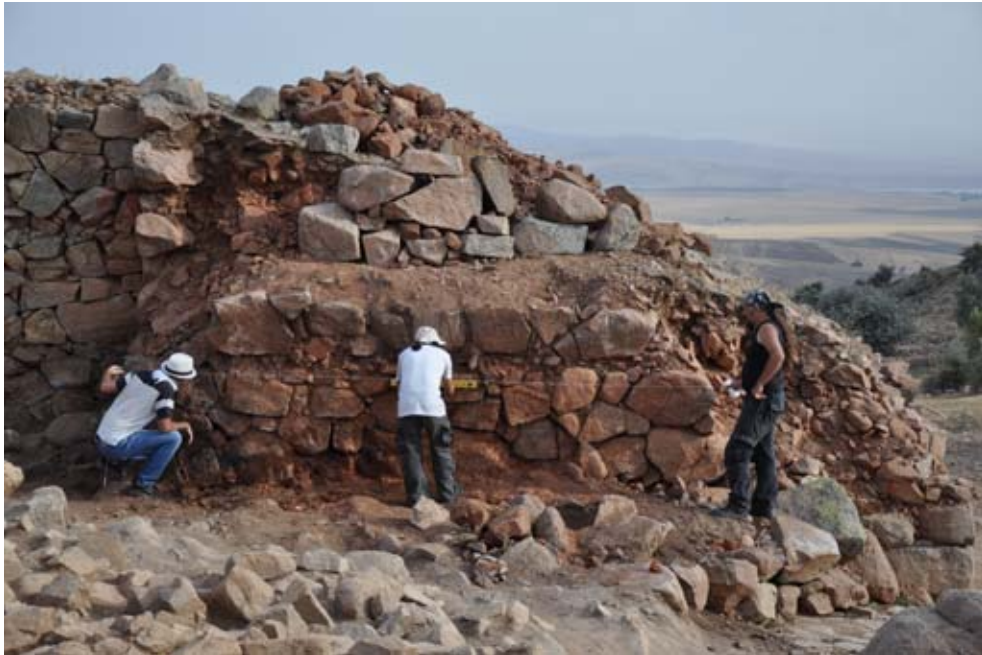
*Figure 104. Control points for rectification of digital photography are marked on wall faces (10dpnd1381)*

Recording of all excavated wall faces by rectified digital photography with control points (Fig. 104) was completed but rain and wall collapse precluded total recording of the stone paving, not least because a portion of the pavement became obscured by wall collapse. Any attempt to remove the newly fallen stone without first consolidating the loose rubble core of the wall above would have been injudicious.

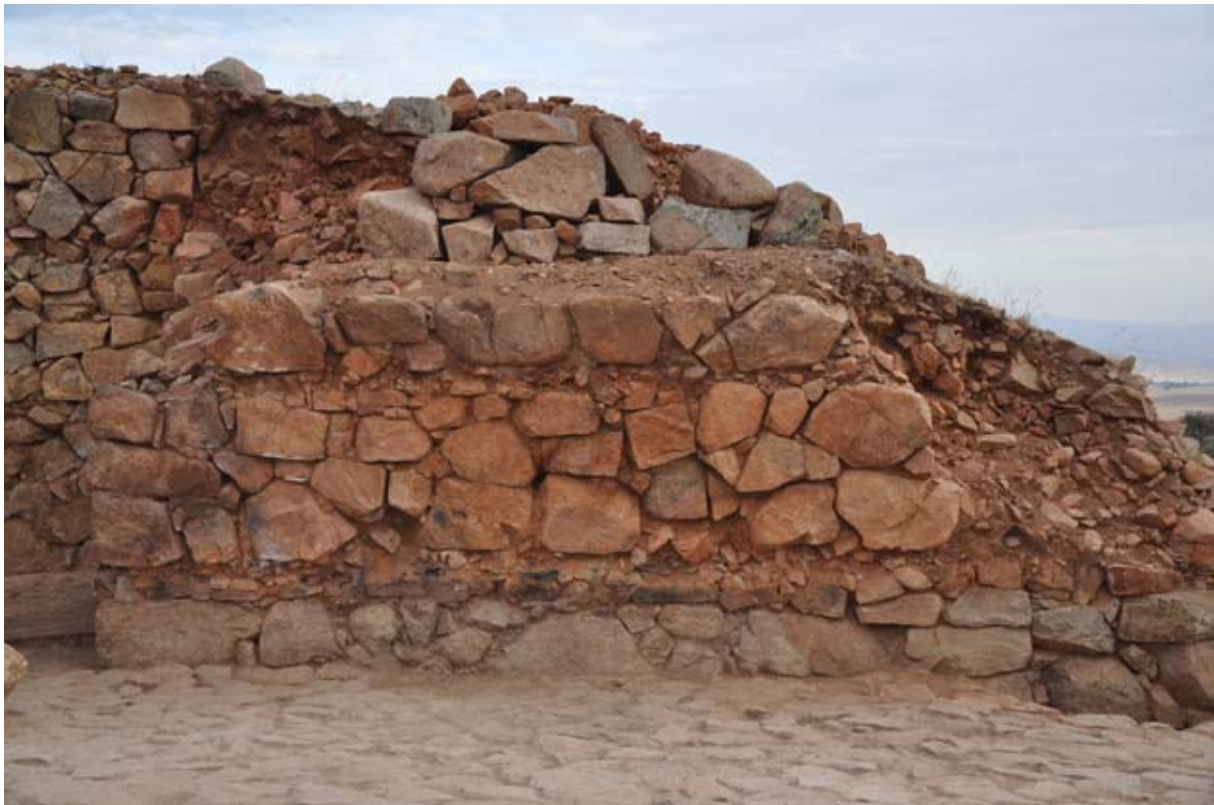
*Figure 106. The inner face of the Middle Tower before it collapsed showing horizontal beam positions and the intensity of the fire. (10dpnd2168)*

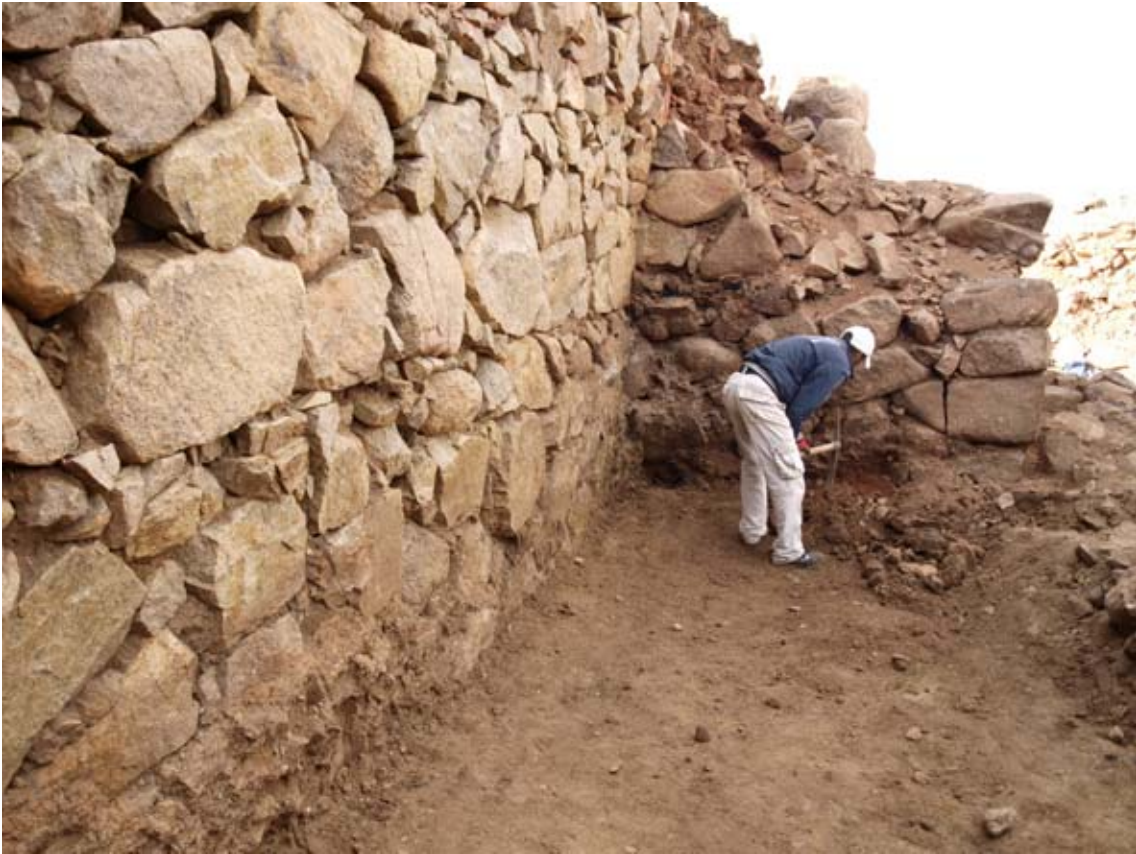
*Figure 107. The level of horizontal timbers in adjacent walls do not always coincide. (10dpkc2253)*

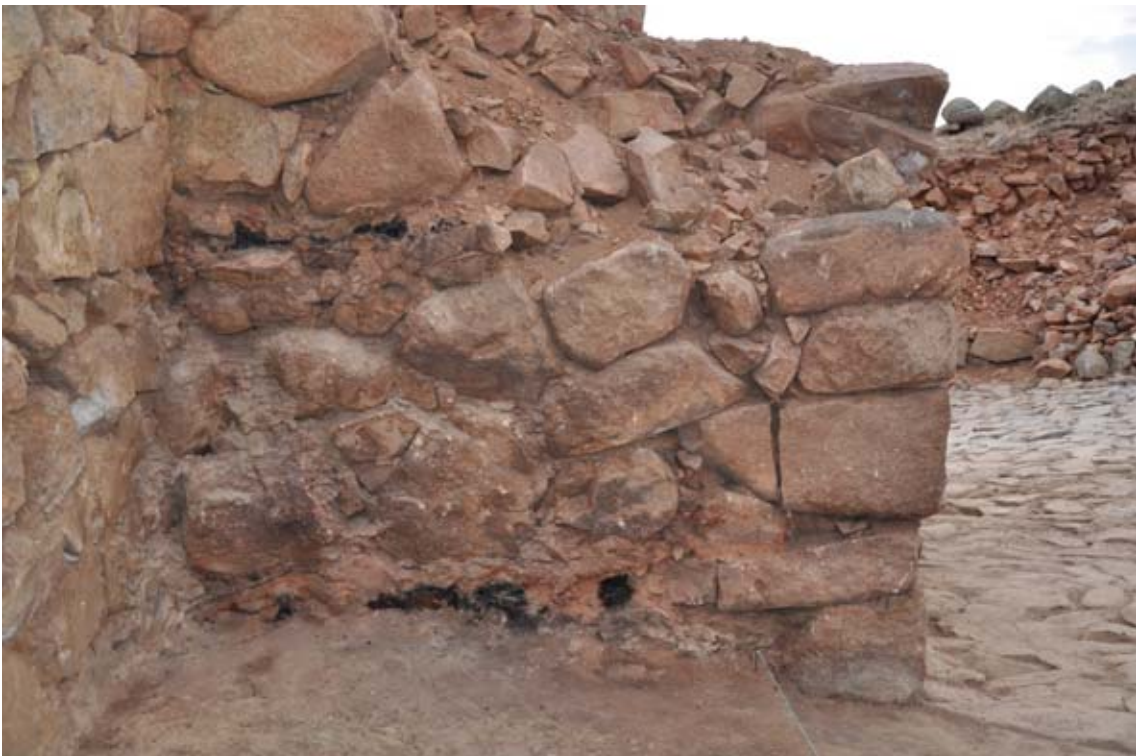
*Figure 108. Timbers appear to have been rounded tree trunks chinked into position with small stones. (10dpnd2163)*

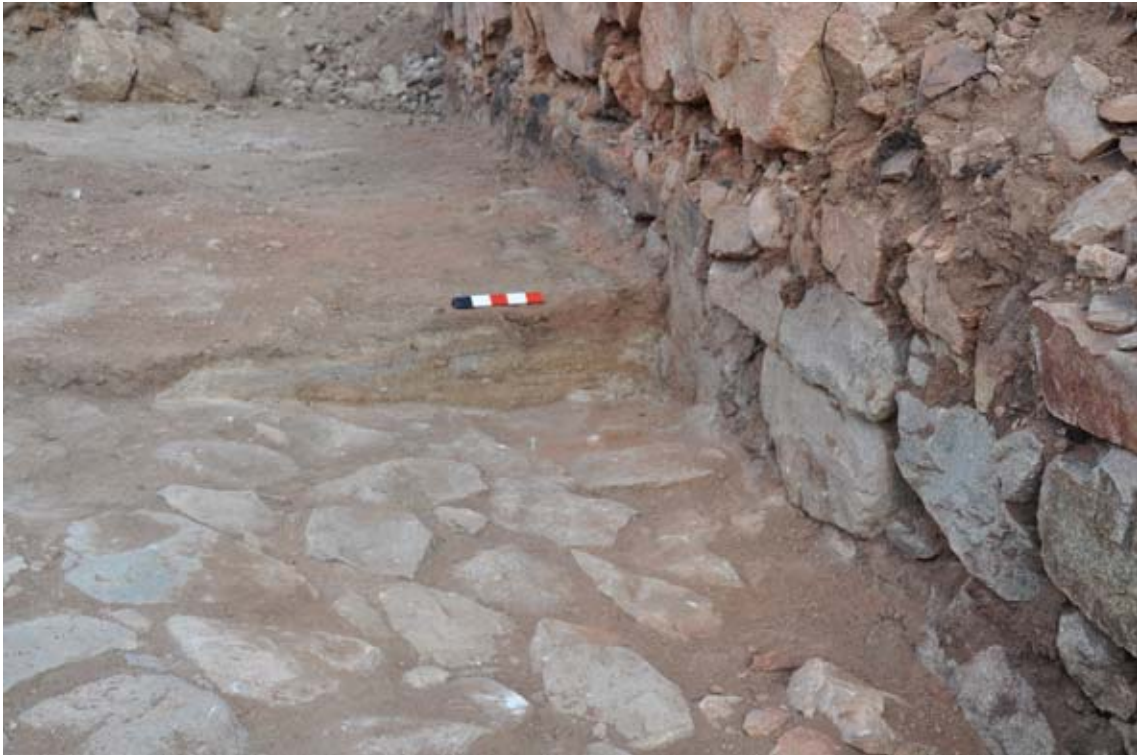
*Figure 109. Silty clay derived from mud plaster on the pavement in front of the Middle Tower. Traces of mud plaster cling to the wall face while reddish destruction debris fill a depression caused by large falling stone (removed). (10dpnd2012)*

The stone rubble fill of both the walls and the glacis was very loose, possessing every appearance of having been tipped in at random. Very large stones appear high up in preserved wall cores. The size of stones in the collapse proves that there was no diminution in the size of stones, nor in the proportion of large stones, incorporated into the upper portions of walls. Wall faces within the gate were covered with two coats of mud plaster that were preserved in places where there was moisture in the lower portion of the collapse and also in sparse patches where plaster had been burnt. It is assumed that this plaster covered the full height of the walling and that much of it had washed down to form the thick silty layer in the eastern sector of the court before the burning (Fig. 109). Once exposed the plaster dried rapidly and then crumbled or just fell away from wall faces.

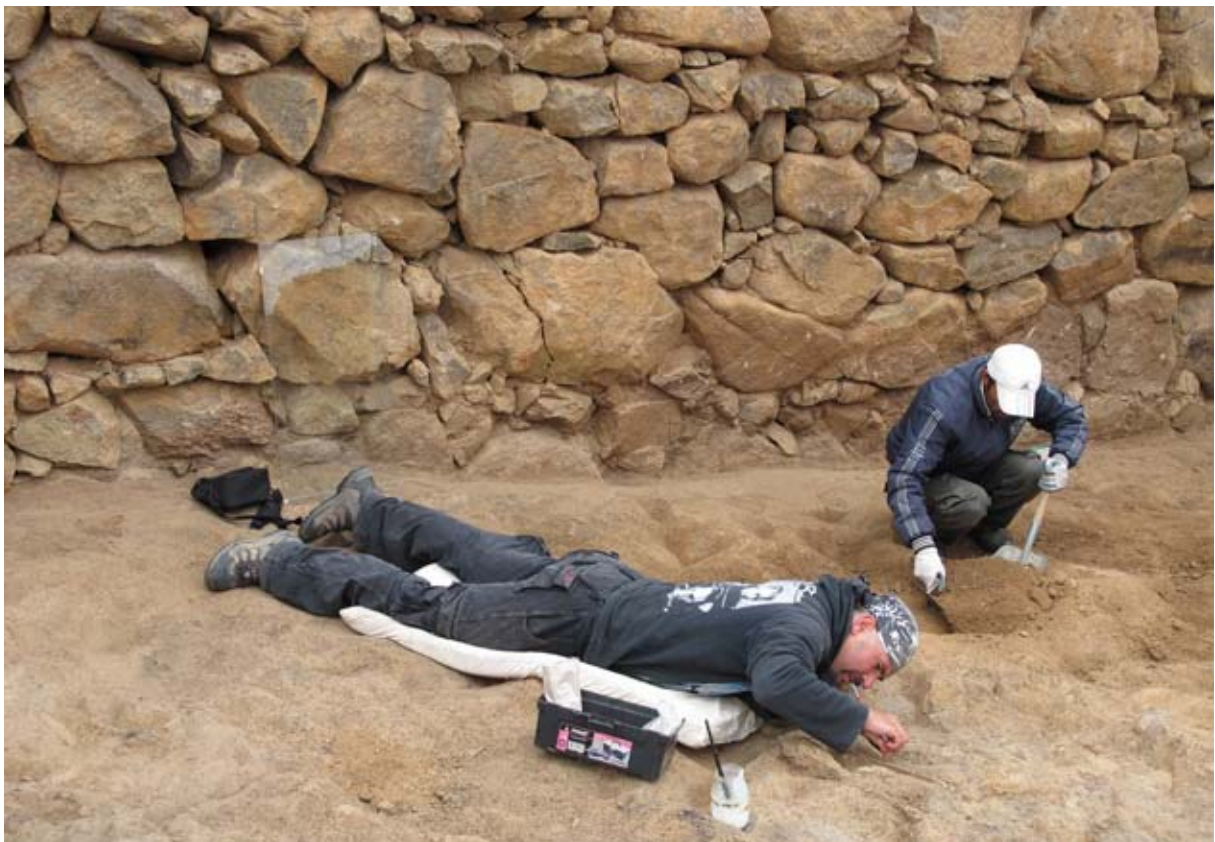
*Figure 111. Ferhat Can excavating the crushed victim in the gate chamber. Note the way in which large falling stones squashed the body into the wet silty clay thereby breaking many of the bones. (10dpcg0732)*

The crushed and partially burnt individual was found at the end of the 2010 excavation campaign in the Gate Court (Fig. 110). Excavation was slow and tedious (Figs 111, 112 and 113). It seems that the person was killed instantly when the walls fell, first falling on his/her knees and then twisting sideways, although these details will need to be confirmed when excavation is completed in 2011. The bones, and especially the skull, are poorly preserved, firstly because of the way in which many of them broke when the body was unevenly squashed into the wet silt and, secondly, because of the acidic nature of the granitic soil. On the final day of excavation, in appalling weather conditions, exposed bones were consolidated, linen sheets laid over the area and a protective covering of earth laid on top.

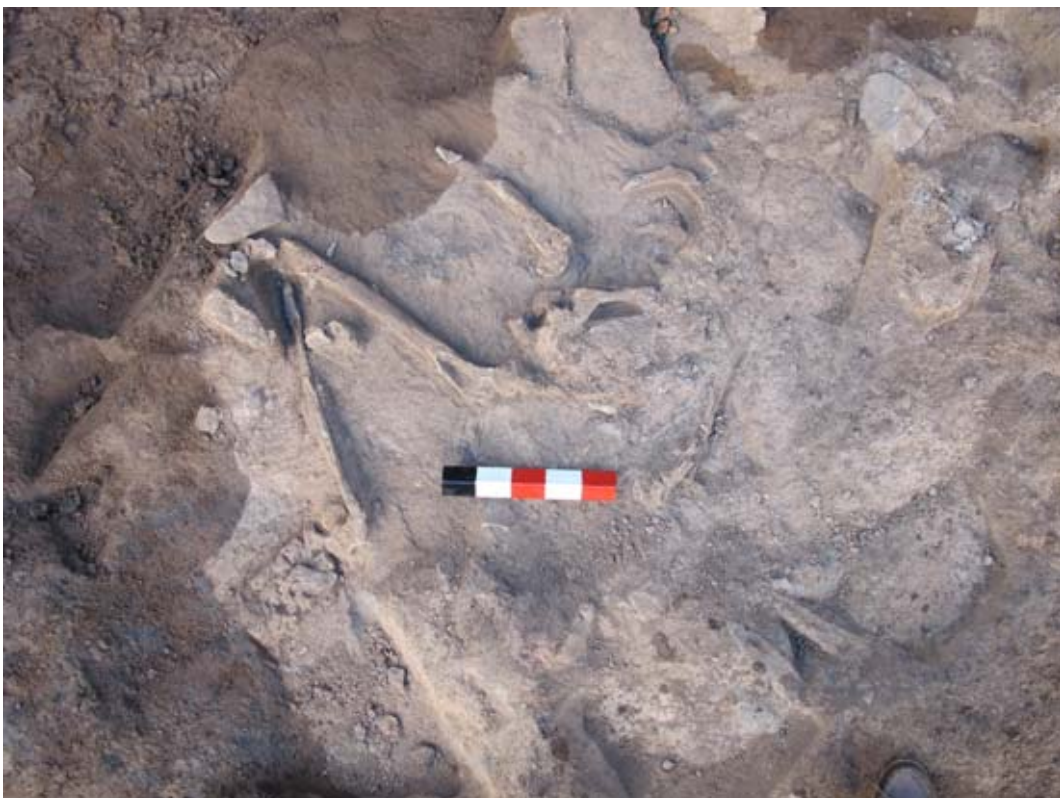
*Figure 113. The skeleton, knees bent, was crushed by the large stones falling from the top of the walls. (10dpcg0747)*

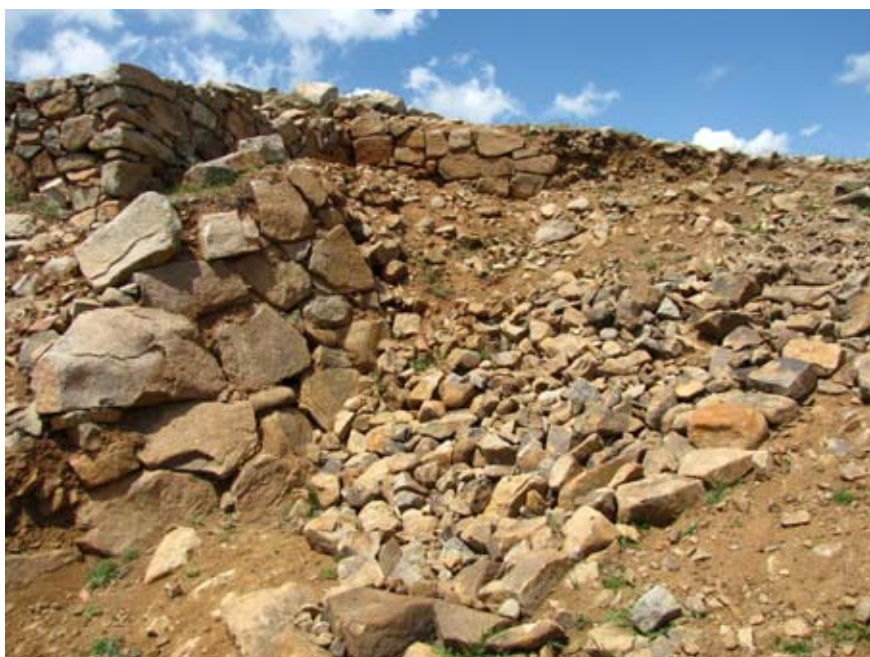
*Figure 114. The east corner of the East Tower photographed in May 2010, before excavation of the glacis. (10dpcp0304)*

Work at the junction of the East Tower and the City Wall, begun in 2009, was completed this year in conjunction with the first stage in a program of restoration of the glacis (Figs 114 and 115). Clarification of outstanding issues and new results were attained because the inner corner of the glacis was found to have collapsed as far down as the basal course (Figs 116 and 117). This circumstance permitted examination of both the northeast face of the East Tower wall and the outer face of the City Wall to within a couple of courses of the base (Figs 118 and 119). Clearance of rubble tumble and fill, which was primarily conducted to examine the present stability of the gate structure, revealed details of construction techniques, building material, fill and collapse. Additionally, a small amount of pottery and animal bone associated with the construction was recovered. Rubble was not removed to the very base of the vertical wall because of concerns over safety, but sufficient was removed to make it certain that the wall faces did continue downwards, an observation that was verified by inspection of the face stones in large voids within the rubble where it had been roughly heaped against wall faces.

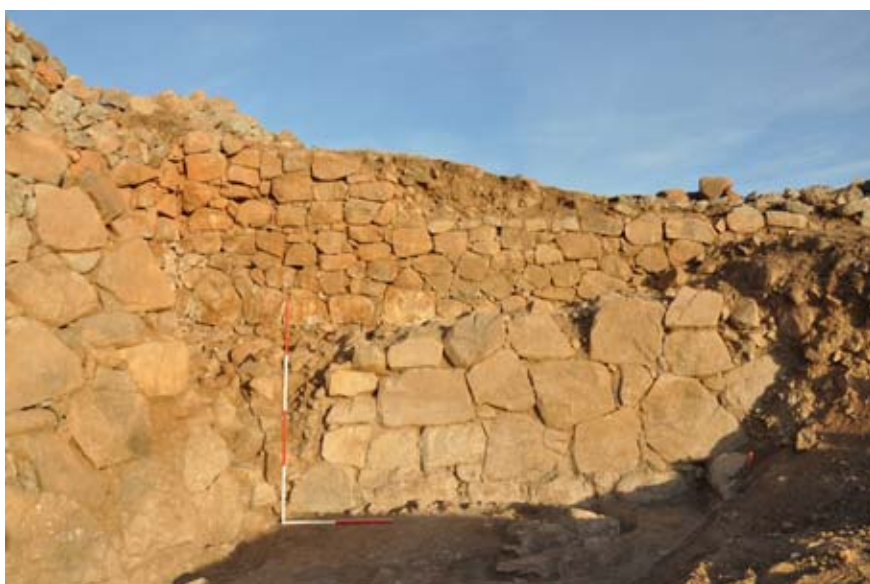
*Figure 115. The junction of the East Tower and adjacent stretch of the City Wall after excavation revealed the surviving portion of the glacis. (10dpnd1012)*
