# THE KERKENES PROJECT

## A PRELIMINARY REPORT ON THE 2010 SEASON

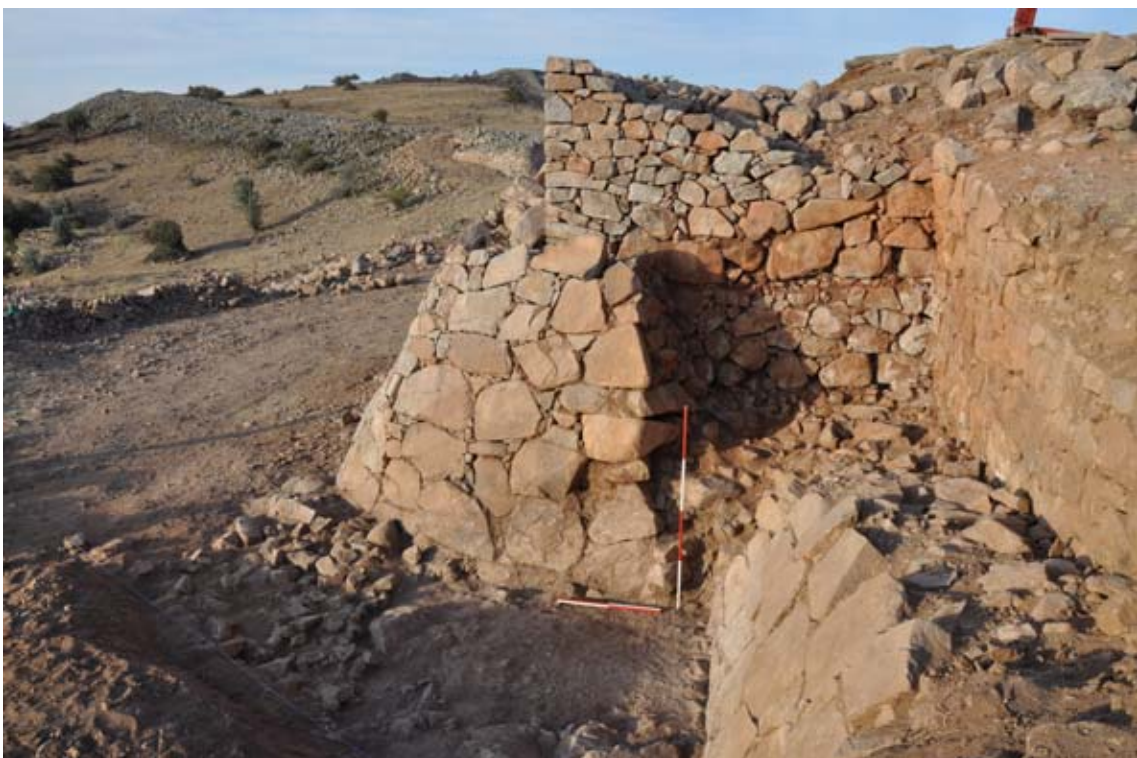
*Figure 117. Excavation at the junction of the East Tower and the City Wall revealed a working transverse face in the tower glacis. (10dpnd1029)*

5. Details of how the glacis was constructed were revealed. The portion of the glacis against the southeast face of the East Tower was found to contain a temporary termination and to have been constructed in two stages. This can be seen in Figure 118 where the top of first stage was marked by a large transverse stone that extended from the glacis face back almost as far as the tower wall. The second stage, immediately above the transverse stone is noticeably different in character. The uppermost few centimetres, above the stones with black mineral staining, are recent. Around the inner corner the portion of glacis against the City Wall had a similar but much less regular temporary end. The corner space thus created appears to have been used for rubbish and perhaps for food preparation (Fig. 119) before the corner was eventually filled in.

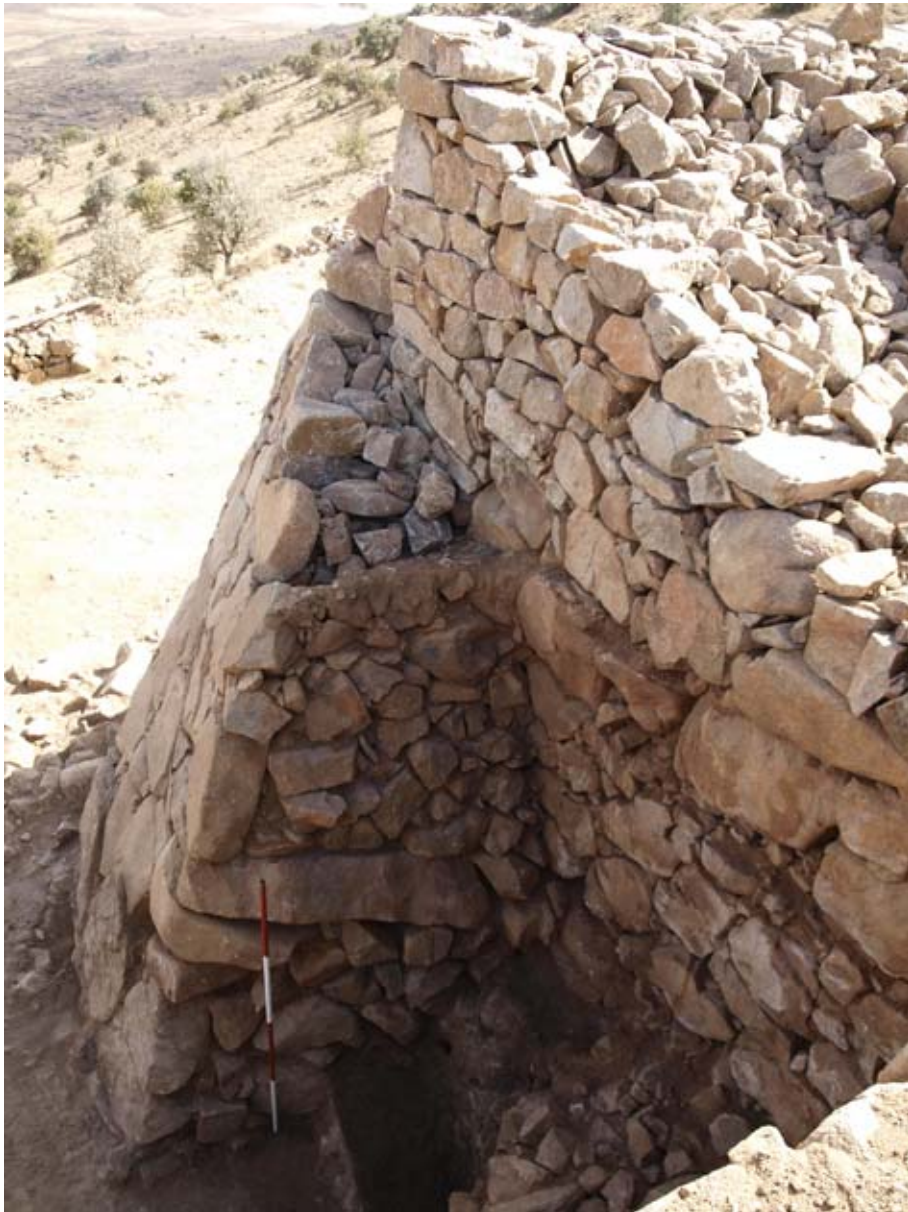
*Figure 118. Glacis construction phases divided by a transverse stone. The nearly vertical working face doubtless contributed to the glacis collapse. Rubbish, including food remains and broken cooking pots, accumulated in this sheltered corner. The uppermost portion has been rebuilt. (10dpkc2156)*

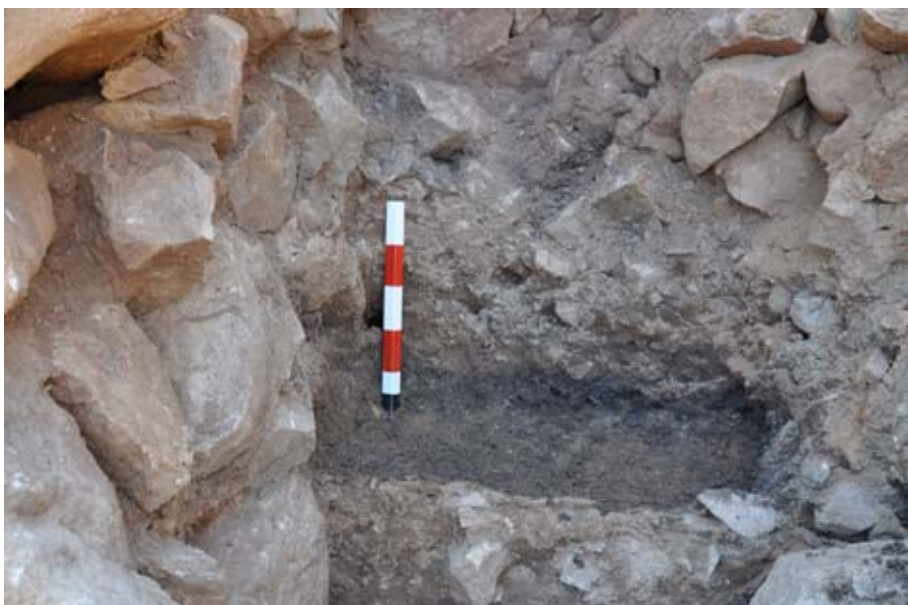
*Figure 119. The midden-like accumulation beneath the stone fill of the glacis ran up against the transverse temporary working end in the tower glacis. (10dpnd1268)*

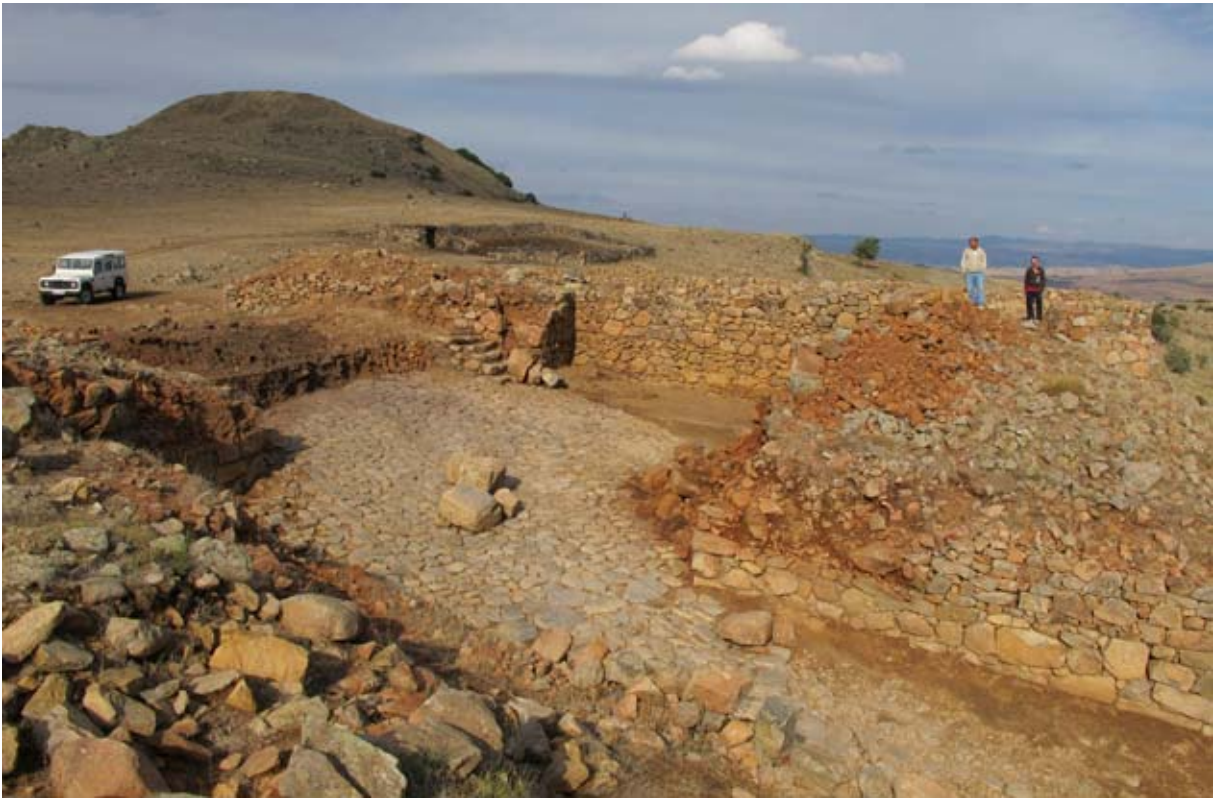
*Figure 121. The Cappadocia Gate at the end of the 2010 excavation season. The northwestern and northeastern limits of the stone pavement were exposed and setting lines indicating the different phases clearly visible. (10dpcg0929)*

The Cappadocia Gate is the only one of the seven city gates at Kerkenes to have been provided with an internal chamber (Figs 120 and 121). In plan the final form of the gate, when it was destroyed by fire along with the rest of the city, comprised five towers, three at the front and two at the rear. The new plan supersedes all earlier plans because it has been drawn, in as far as was possible, at ground level. Generally the discrete elements of the gate structure are poorly aligned with one another, ninety-degree angles are rare and then only approximate. The road leading up to the gate from the rolling fields below (Fig. 122) might in part explain why the entrance passage was on a different alignment to the rest of the gate structure.

Immediately to the right of the doors stood a stepped monument crowned by a semi-ionic idol that backed against the wooden structure (Figs 121 and 123). In the same position to the left of the doors, excavation revealed the southwestern face of yet another stone structure. This latter feature awaits further elucidation in 2011.

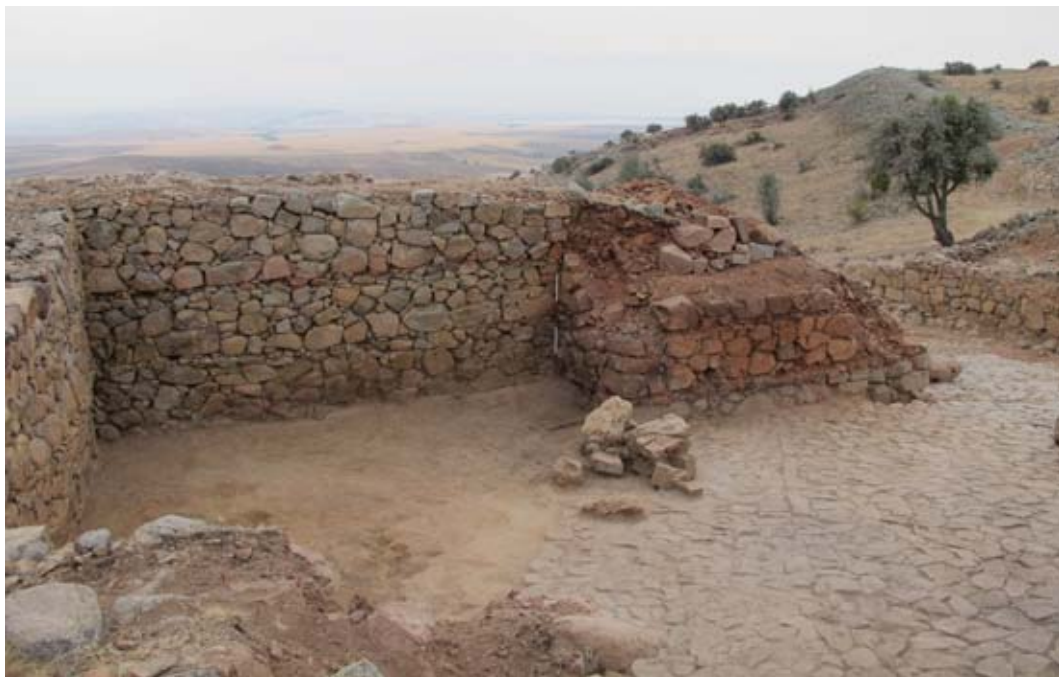
*Figure 125. Looking towards the Middle Tower from which sandstone blocks, at centre, had fallen. Note the line of the paved road and the curved edge of the eastern extension. (10dpcg0729)*

An aniconic granite stele was set into the secondary paving against the northwest corner of the Middle Tower immediately adjacent to the passage with what appears to be a semi-circular pit behind it seen in Figure 125 after removal of the stele. Collapse of the tower corner in the winter of 2010 dislodged this stele which was removed to the safety of the Stone Conservation Workshop at the Kerkenes House.

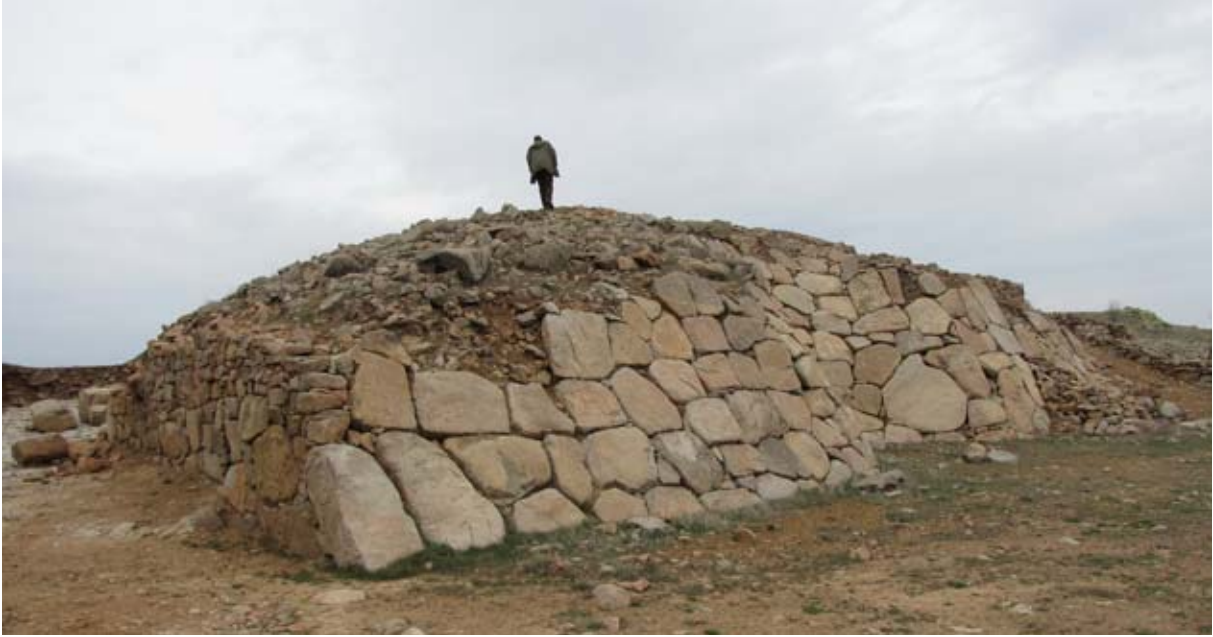
*Figure 126. The Cappadocia Gate glacis photographed in May 2010 before the start of restoration work. (10dpcp0118)*

In the 2009 and 2010 seasons, architectural fieldwork focused on the documentation, conservation, strengthening and enhancement for presentation and visitor security of the Cappadocia Gate (Figs 126 and 127), located on a southeastern elbow on the city walls and named after the direction in which it faces. Field survey was completed in 2009, and the documentation project was presented to the Sivas Regional Commission on the Conservation of Cultural and Natural Property, under whose jurisdiction Kerkenes Dađ falls, in 2010.

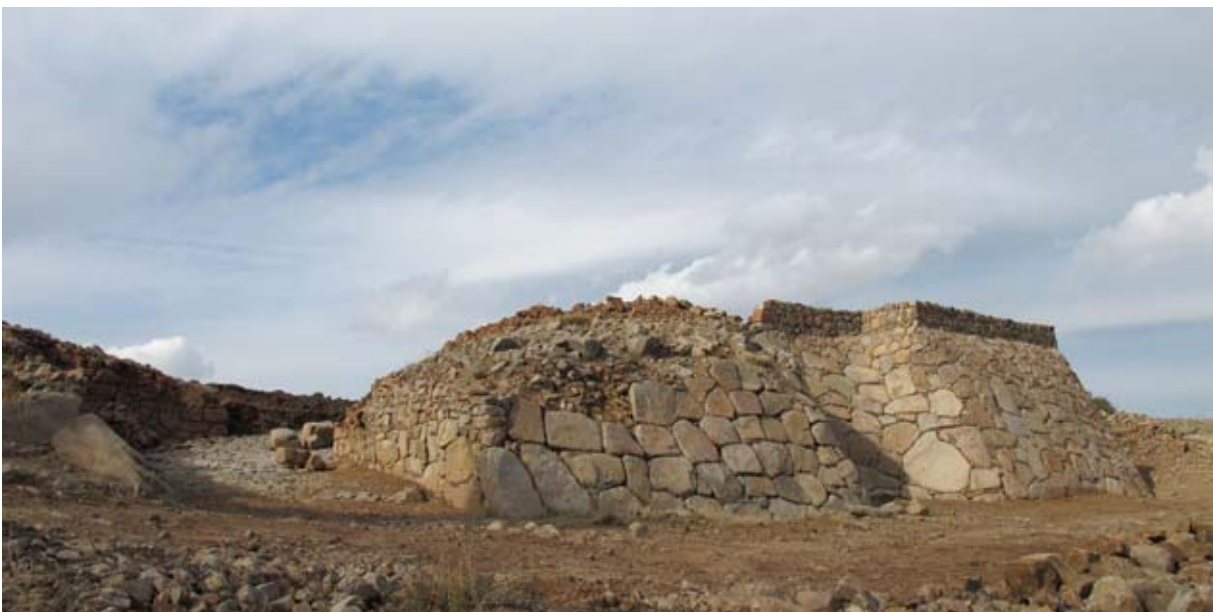
*Figure 127. The Cappadocia Gate glacis photographed in October when the 2010 restoration work was completed. (10dpcg0933)*

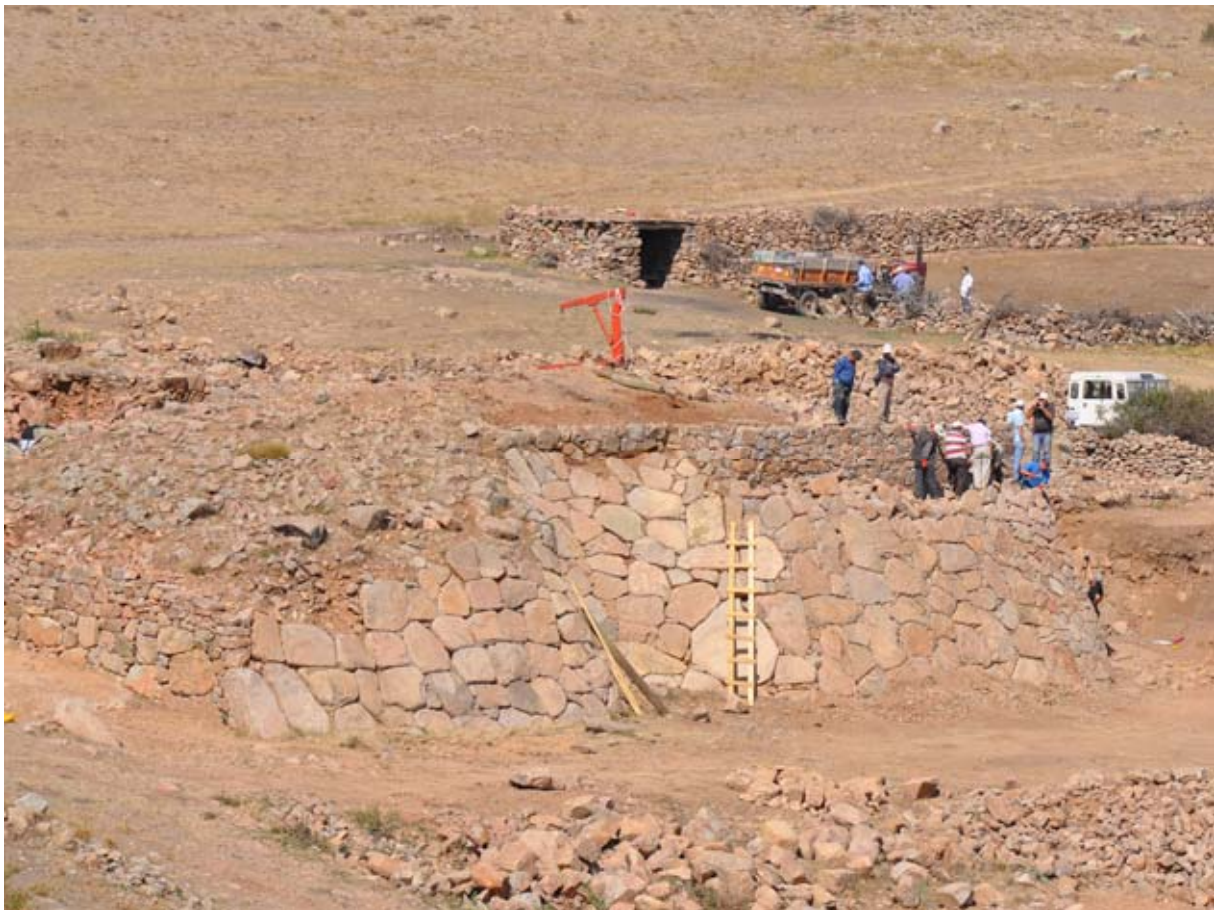
*Figure 130. Stones, previously cleared from around the Gate structure and dumped nearby, were used to restore the glacis. (10dpnd1121)*

The rubble as well as wall and glacis facing stones used for strengthening and completion were recovered from earlier excavation and cleaning work at the gate. For the wall and glacis faces the stones had to be minimally reshaped for fitting. The reconstructed glacis face on the southeastern corner of the East Tower was made with comparatively smaller stones so that it may be distinguished.

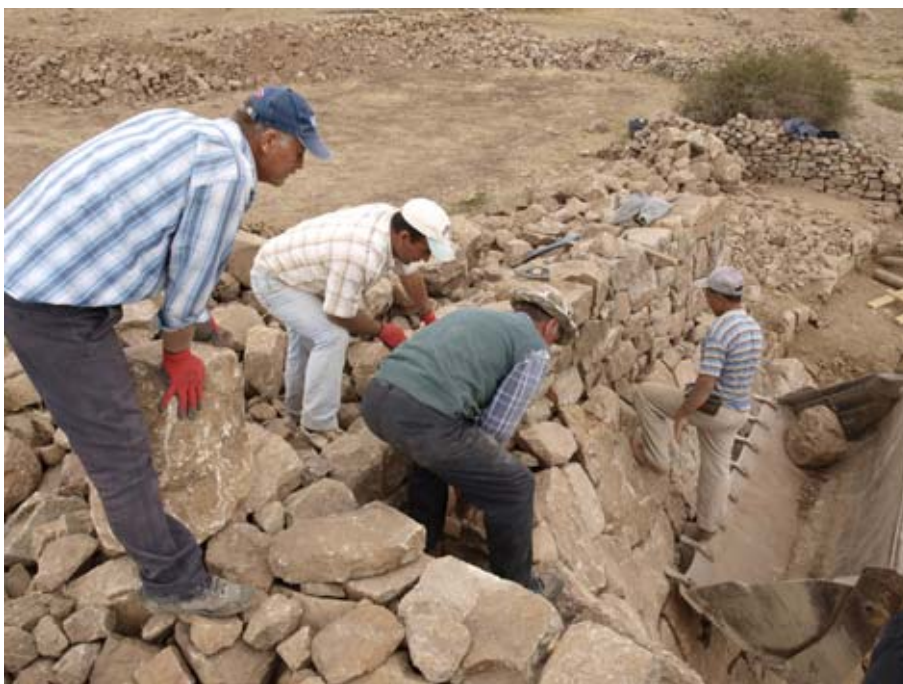
*Figure 133. Once the East Tower wall was safely built up, it was possible to raise the large city wall on top of its existing base. (10dpkc2505)*

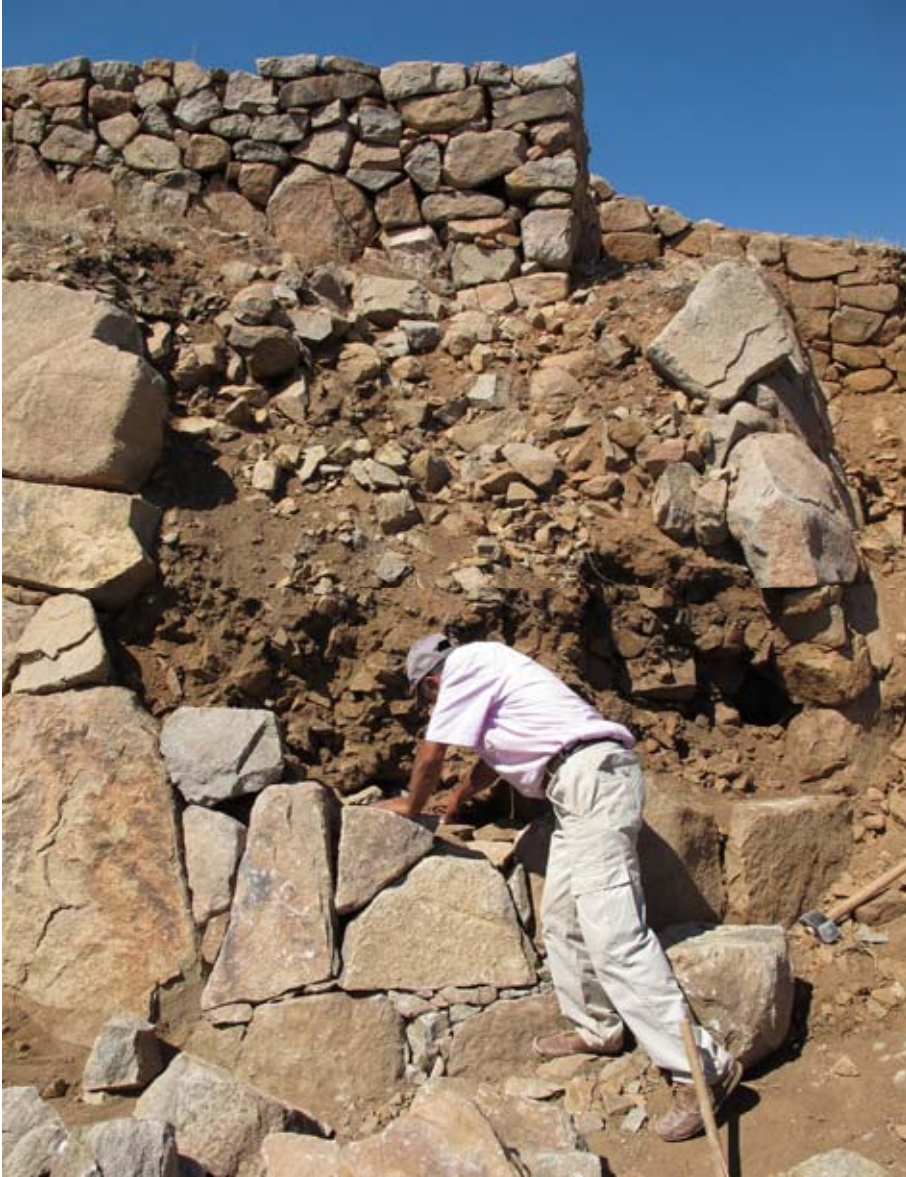
*Figure 139. Restoration of the glacis was essential if the very loose fill of rubble and soil was to be stopped from washing down. (10dpcg0301)*

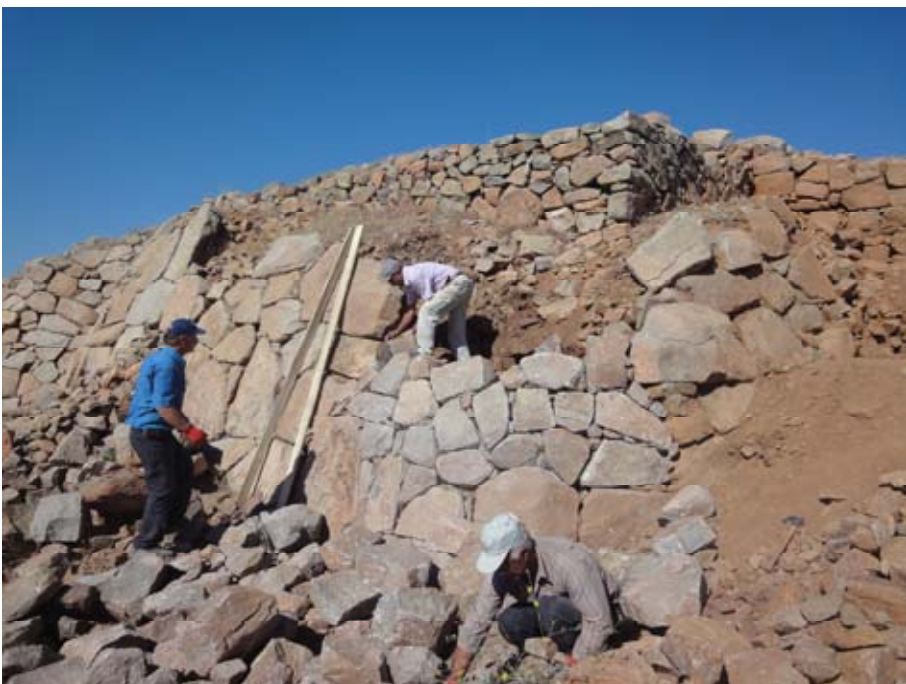
*Figure 140. The east corner was restored before the remaining portion of the glacis was uncovered, thus providing structural stability and minimising the risk of further collapse. (10dpkc3302)*

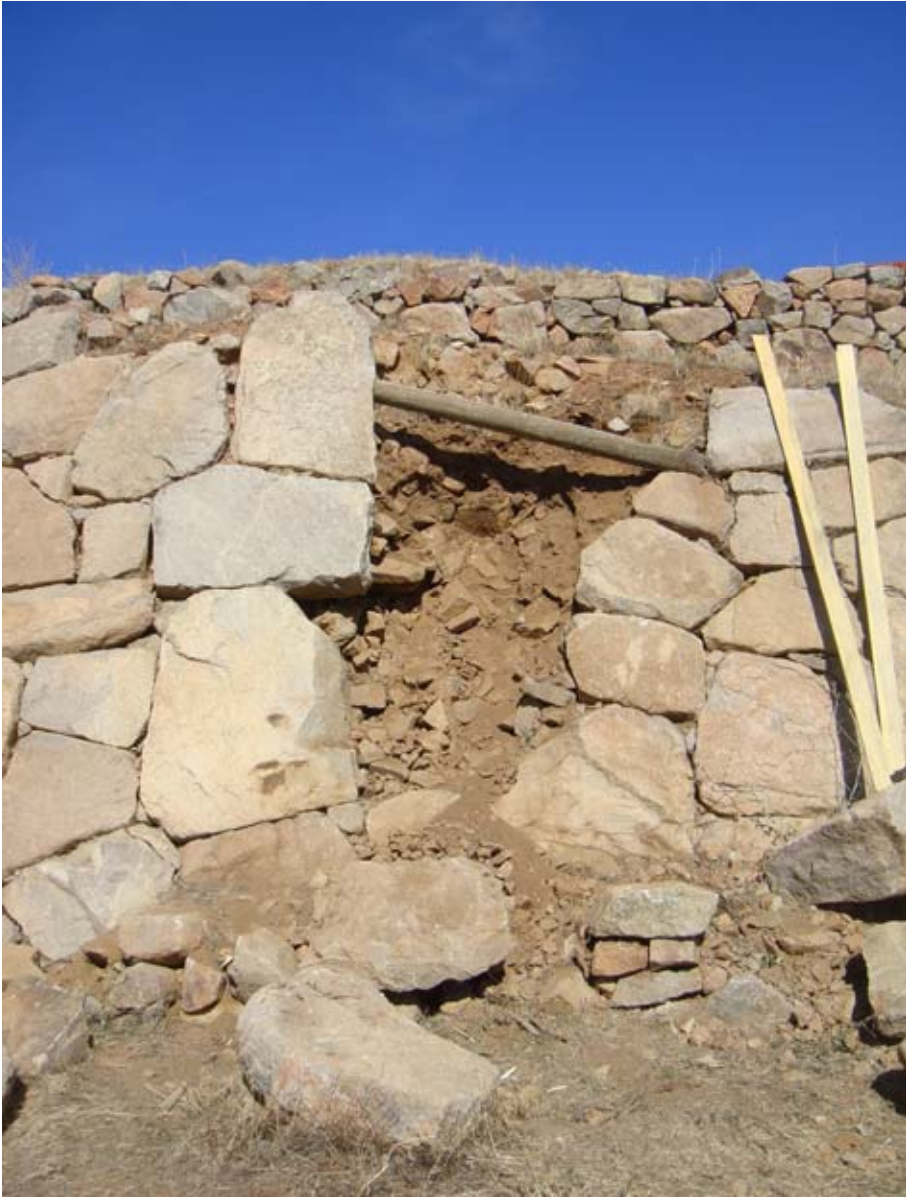
*Figure 141. The large stones that had slipped down from the southeast face were identified from photographs taken in 1999 and put back in place. (10dpkc3513)*

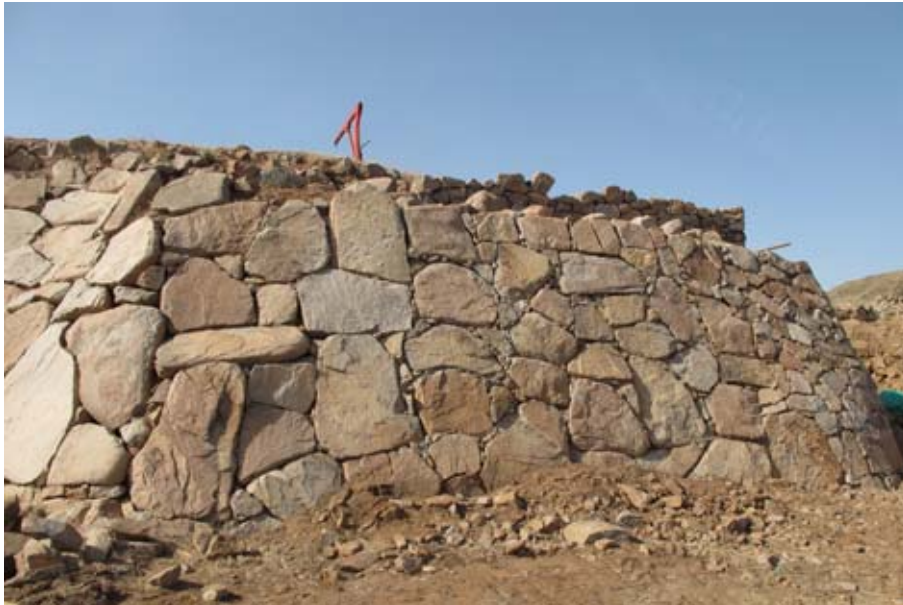
*Figure 143. Once the east side of the glacis was built up to the height of the adjacent stretch of glacis, it was found necessary to relocate two slipped stones, at left, before rebuilding the top of the glacis. (10dpcg0318)*

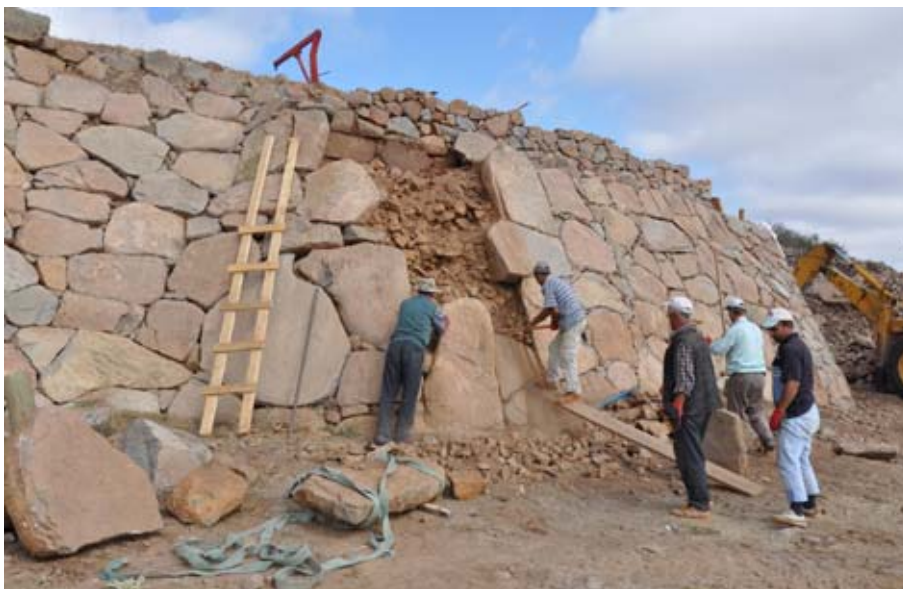
*Figure 144. The machine operator skilfully lifted the upper stones to bring them down. The large stone that had slipped forward was pushed back in line with the glacis face. (10dpnd0848)*

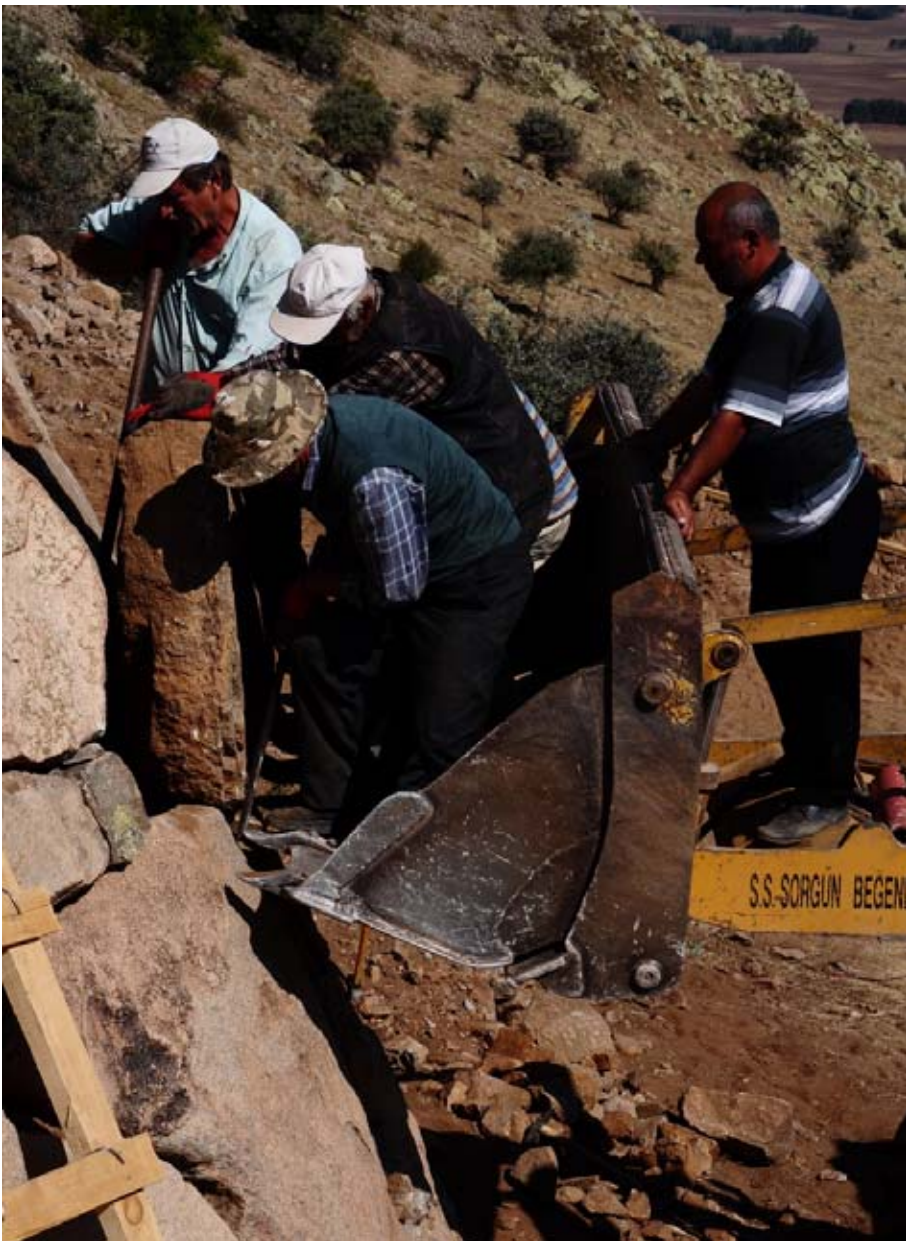
*Figure 147. Stones were lifted up and pushed back into their original position. (10dpnd0882)*

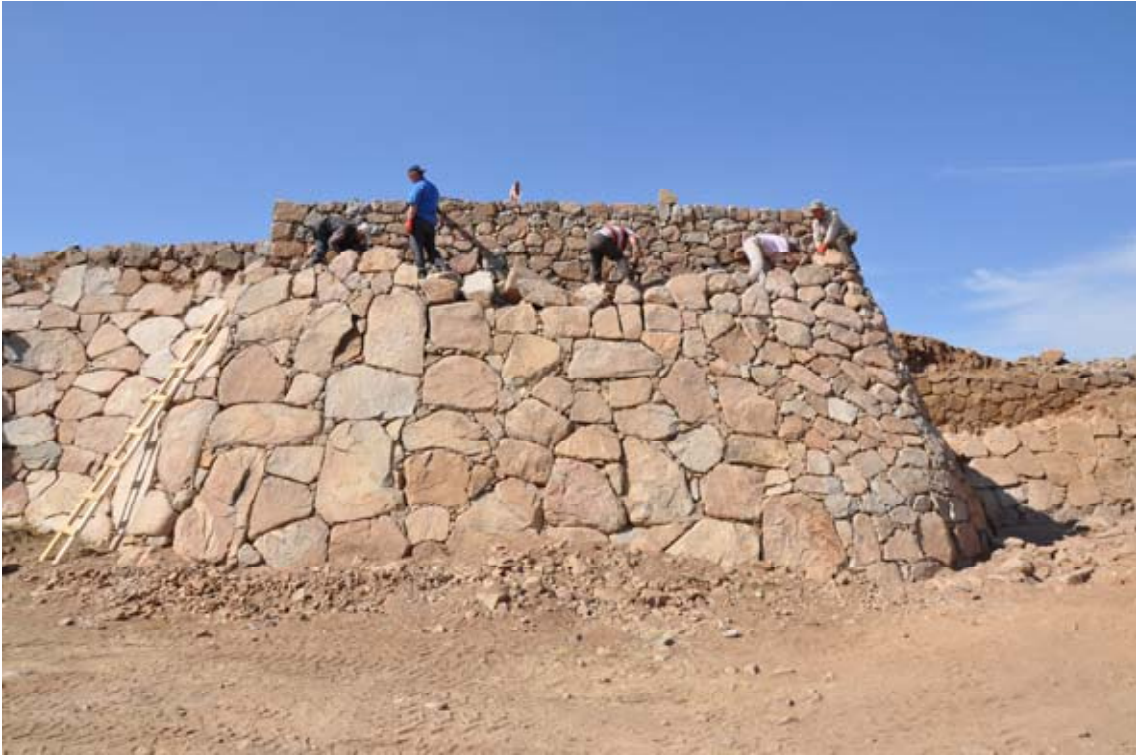
*Figure 148. Once the two large stones in front of the Middle Tower were moved back to their original position it was possible to rebuild the glacis to its original height. (10dpnd1141)*

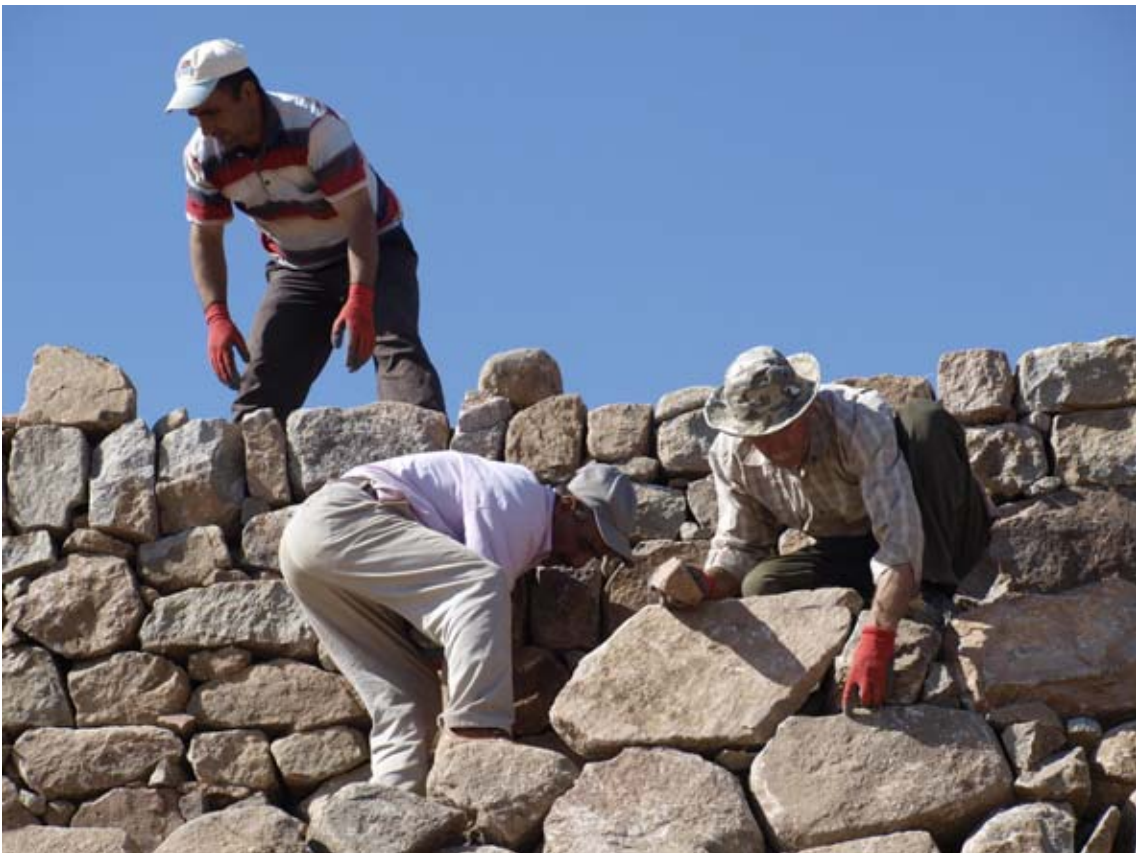
*Figure 149. Where the sloping glacis joined the vertical wall stones were carefully selected to fit in the gap. (10dpkc1936)*

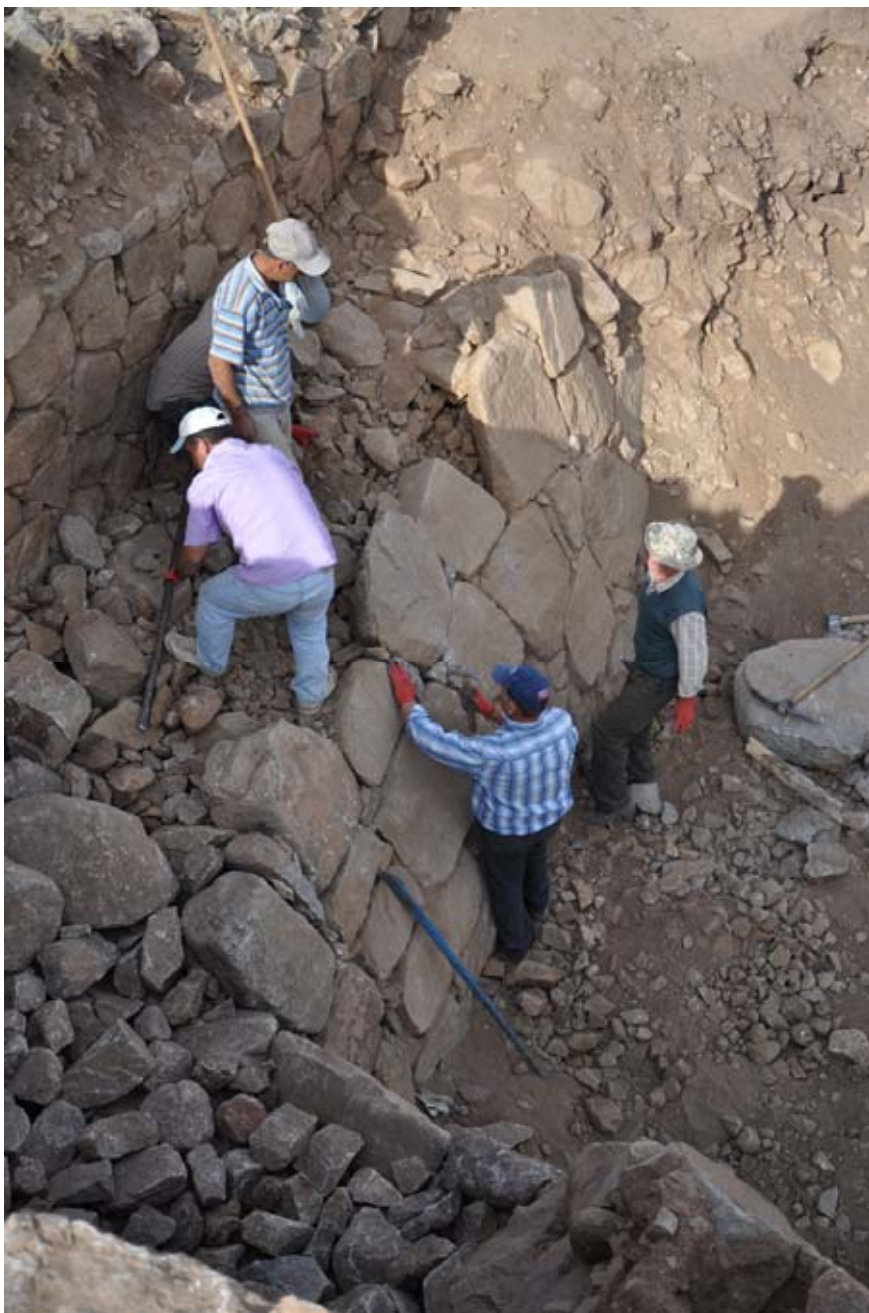
*Figure 151. The masons filled in the space behind the large glacis stones with medium and small stones. (10dpnd1376)*

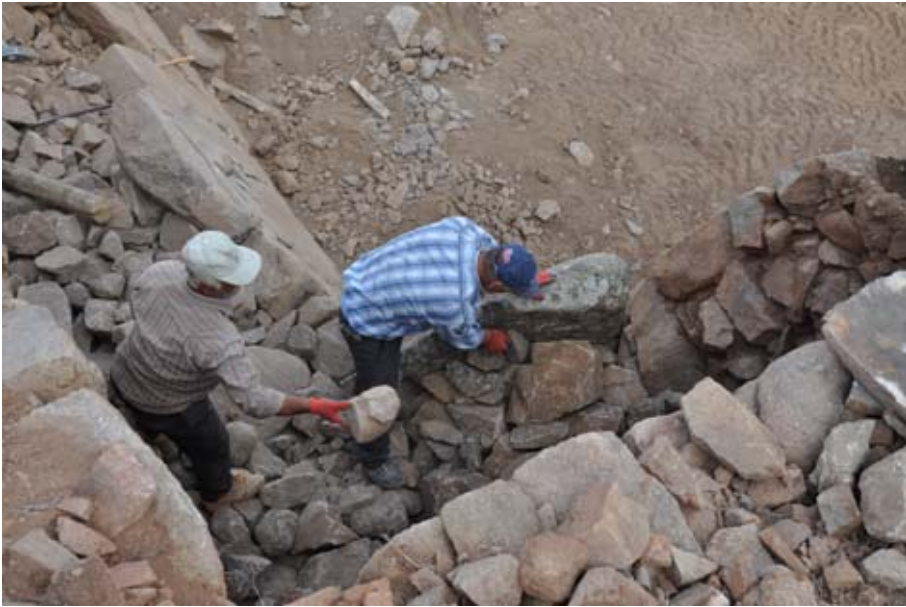
*Figure 152. Small and medium stones were selected to fill up the space behind the facing stone. (10dpnd1387)*

As the wall and glacis faces were raised the wall cores and backing behind the glacis were filled with rubble stone and compacted to stabilize them. The wall core was levelled at the glacis top level in order to prevent the existing interior wall faces and loose core rubble from sliding towards the lower exterior side. The wall face in this area was raised two courses (30-50cm) above the top level of the glacis and it was mitred on the inside, thus preventing visitors from getting too close to the exterior wall and glacis faces. The wall now rises approximately 6m above the exterior ground level, making it impossible to push the top glacis stones outwards, which appeared to be a possible form of vandalism.

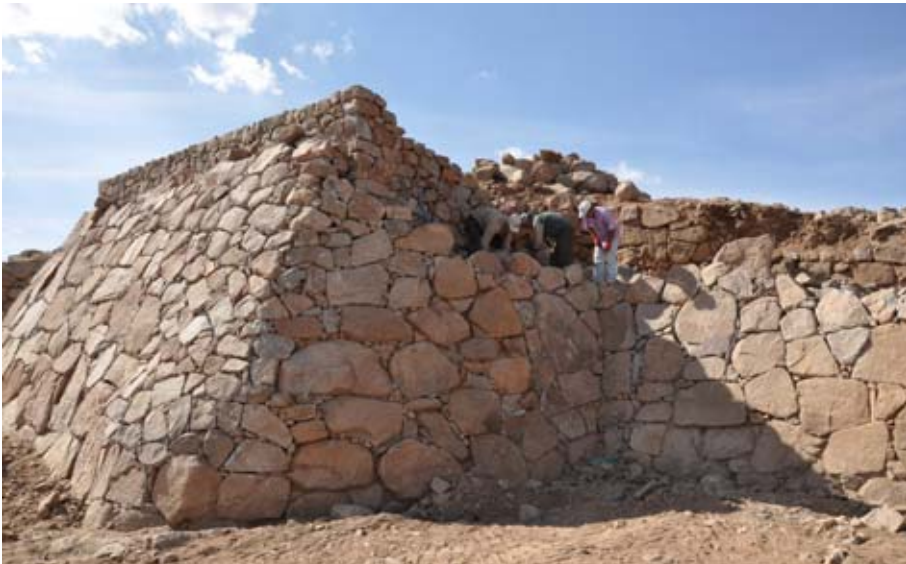
*Figure 153. The glacis was rebuilt to its full height across the junction between the East Tower and the City Wall. (10dpnd1422)*

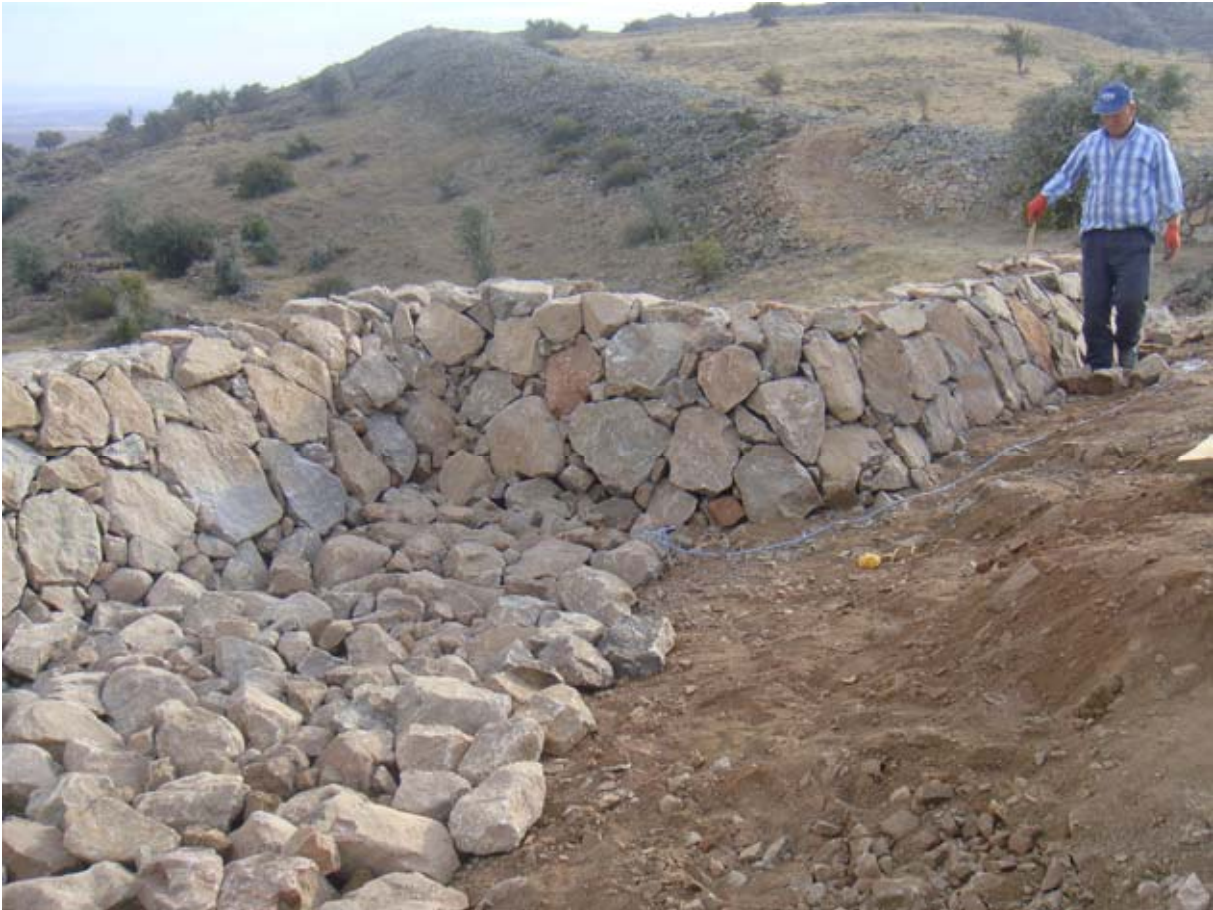
*Figure 155. As a safety measure, the restored tower walls have been raised to form a parapet preventing visitors from walking too near the edge. (10dpkc3942)*

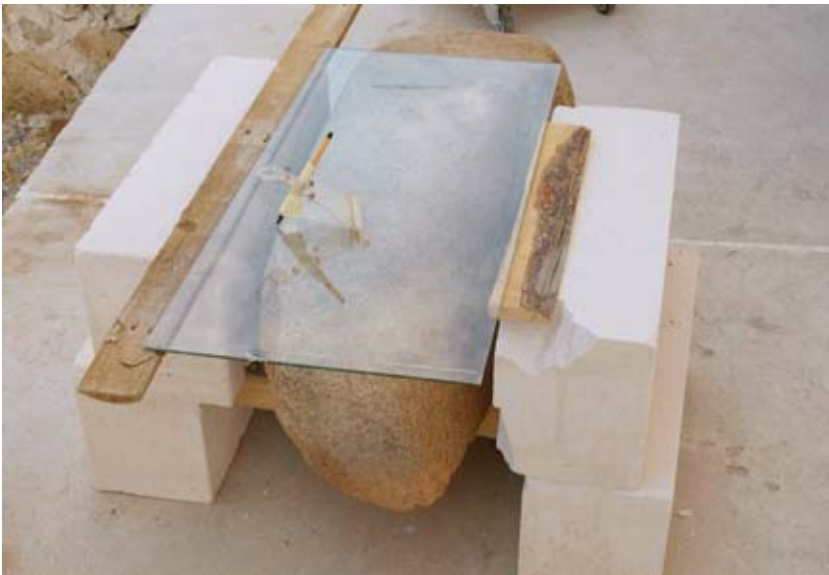
*Figure 160. A sheet of glass and a drafting pen were used to draw the outline of the stele at 1:1. (10dpkc1515)*

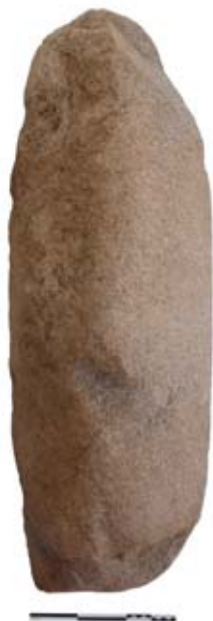
*Figure 161. Documentation is facilitated by digital photographs from which detailed drawings are produced. The scale is 30cm long. (10dpkc1510)*

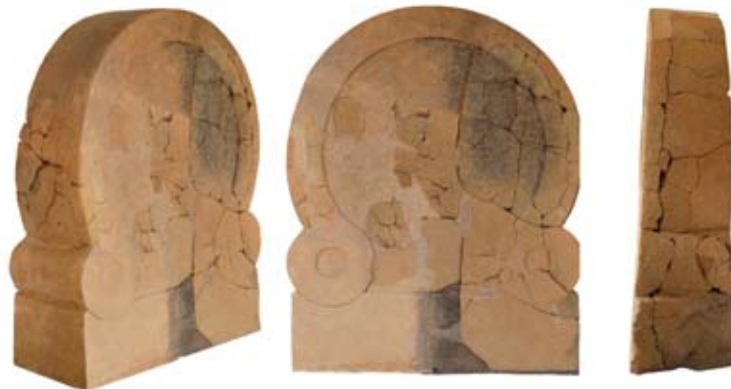
*Figure 165. The idol viewed from different angles. (10dpkc1723)*

This is the only idol that bears incised Phrygian characters, reversed Cs, one on the burnt fragment at bottom centre, the other at lower right. These idols are two-sided, but there are no incised marks on the lower portion of the reverse.

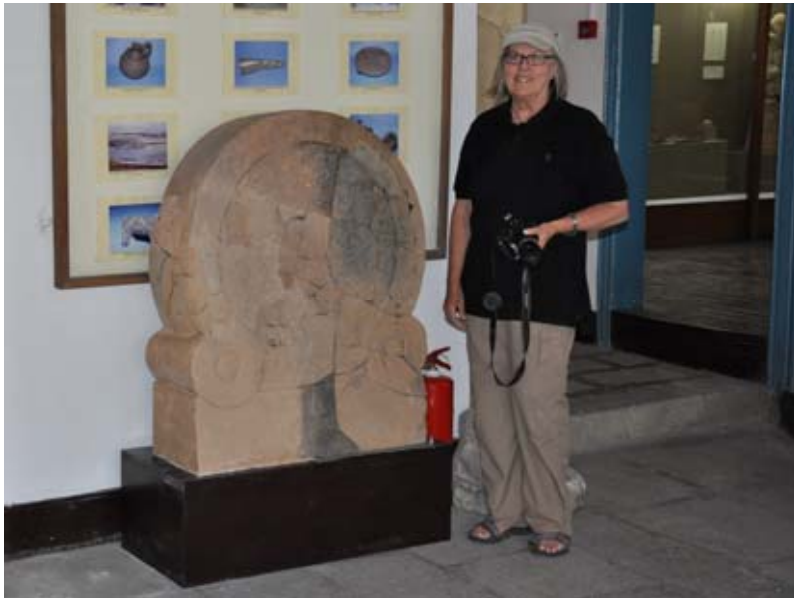
*Figure 167. The most complete of the Phrygian semi-iconic sandstone idols from the Monumental Entrance to the Palatial Complex was installed in the Yozgat Museum in 2010. (10dpnd0304)*

In a continuing effort to promote tourism, the restoration and installation of two major artifacts for permanent exhibition in the Kerkenes Dağ Gallery of the Yozgat Museum were completed this year (Fig. 162). These large stone objects were the semi-iconic Cappadocia Gate stele and the upper step of its stepped base (Figs 163 and 164) and the best preserved exemplar of the semi-iconic idols from the Monumental Entranceway to the Palatial Complex (Fig. 165). Work on this multi-year project of conservation and restoration was completed by both our conservation staff and the head preparator from the Oriental Institute Museum in Chicago, Erik Lindahl. Extensive stabilization and reconstructive work was required to complete the restoration of both pieces for public display (Figs 166, 167 and 168).

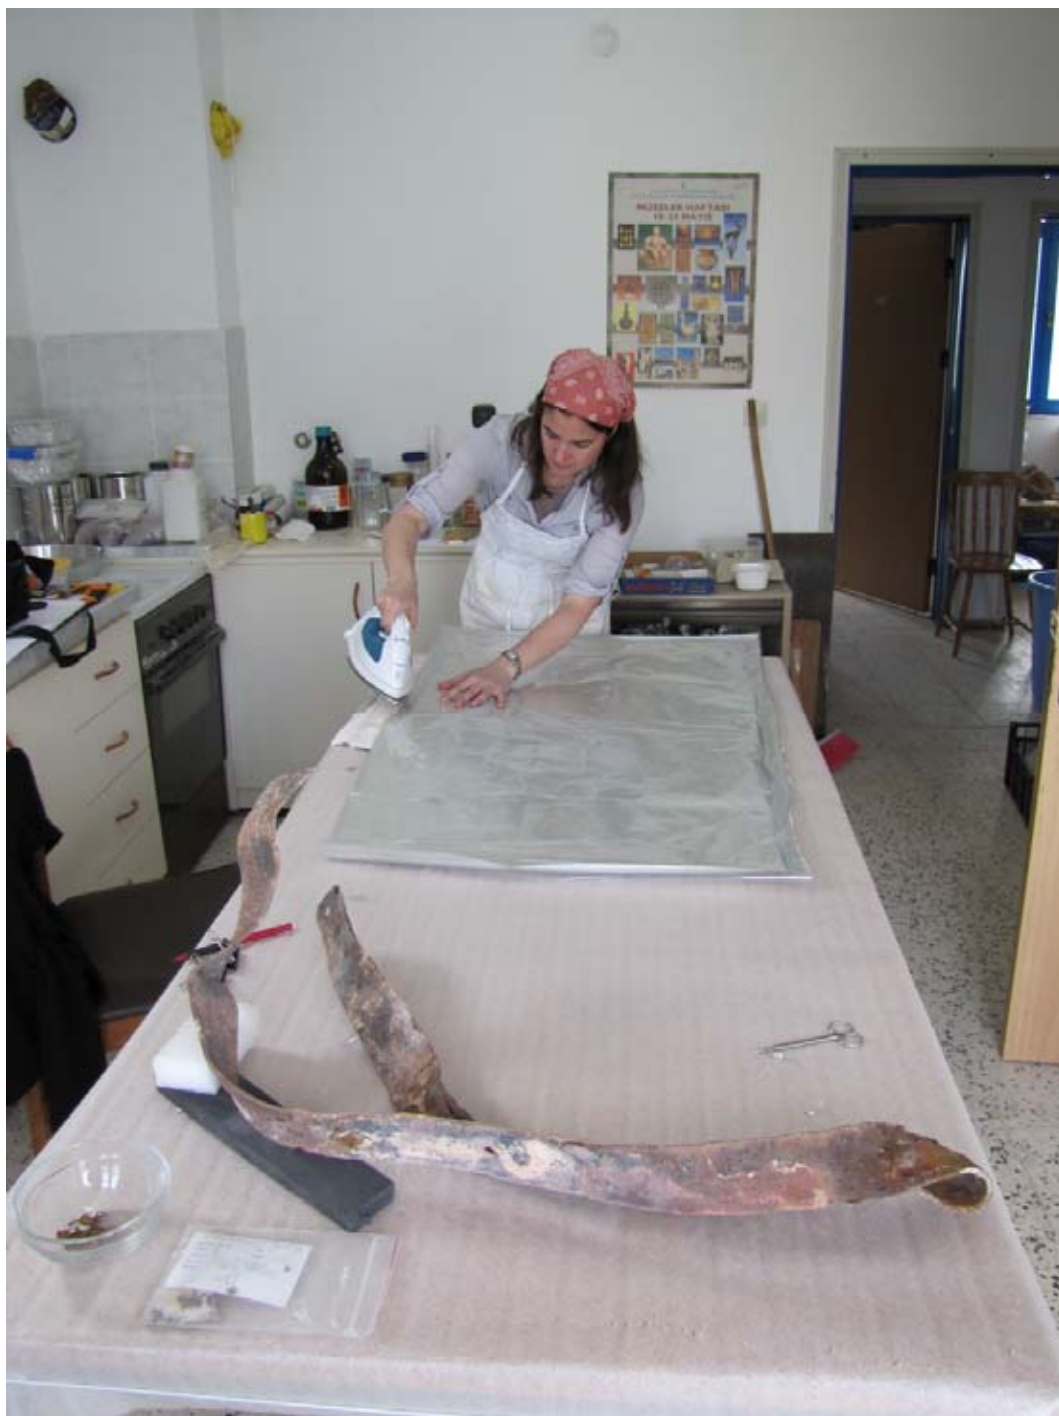
*Figure 169. Alison Whyte heat sealing ESCAL barrier film bags for storage of iron door straps from the Monumental Entrance to the Palatial Complex. (10dpkc1001)*

Additional work focused on the conservation and drawing of artifacts uncovered in 2009 and 2010, as well as limited join finding and conservation of the remaining architectural blocks and structural elements uncovered in the Monumental Entrance to the Palatial Complex in earlier seasons. The iron door straps from the Monumental Entrance to the Palatial Complex were hermetically sealed in storage bags specially constructed from ESCAL barrier film (Fig. 169).
