# THE KERKENES PROJECT

## A PRELIMINARY REPORT ON THE 2010 SEASON

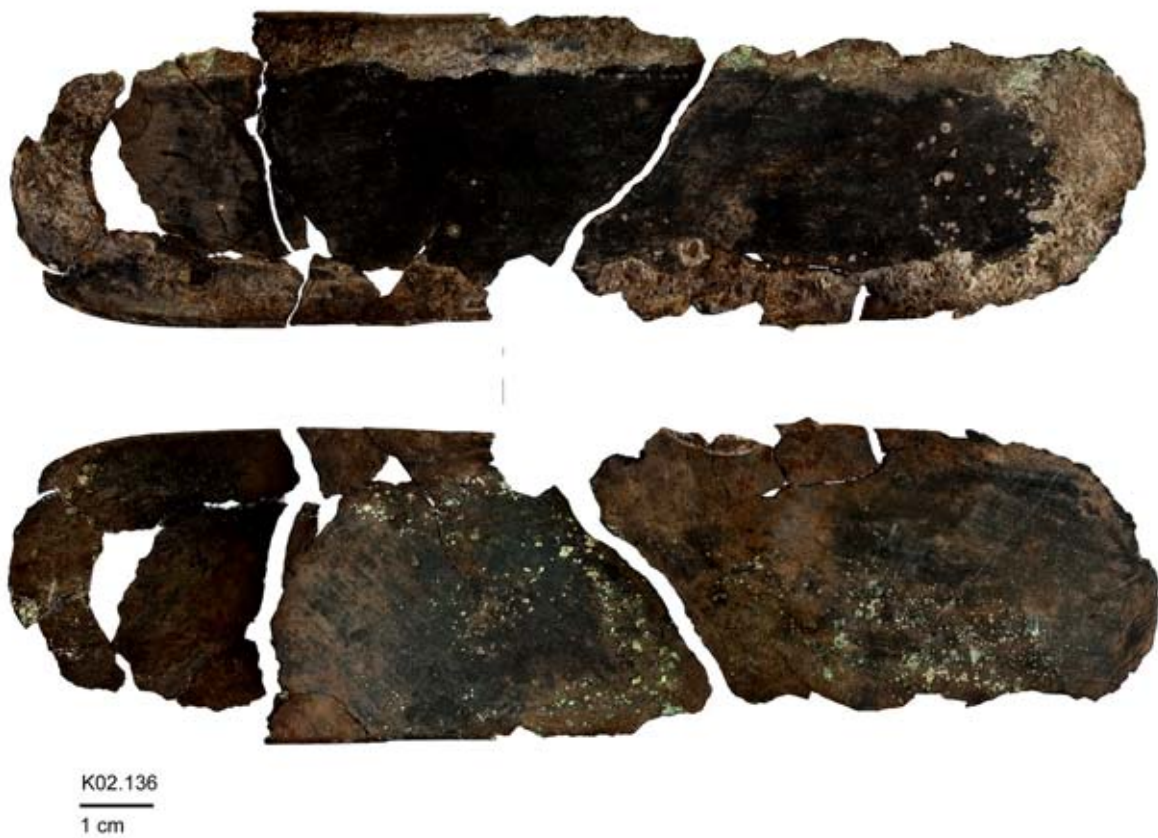
*Figure 172. Copper alloy piece with tinning, 02TR01U07met01, K02.136, from trench TR01 excavated in 2002. (10dpkc1270)*

A copper alloy piece with tinning (Fig. 172), from trench TR01 located in the Palatial Complex excavated in 2002 was among the metal objects studied.
