THE KERKENES DAĞ SURVEY

PRELIMINARY REPORT ON THE 1997 SEASON

Geoffrey and Françoise SUMMERS

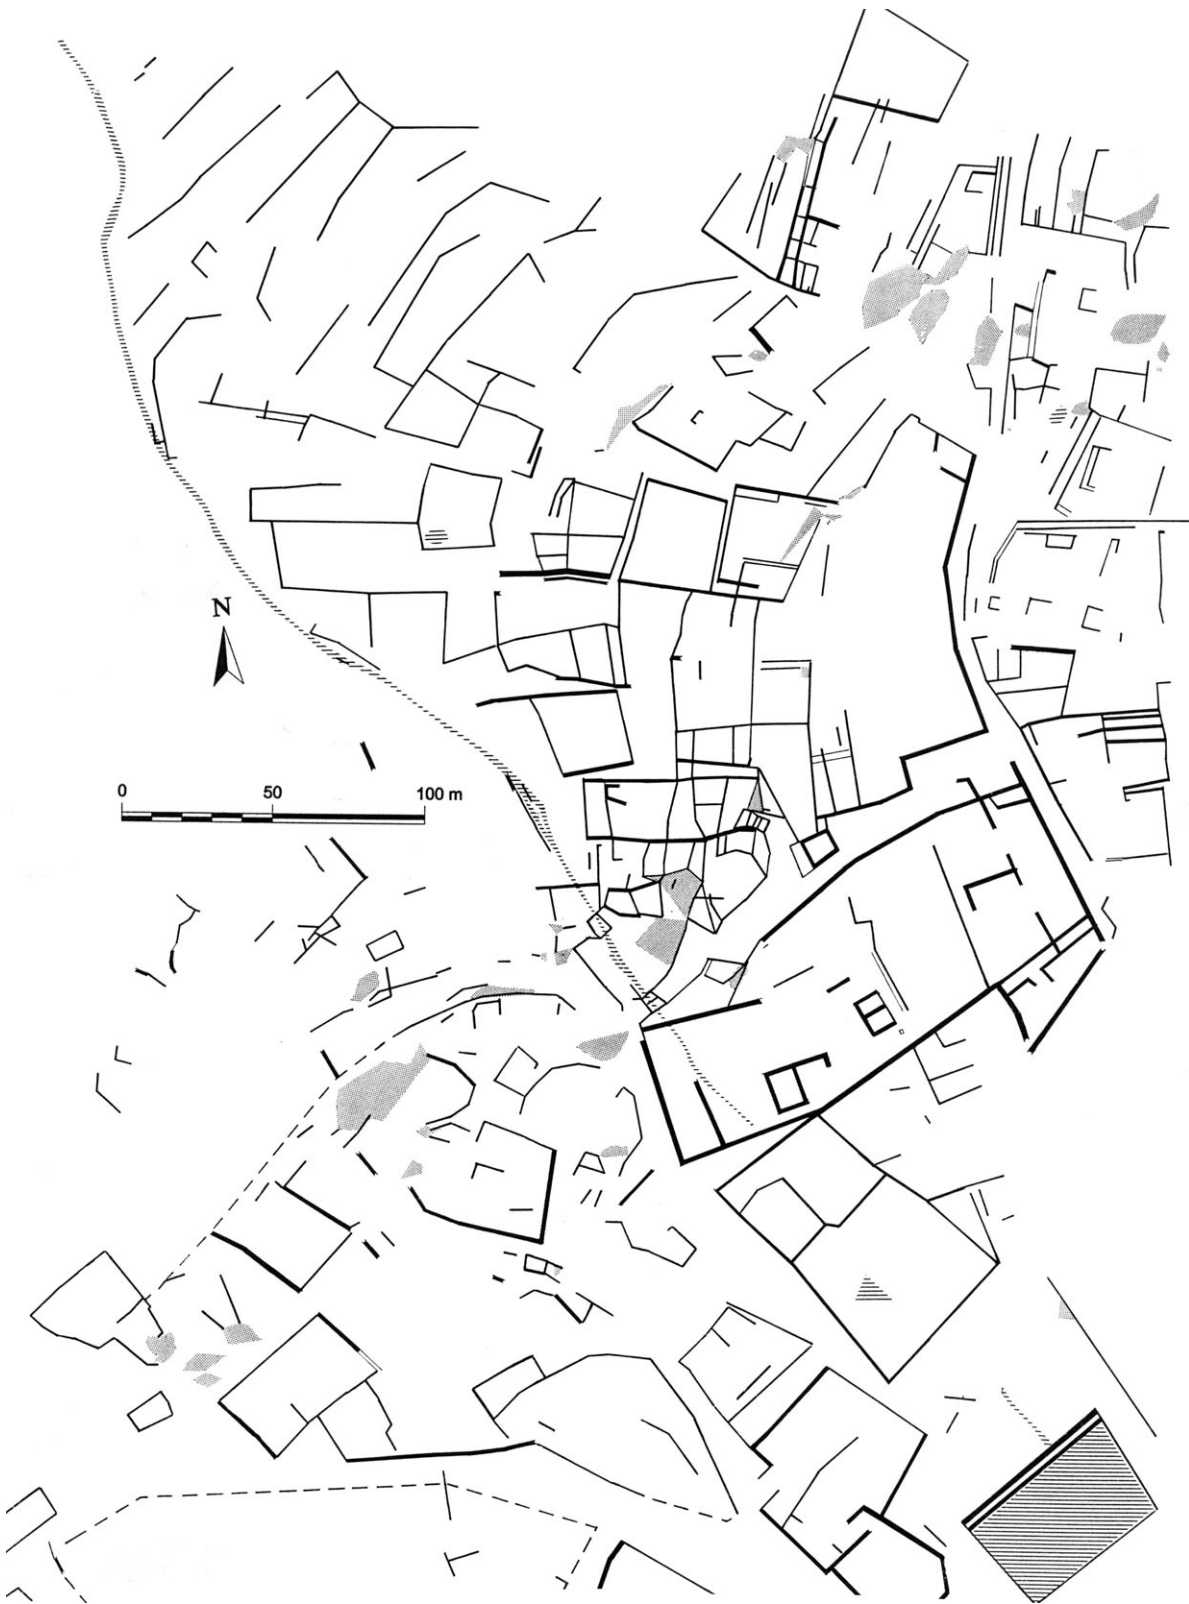
Figure 6 (Fig. 5 Plan A). Surface features: Sülüklü GOI at bottom right, urban blocks, terraces, streets & passages on steep slopes below the Kale are NE of the stream, those on the slopes below the “Public Zone” are SW of the stream.

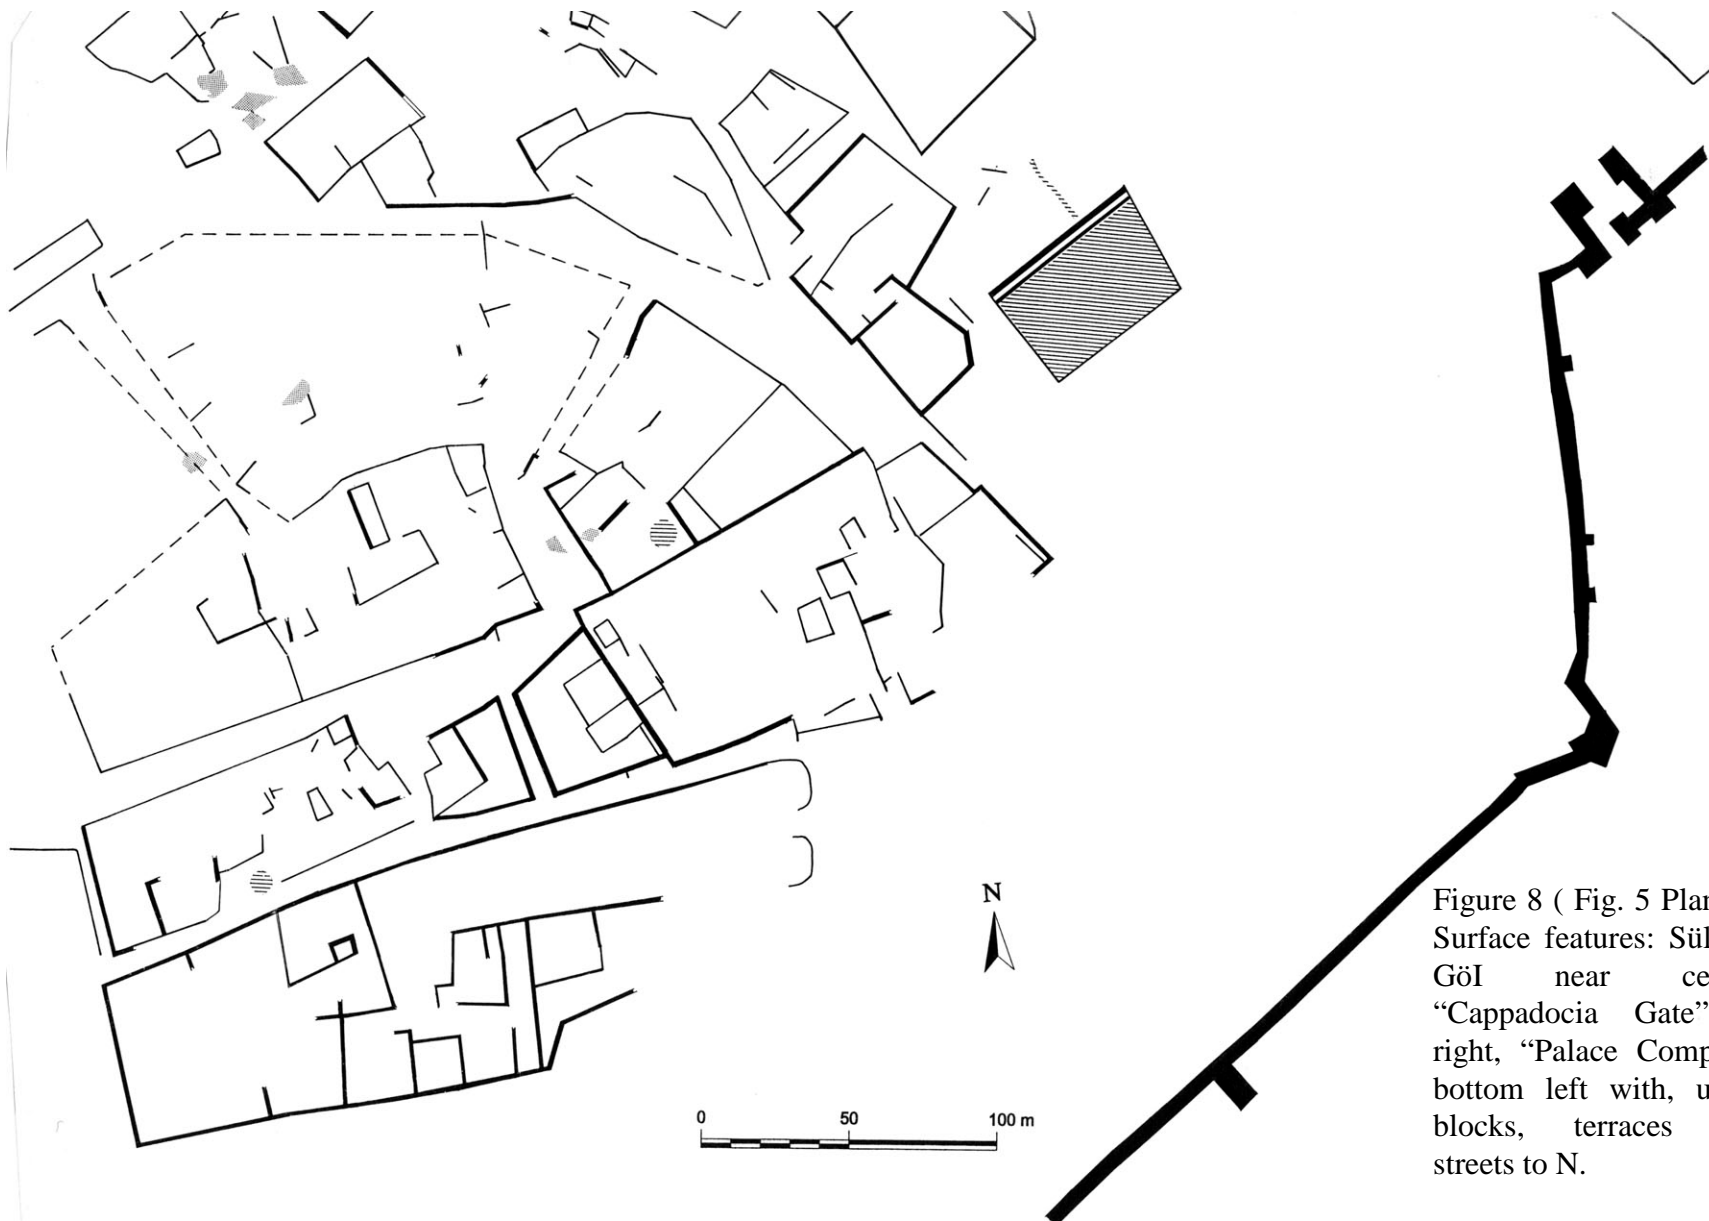
Figure 8 (Fig. 5 Plan C). Surface features: Sülüklü GÖI near centre, "Cappadocia Gate" at right, "Palace Complex" bottom left with, urban blocks, terraces and streets to N.
